Aviation Occurrence Investigation AO-2009-032

Final

**Collision with terrain**  
**Gold Coast Aerodrome, Queensland**  
**2 July 2009**  
**VH-OML**  
**Robinson Helicopter Company**  
**R22 Beta II**

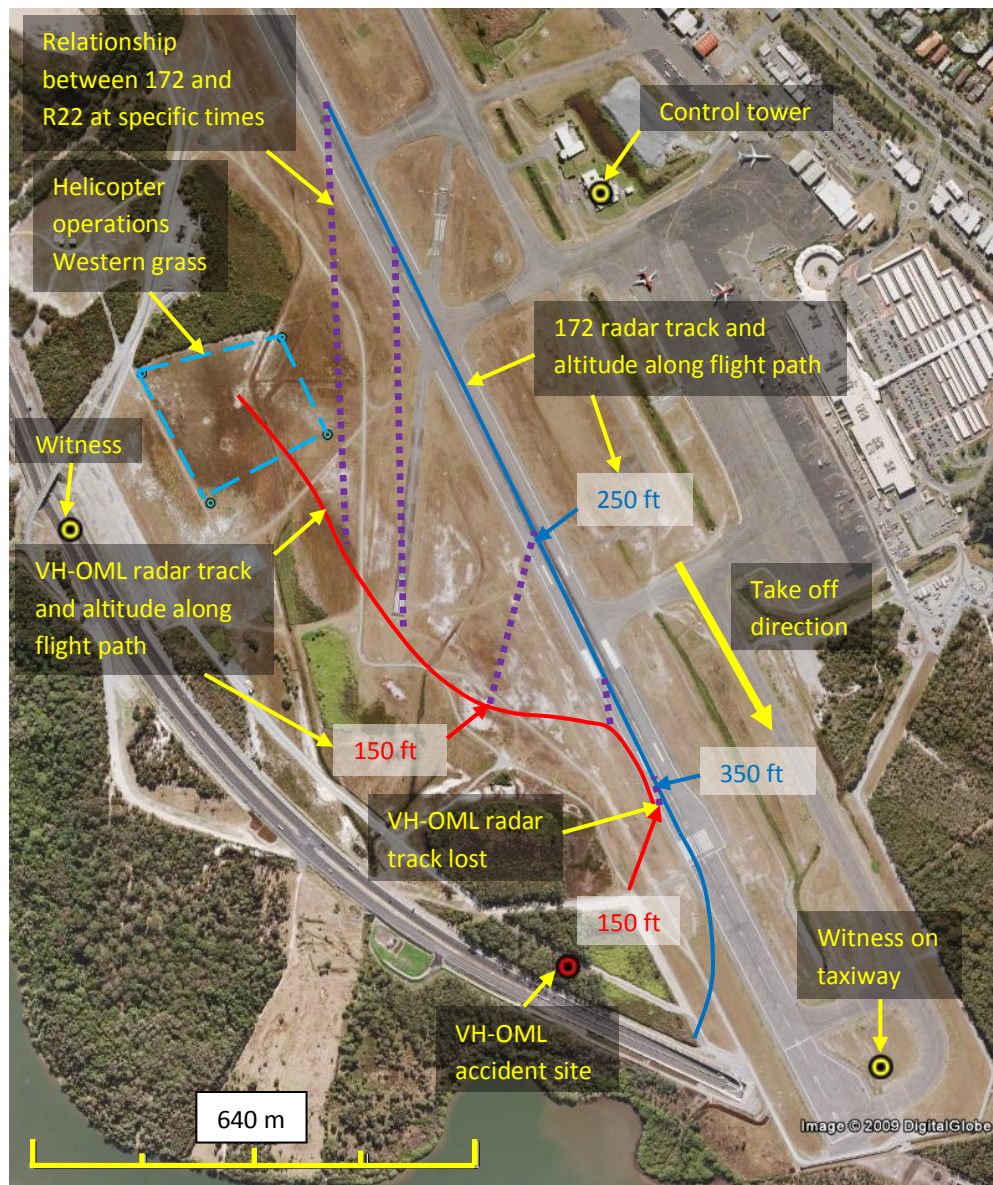
**Figure 1: Gold Coast Aerodrome overview**

A replay of the recorded air traffic control radar data indicated that, after takeoff, the helicopter commenced a slow, gradual climbing left turn to a height of about 200 ft above mean sea level (AMSL) (Figure 1). When the helicopter was almost over the boundary of the runway 14 flight strip, it turned right and descended. The 172's radar track showed it to be slightly right (or west) of the runway centreline, and about 84 m to the left and behind the helicopter at that time.

The wreckage of the helicopter was located about 240 m to the west of the runway 14 centreline (Figure 1). The wreckage, including pieces of the tail boom skin, tail rotor driveshaft and tail rotor, was dispersed in a heavily wooded area, over a distance of about 130 m (Figure 2). The approximate bearing of the wreckage trail was 120°. The helicopter came to rest facing back along the direction of flight, lying on an angle of about 30° to the right of vertical (Figure 3).
