**Bureau of Air Safety Investigation**

INVESTIGATION REPORT

9403038

**Boeing 747-312 VH-INH  
Sydney (Kingsford-Smith) Airport  
New South Wales  
19 October 1994**

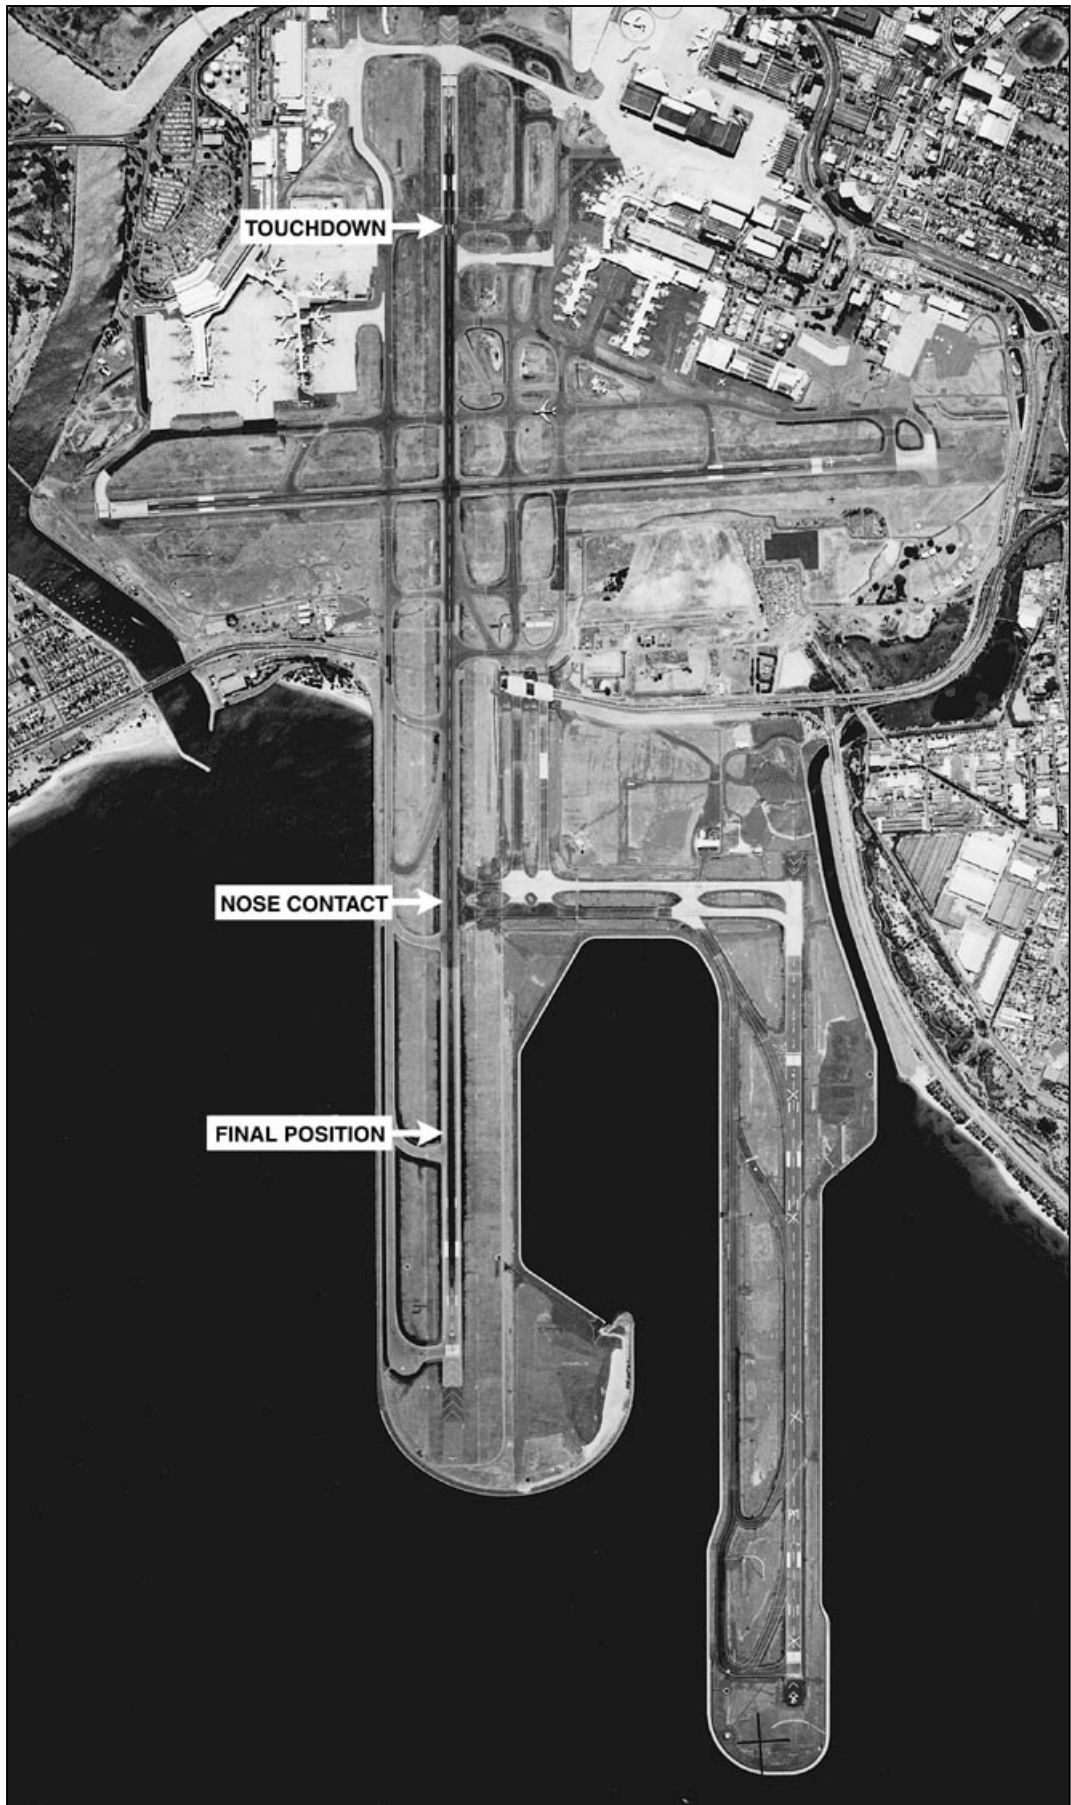
**Figure 3.** Photograph of Sydney Airport indicating the approximate touch-down, nose contact and stop points on R/W 16.

The aircraft touched down approximately 540 metres from the threshold of runway 16 (now 16R), abeam taxiway F (see figure 3). It came to a halt in the centre of the runway with its nose approximately 50 metres north of the entrance to taxiway A5. A scrape mark on the runway indicated that the fuselage first contacted the runway surface adjacent to the island between taxiways B10 and B11 (see below). The scrape mark continued for 810 metres to the point where the aircraft stopped. The total distance from the initial touchdown of the aircraft to the point where it stopped was approximately 2,770 metres.

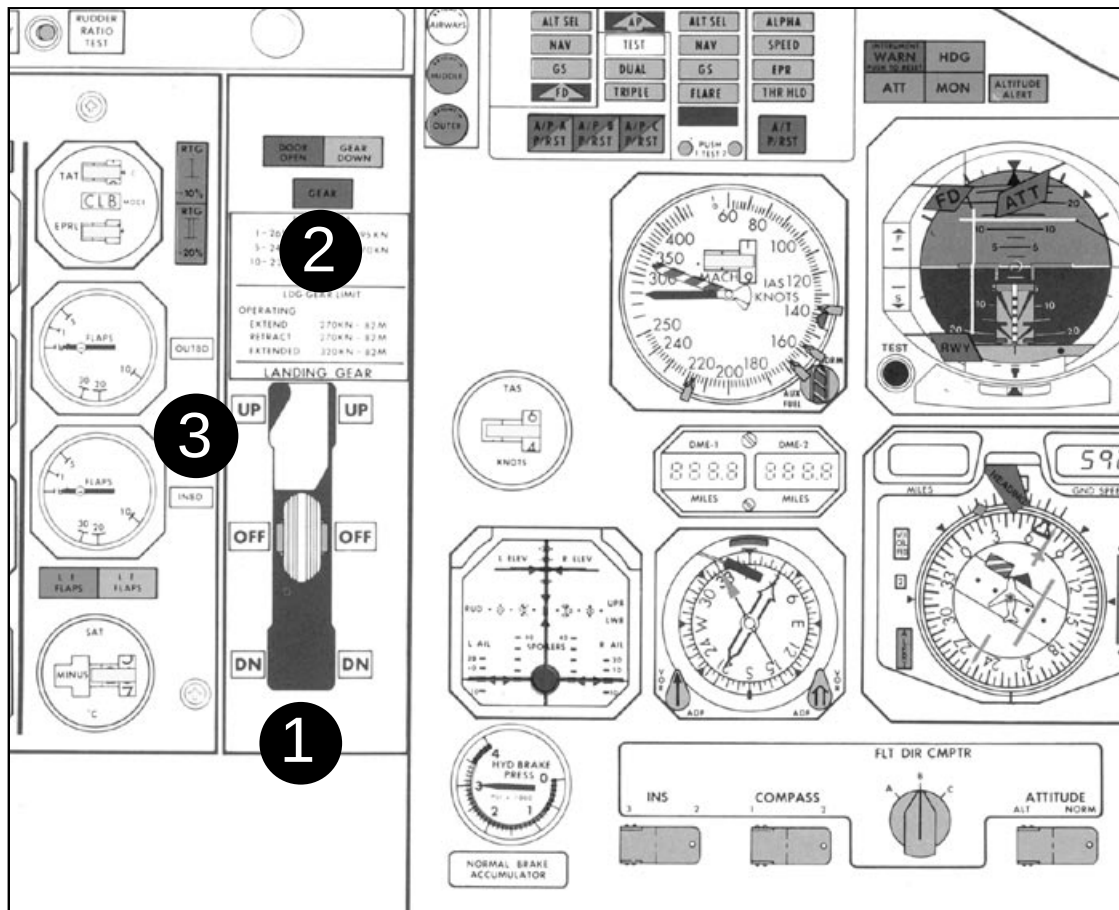
**Figure 6.** Portions of centre and co-pilot instrument panels with landing gear selector handle (1); red gear unsafe light (2); and inboard flap indicator (3) marked.

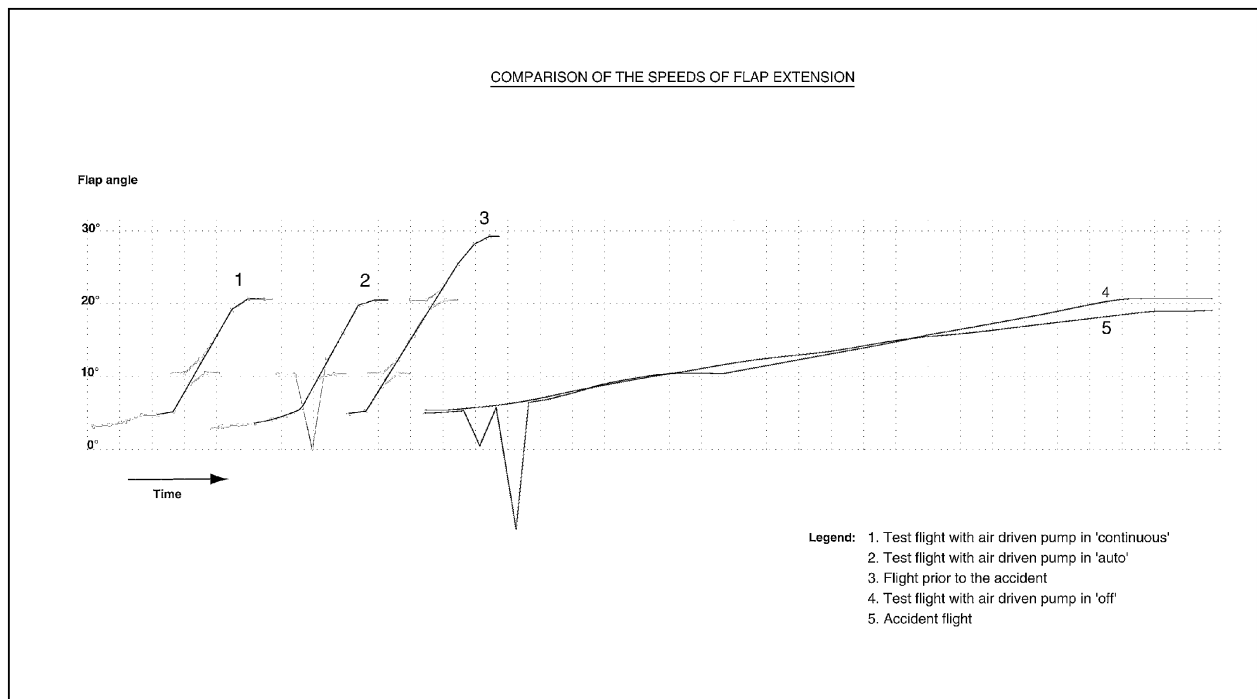
The data from the flight preceding the accident flight, the accident flight and the three simulated approaches from the test flight were integrated into one graph, which is shown in figure 11.

**Figure 11.** Reproduction of the combined flight data recording output for the accident and the test flights. The principle area of focus is flap movement.

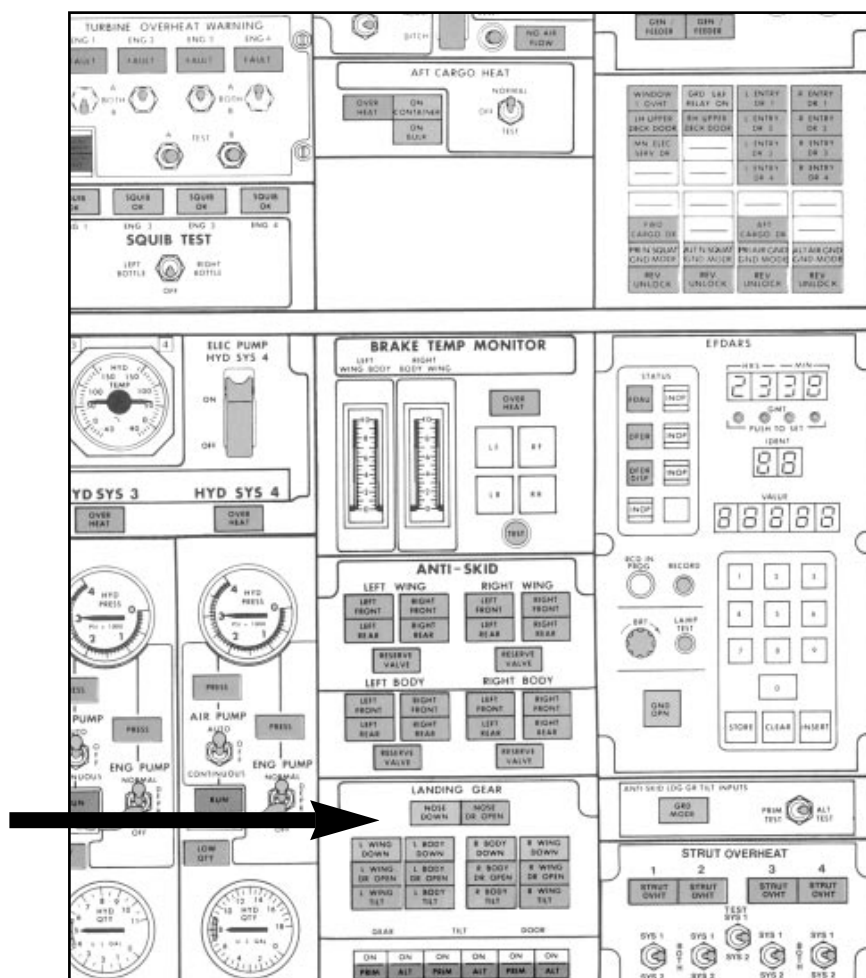
The investigation team discovered that some of the B747 fleet from an Asian airline had fine lines bordering critical groups of instruments on the pilots' and the flight engineers' panels. In particular, there were fine lines added to the flight engineers' landing gear annunciator panels apparently so as to better define the five lights as a unit. Inquiries were unable to determine why the airline took such steps.

**Figure 12.** Portion of the lower flight engineer panel. The landing gear annunciator panel is indicated.
