Aviation Occurrence Investigation – AO-2008-078

Final

Wirestrike
13 km north of Murray Bridge, SA
19 November 2008
VH-PLJ
McDonnell Douglas 369D

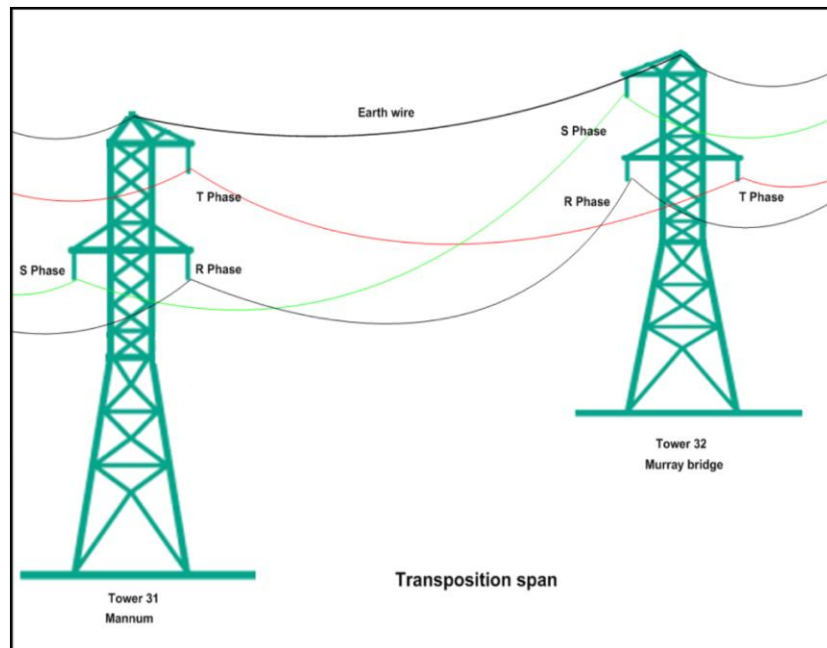
Figure 6: Mid-span transposition

In the case of a mid-span transposition, the insulator arrangement on consecutive spans is rotated, allowing the 'R' phase conductor to pass underneath the 'T' phase conductor to an insulator on the opposite side of the next tower. Similarly, the 'S' phase position is changed from bottom to top on the same side of the two affected towers. That was the situation between towers STR0031 and STR0032 on the Mannum to Mobilong line (Figure 6). A mid-span transposition results in structural differences between adjacent towers and electrical industry personnel indicated that the best means of identifying mid-span transpositions was through the in-flight recognition of those differences.

There were no tags or similar attachments to the towers, conductors or joiners to alert crews to a transposition section, nor was there any standard or other regulatory requirement to do so.

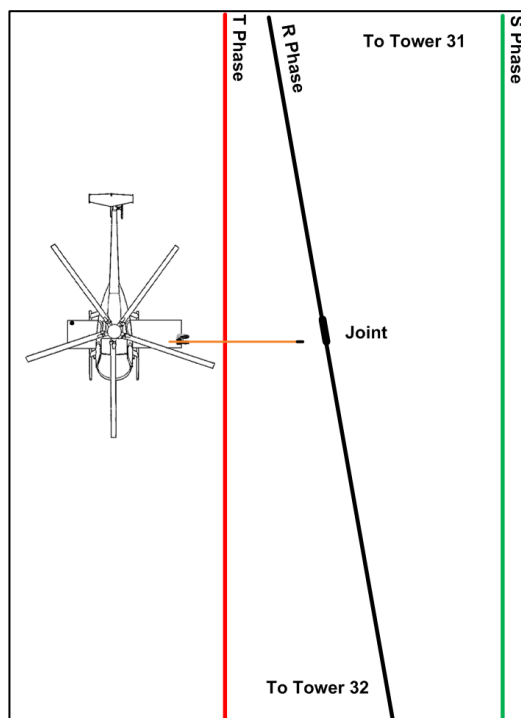
Figure 7: Relative positions of the helicopter and conductors

A plan view representation of the position of the helicopter and conductors adjacent to the 'R' phase conductor joint between towers STR0031 and STR0032 is at Figure 7.¹⁹ The consequence of the 'R' phase diverging from underneath the 'T' phase was that, in order to joint test the 'R' phase, the helicopter's main rotor blades were placed closer to the 'T' phase.

¹⁹ The representation is not to scale and the angle that the 'R' phase crosses from the side of one tower to the other tower has been expanded for clarity.

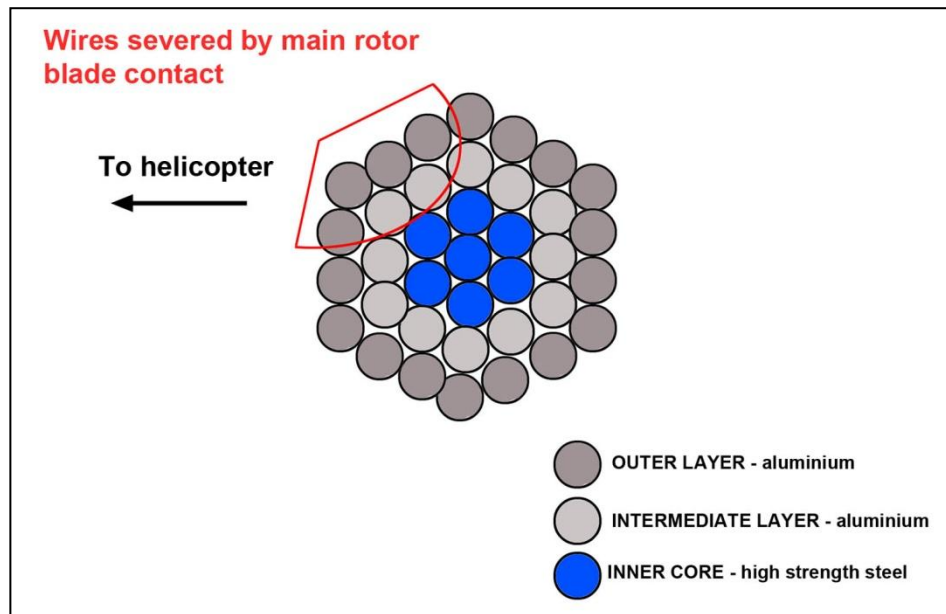
Figure 14: Conductor cross-section

The damaged conductor was comprised of outer and intermediate layers of 18 and 12 counter-woven aluminium alloy wire strands respectively, and an inner core of seven high strength steel wire strands. The aluminium alloy wires were used for their electrical conductivity properties, while the steel wires provided the strength necessary for suspension between the transmission towers (Figure 14).

All of the severed wires at the first point of contact with the main rotor blade were grouped at the same weave location, near the upper-outer quadrant. A total of about 8 m of conductor was damaged from the contact with the helicopter.

The majority of the damage to the conductor was to the outer and intermediate layers of aluminium wire. The aluminium wires at the Mobilong end were severed and splayed outward from the main weave, while those at the Mannum end were bunched into a loosely coiled, 1 m length (Figure 15). That damage was consistent with the anti-clockwise rotation (when viewed from above) of the helicopter's main rotor blades.

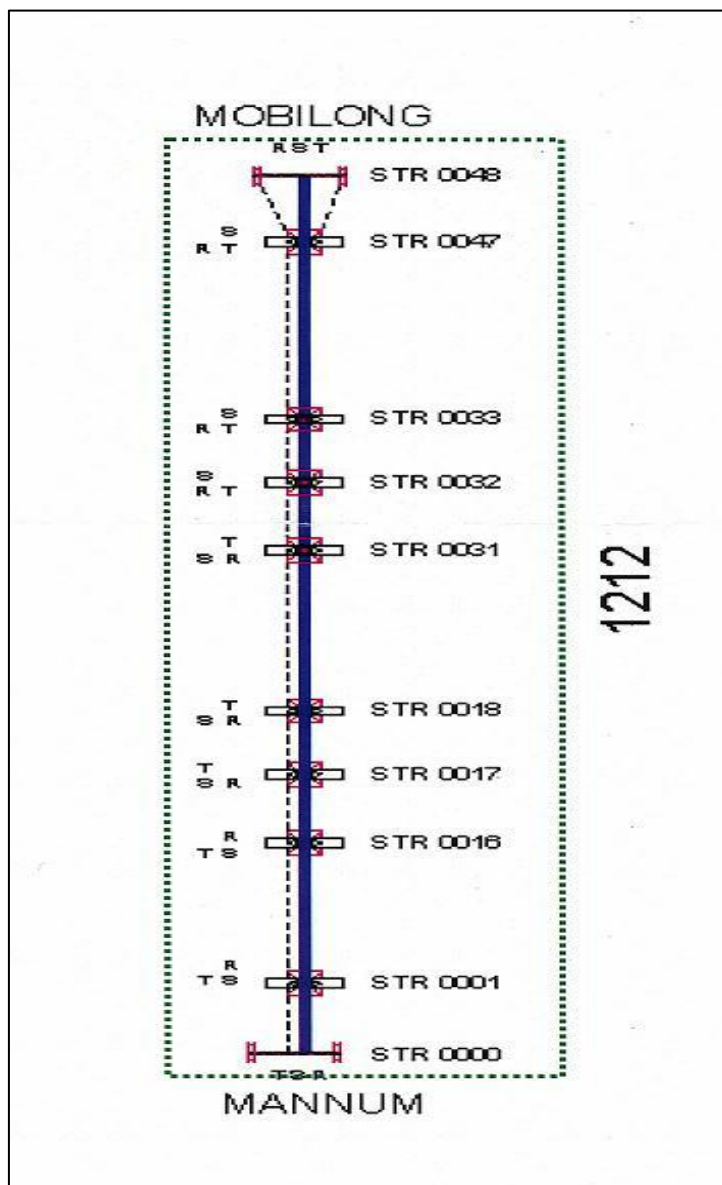
Figure 16: Mannum to Mobilong connectivity diagram

The connectivity diagram for the Mannum to Mobilong feeder line showed the ‘R’, ‘S’ and ‘T’ phase positions and tower numbers for that line (Figure 16). From that information, the location of any transpositions could be established by comparing the phase position information (as depicted by the position of the ‘R’, ‘S’ and ‘T’ phases) between consecutive towers.²⁸ For example, there were transpositions between STR0016 and STR0017, and between STR 0017 and 0018, while the phase positions remained unchanged between STR0018 and STR0031 and STR0001 and STR0015. Similarly, the diagram showed that there were transpositions between STR0031 and STR0032, and STR0032 and STR0033.

The maintenance provider forwarded a copy of the asset owner's project brief to the helicopter operator. The operator advised that they received a spreadsheet detailing the joint locations but had never received a connectivity diagram or line schedule from the maintenance provider prior to the occurrence.
