ATSB TRANSPORT SAFETY REPORT
Marine Occurrence Investigation M0-2009-011
No. 271
Final

Engine room fire on board the container ship *Maersk Duffield* in Moreton Bay, Queensland 10 December 2009

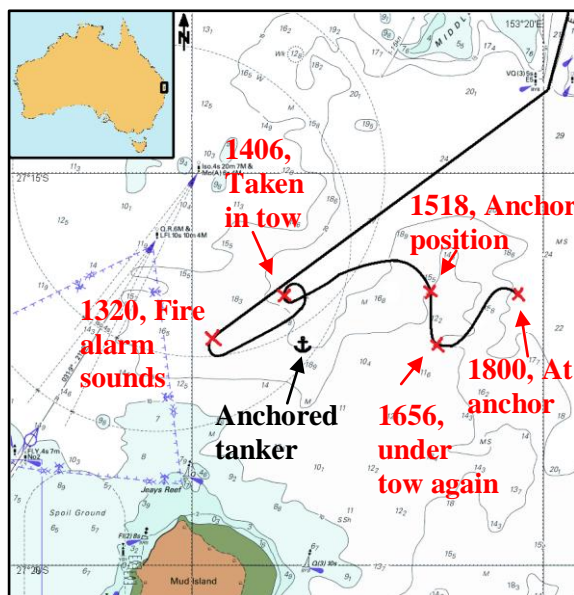
Figure 6: Section of chart Aus 236 showing *Maersk Duffield's* track.

At this time, *Maersk Duffield* was outside the Moreton Bay shipping channels and approaching an anchored gas tanker. The pilot immediately ordered hard to port to turn the ship around (Figure 6) and set it on a heading of about 040°(T). He then reported the fire to the Brisbane Vessel Traffic Service (VTS) and requested tug assistance for the ship.

At 1406, the tug *Wilga* was made fast forward and, following the pilot's instructions; it started pulling the ship away from the anchored tanker (Figure 6). At about 1427, the tug *Newstead* arrived and it began pushing on *Maersk Duffield's* stern.

At 1800, towing ceased in position 27°16.34' S, 153°19.8' E (Figure 6) and the ship was brought up at anchor.
