ATSB TRANSPORT SAFETY INVESTIGATION REPORT Rail Occurrence Investigation 2004/005 Final

Derailment of Train 4VM9-V Benalla, Victoria

23 September 2004

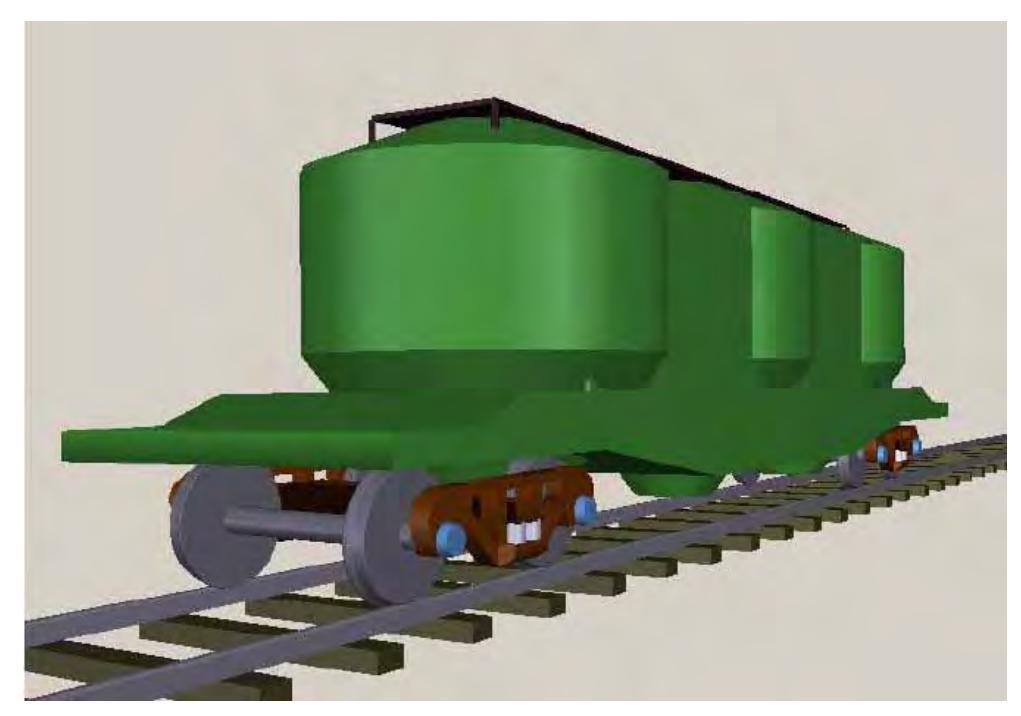
Figure 20: Vampire generated model of VPBX type wagon and track

The vehicle simulation was run over 5000 metres of irregular track. Vertical and lateral accelerations were predicted at various points on the body, plus rotational acceleration at the body centre of gravity in roll, pitch and yaw directions. The dominant body frequencies were identified as follows:
