ATSB TRANSPORT SAFETY INVESTIGATION REPORT

Rail Occurrence Investigation 2006/001

Derailment of Freight Train 3AB6

Yerong Creek, New South Wales

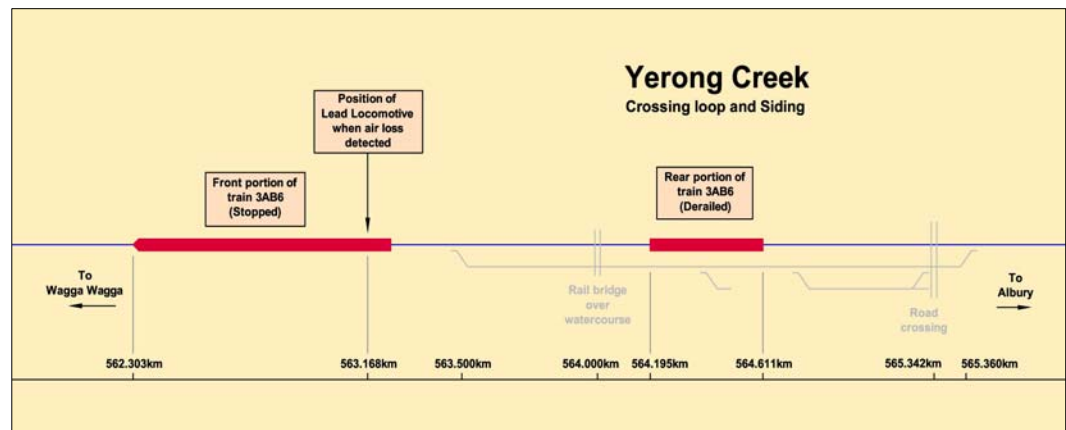
Figure 3: Overview of train location

The crew found that the train had separated at the coupling between the 40th and 41st wagons and that the eight wagons following the 40th had derailed. The forward portion of the train consisting of the three locomotives and the first 40 wagons had come to a stand with the front of the lead locomotive at 562.303 km and the rear of the 40th wagon at 563.168 km. The rear derailed portion of the train occupied the rail corridor between 564.195 km and 564.611 km.

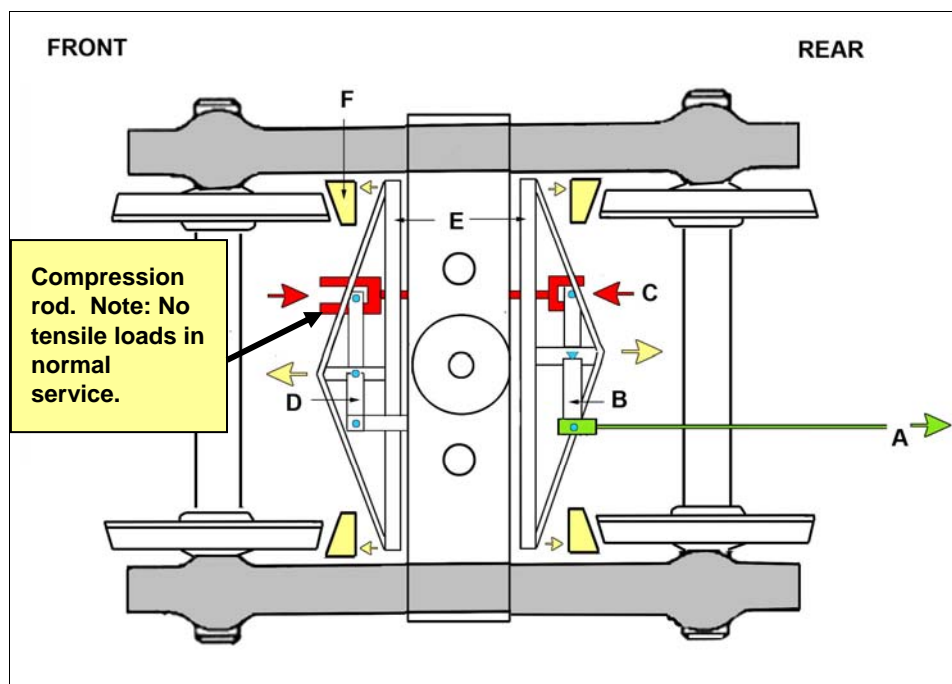
Figure 8: Schematic of mechanical rigging and linkages. (A) long rod, (B) live lever, (C) compression rod, (D) dead lever, (E) brake beam, (F) brake blocks

The first two wagons to derail were examined in detail, including an independent specialist examination and a metallurgical examination. The specialist examination revealed that, apart from a broken compression rod³ on the 41st wagon, no mechanical defects were found that could have caused the derailment. The examination of the broken compression rod revealed that it had probably failed after the wagon had derailed, as a consequence of forces arising during the derailment sequence.

initial site inspection of the derailed rollingstock (Figures 7 and 8). The fractured compression rod, which normally sits between the 'live' and 'dead' brake levers beneath the bogie (see Figure 8), was protruding rearwards (see Figure 7).

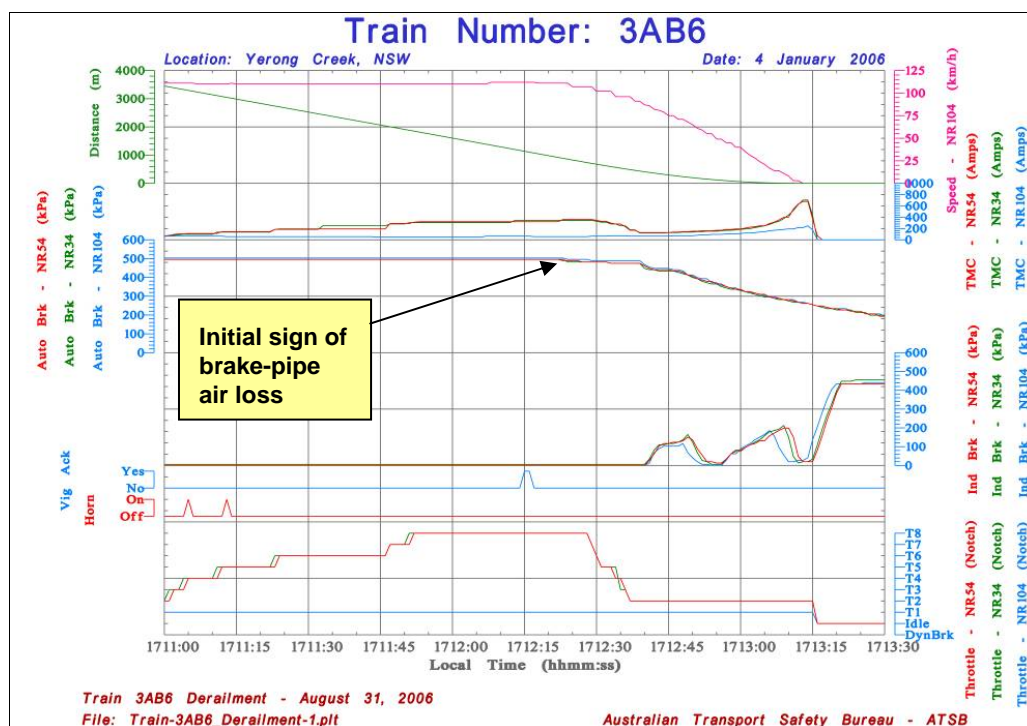
Figure 13: Locomotive data reproduction

At 1722:14 the leading end of the front portion of the train stopped at 562.303 km. The whole of the front portion of the train was now outside the Yerong Creek station yard limits.

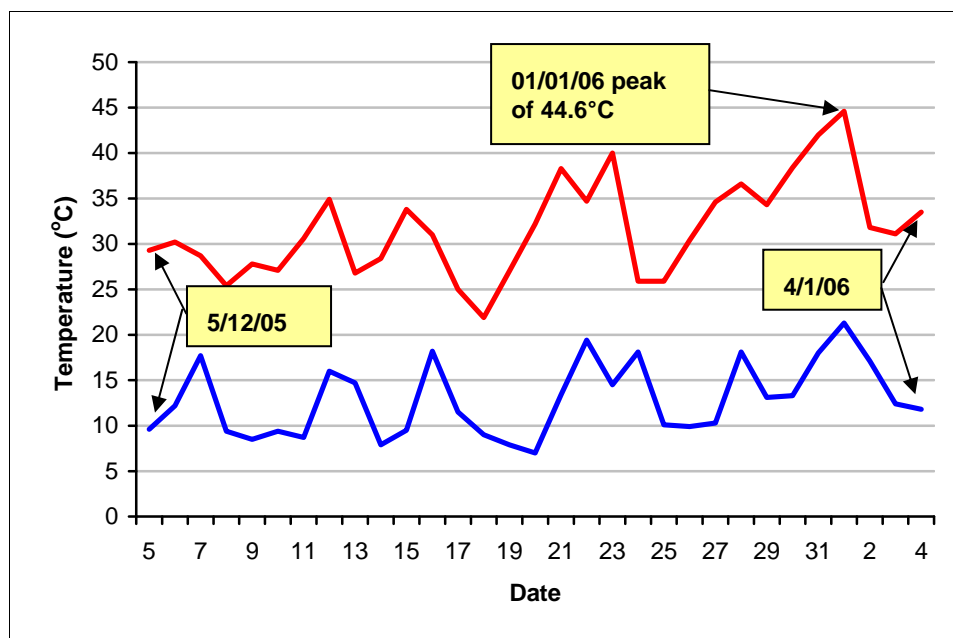
Figure 16: Maximum and minimum temperatures from 5th December 2005 to 4th January 2006, recorded at Wagga Wagga

During the four days prior to the derailment (including 4 January 2006) there were some significant temperature variations. A maximum temperature of 44.6°C was recorded at Wagga Wagga on Sunday 1 January 2006 (the temperature reached 47°C at Lockhart on that day); and a minimum of 11.8°C was recorded early on the day of the derailment. This is a variation of nearly 33°C within three days.

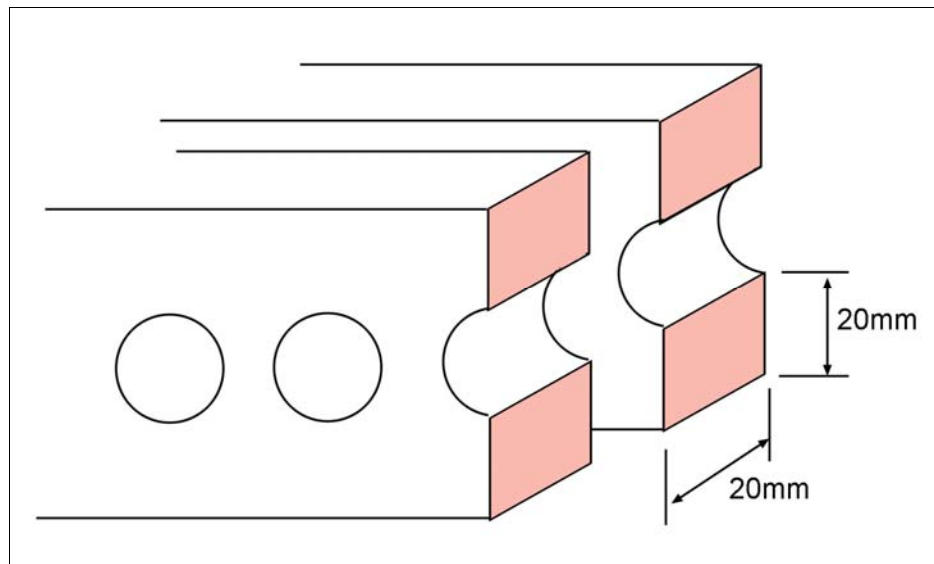
Figure F: Schematic of the broken rod clevis

Therefore the minimum tensile load needed to structurally overload the component was calculated as a tensile application of ~210 t, or equivalently ~2064 kN.
