**ATSB TRANSPORT SAFETY INVESTIGATION REPORT**

Aviation Occurrence Report – 200606570

**Aircraft loss of control - Palmers Island, NSW**  
**2 November 2006**

**Bell Helicopter Company 206A**

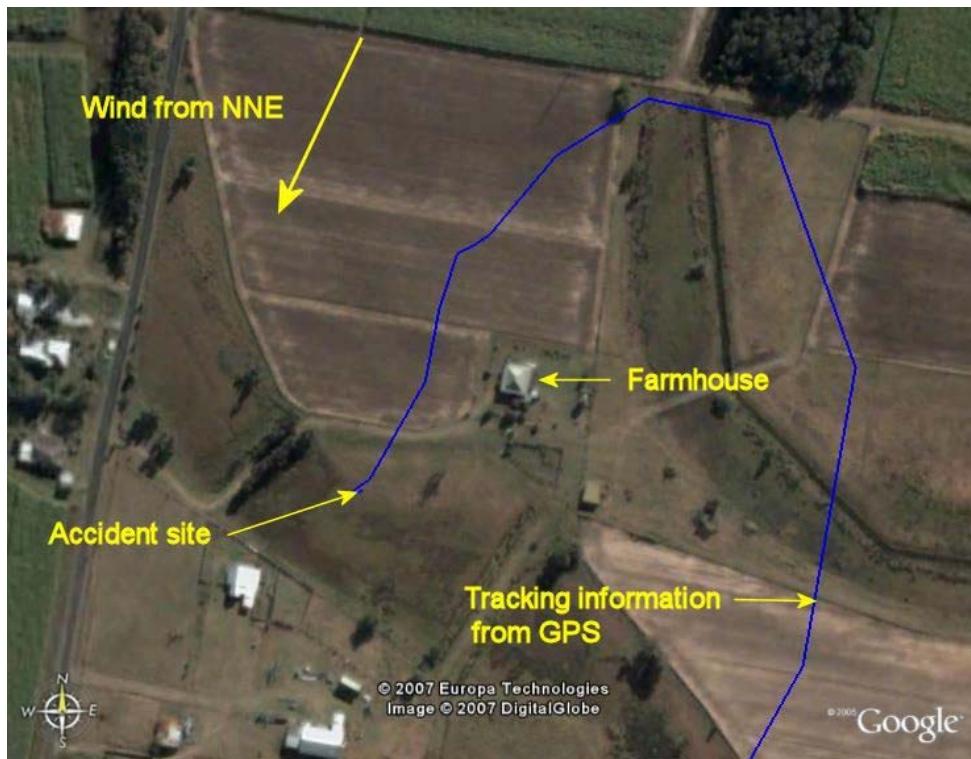
Figure 1: Helicopter GPS track data overlaid on satellite image

As the helicopter passed to the east of the house at a height of between 100 and 200 ft, the pilot commenced a banked turn to the left (Figure 1). The pilot later reported that as he was completing the turn onto a southerly heading, the helicopter suddenly and unexpectedly 'threw around' (yawed<sup>2</sup>) to face back in the opposite direction. He reported that he applied opposite tail rotor pedal to correct the situation and that the helicopter responded and turned back towards the south. At this point, the helicopter once again 'flicked' back sharply in the opposite direction, but then continued in an uncommanded yaw. Further attempts by the pilot to control the yaw by application of opposite tail rotor pedal were ineffective and the helicopter continued to yaw and to descend until it impacted the ground in the landing site paddock. The pilot later reported that when the helicopter had begun to yaw, he believed that the tail rotor had failed. While he had continued to apply tail rotor pedal inputs, his main concentration had then been on trying to keep the helicopter level. He also recalled raising the collective lever<sup>3</sup> during the accident sequence in an attempt to arrest the descent rate.

A portable global positioning system (GPS) unit was recovered from the helicopter wreckage and the tracking information was successfully downloaded. The GPS tracking information showed that the pilot initially approached the intended landing site from the south south-west into a head wind of about 25 to 30 kts. The pilot later recalled his indicated airspeed to be approximately 65 to 70 kts at that time. After passing abeam the farmhouse, he commenced a 180 degree left turn onto a downwind heading. The radius of that turn was later calculated to be approximately 105 m. As the pilot was completing the turn, it placed the helicopter into a strong quartering tail wind, and it was at this point that both the pilot and a number of witnesses on the ground reported that the helicopter commenced the uncontrolled yaw.

The witnesses had observed the helicopter arrive over the house and commence what they described as a 'steep' banked turn. They reported that the helicopter then continued to turn or rotate (yaw) in a 'flat' motion while also continuing to descend slowly. While the recollection of the number of rotations and direction of yaw varied among witnesses, it was considered that somewhere between 5 and 9 rotations to the right (clockwise) may have been completed. All witnesses provided consistent reports of a relatively stable rotation and descent before a heavy impact was heard and observed.

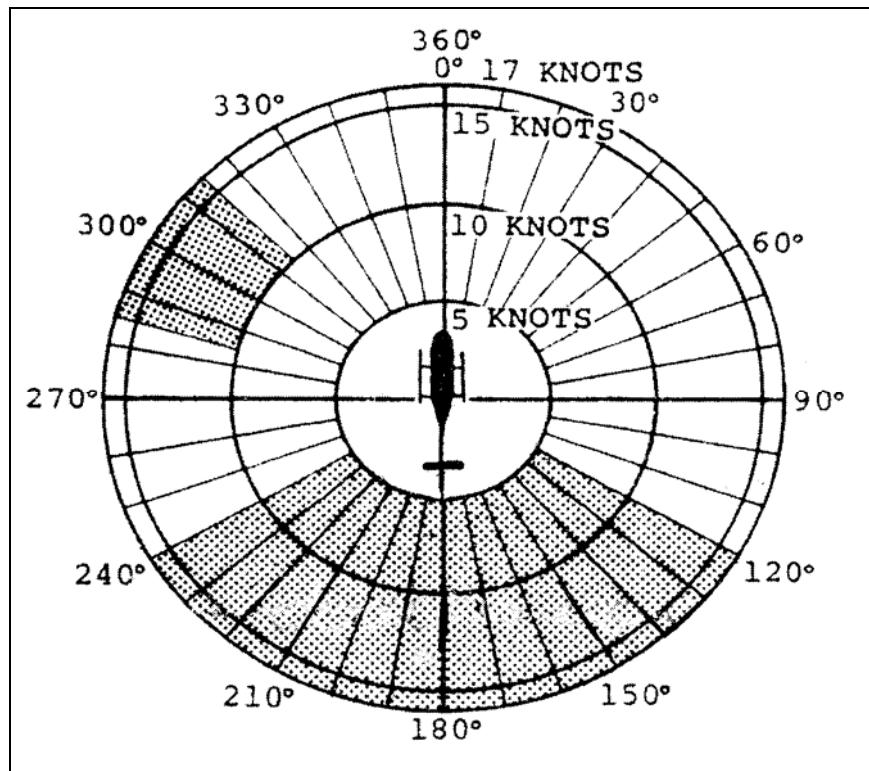
## Relative Wind Chart

Note: An unanticipated right yaw may occur when operating in the shaded areas of the chart.

Note: This chart refers to unanticipated right yaw and does not replace the critical relative wind azimuth chart in the performance section of the flight manual which refers to tail rotor control margin.
