Piper PA31-350 Chieftain VH-MZK Spencer Gulf SA

SUPPLEMENTARY
AVIATION SAFETY INVESTIGATION REPORT
200002157-A

Piper PA31-350 Chieftan VH-MZK
Spencer Gulf SA
31 May 2000

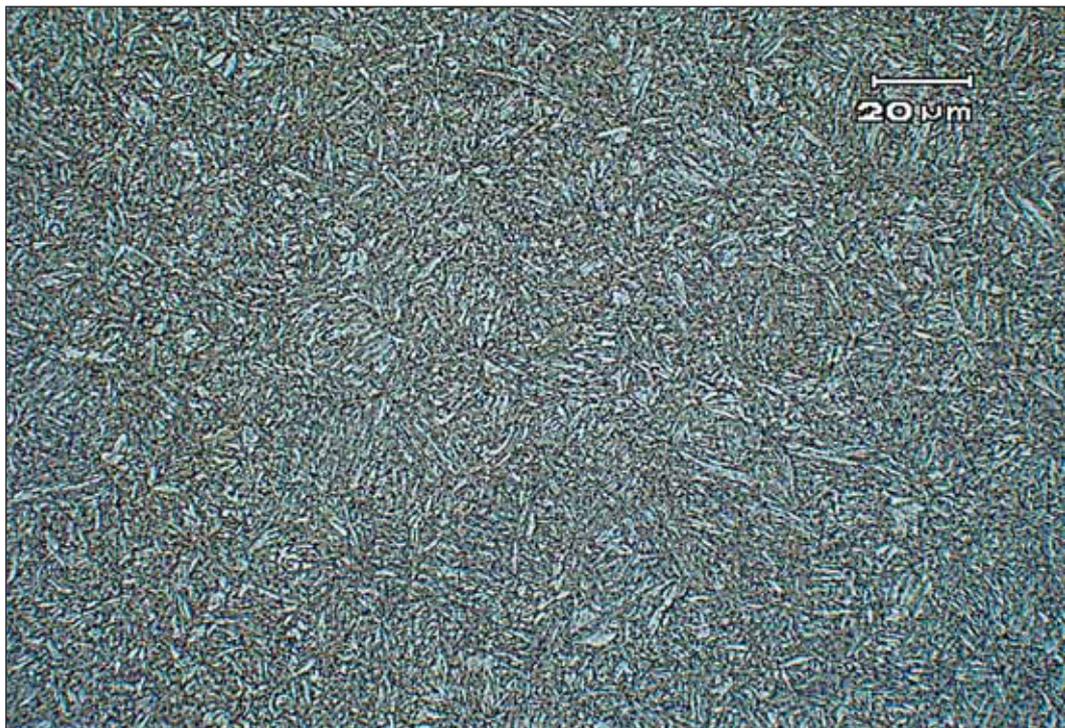
FIGURE 1:

The microstructure of the core of the crankshaft is typical of fine grained low alloy steel fully transformed to tempered martensite, see fig. 1.

Reflected light photomicrograph showing the typical features of the core of crankshaft s/n V537912936, etched lightly with 1 per cent nital then immersed in a sodium metabisulphate solution

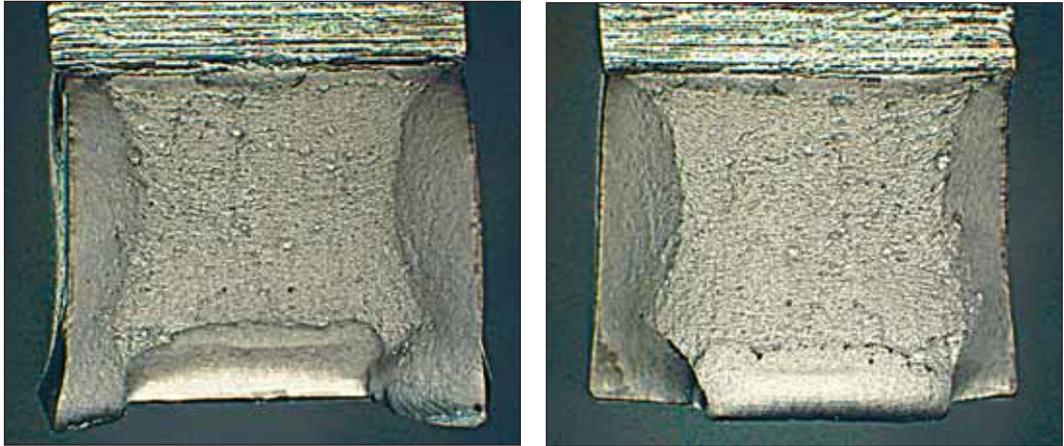
Specimen PB

The fracture surfaces of the impact test were recovered and examined in detail, from low magnification to high magnification, see figs. 2, 3 and 4. In addition, a small section was removed from the core material in the No. 6 connecting rod journal and was fractured in the laboratory by hammer blows (nick break test). In each case the fractures exhibited the features of ductile fracture.

FIGURE 2.
Photomicrographs of both fracture surface of the three Charpy V notch impact test specimens machined from crankshaft s/n V537912936

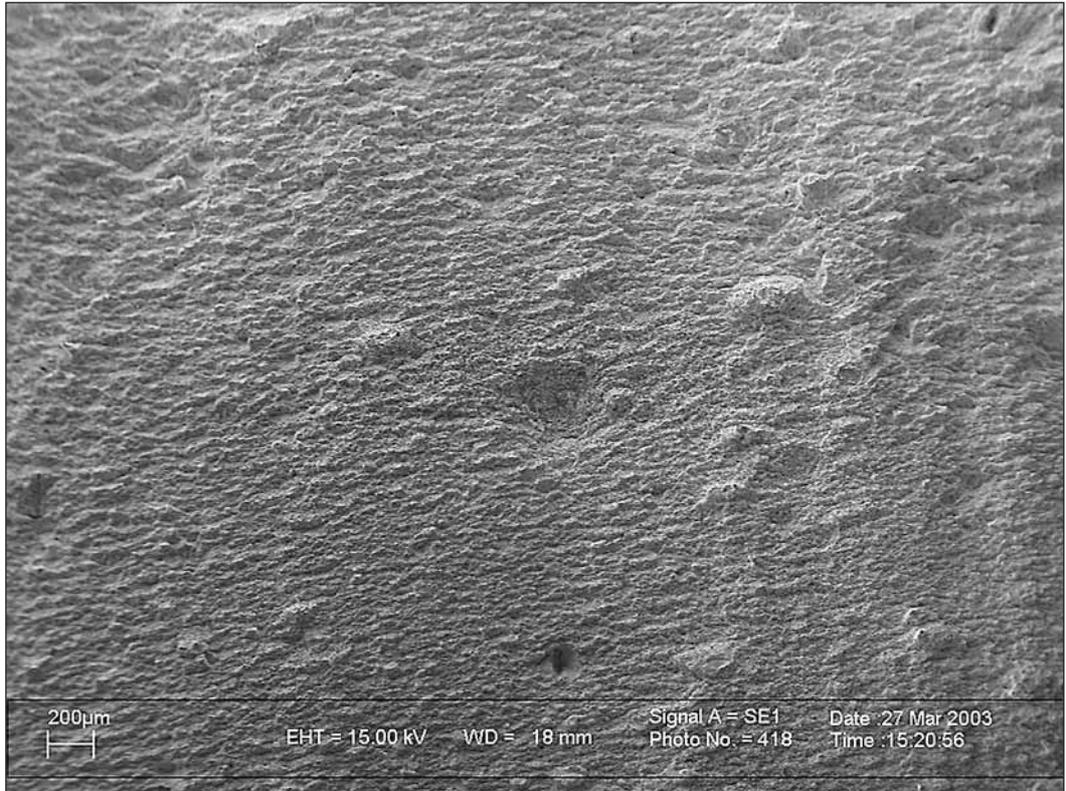
FIGURE 5:
Scanning electron micrograph, low magnification, showing a 'pullout' region in the centre of the micrograph

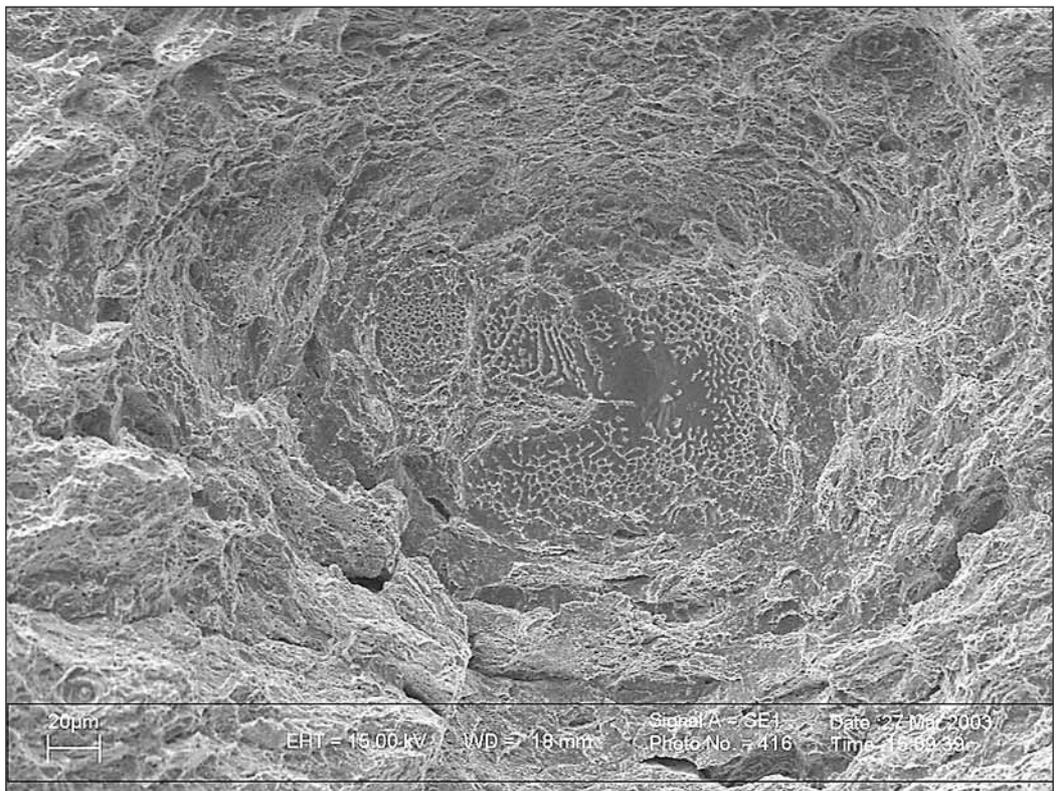
FIGURE 6:
Scanning electron micrograph showing the pullout feature

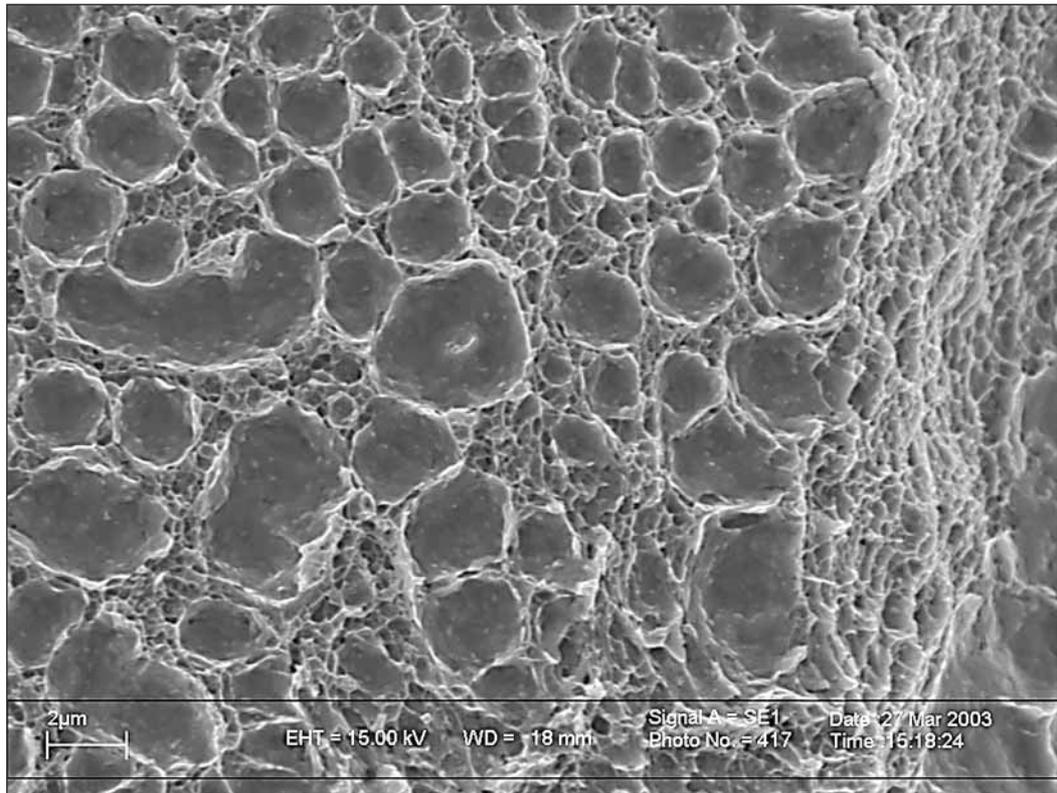
FIGURE 7:
Scanning electron micrograph showing the features at the bottom of the 'pullout' in detail

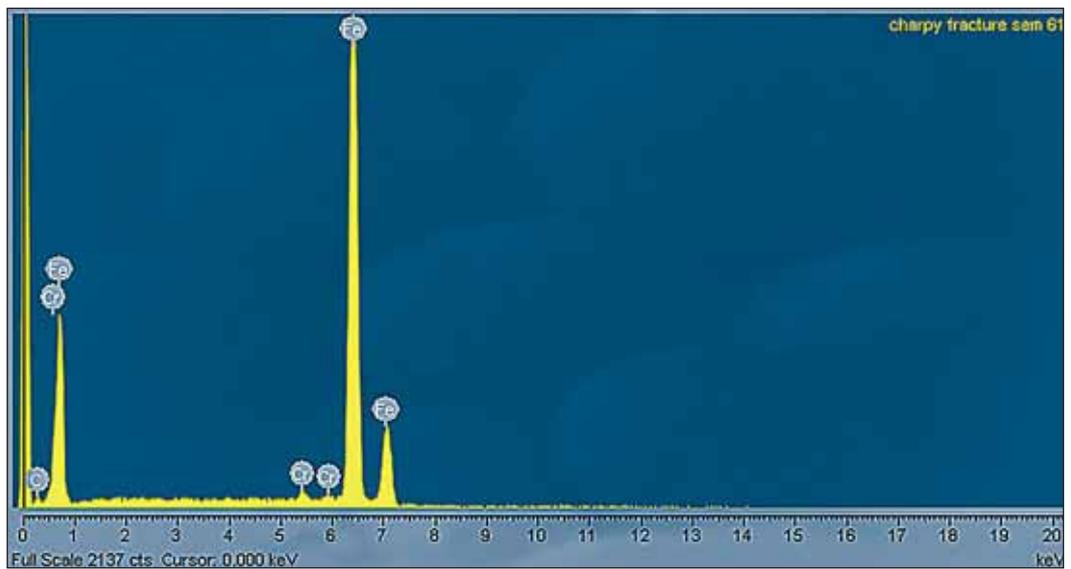
FIGURE 8:
Energy dispersive Xray spectrum obtained from an area scan of the 'pullout' feature

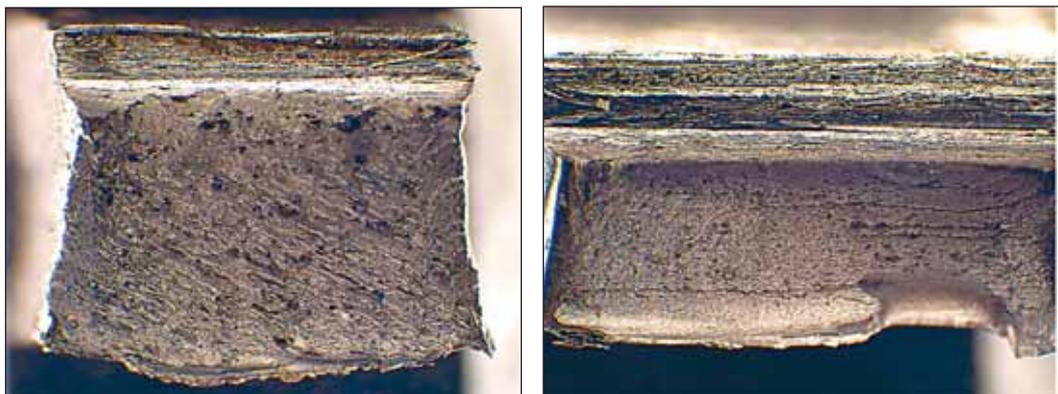
FIGURE 9:
Nick break fracture surfaces, air melted crankshaft core material (left), vacuum arc remelted crankshaft core material (right)

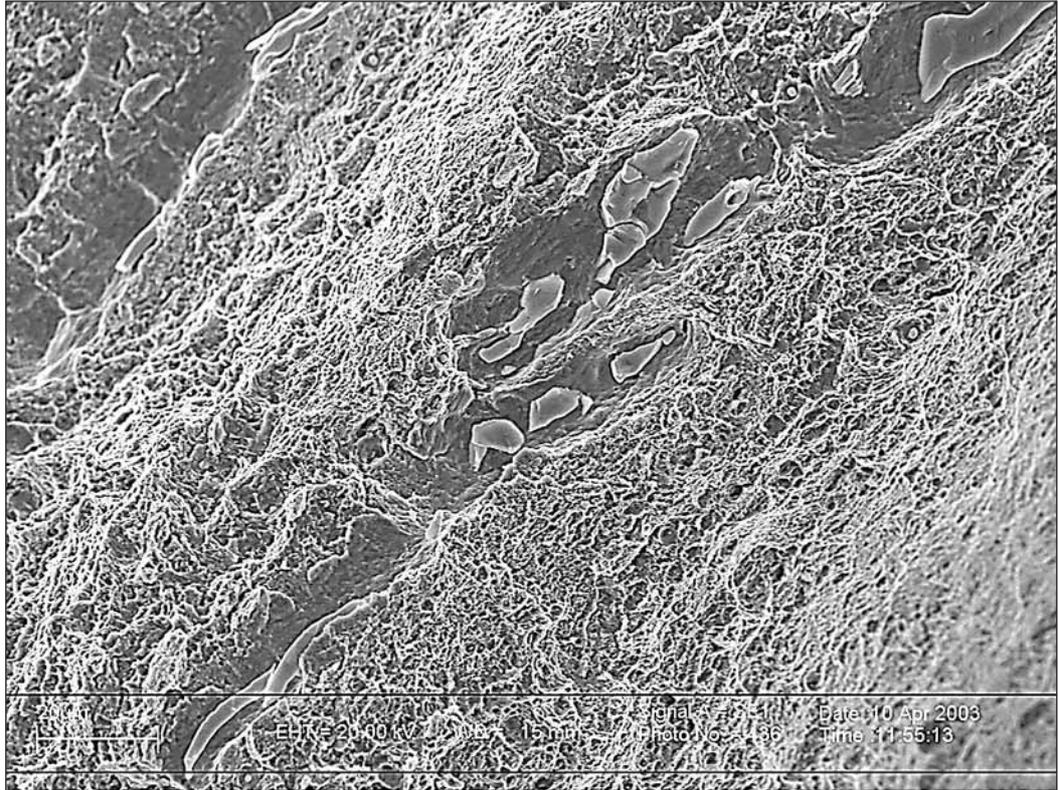
FIGURE 10:
Nick break fracture surface, air melted crankshaft (core material). The string of inclusions in the centre of the micrograph are manganese sulphides

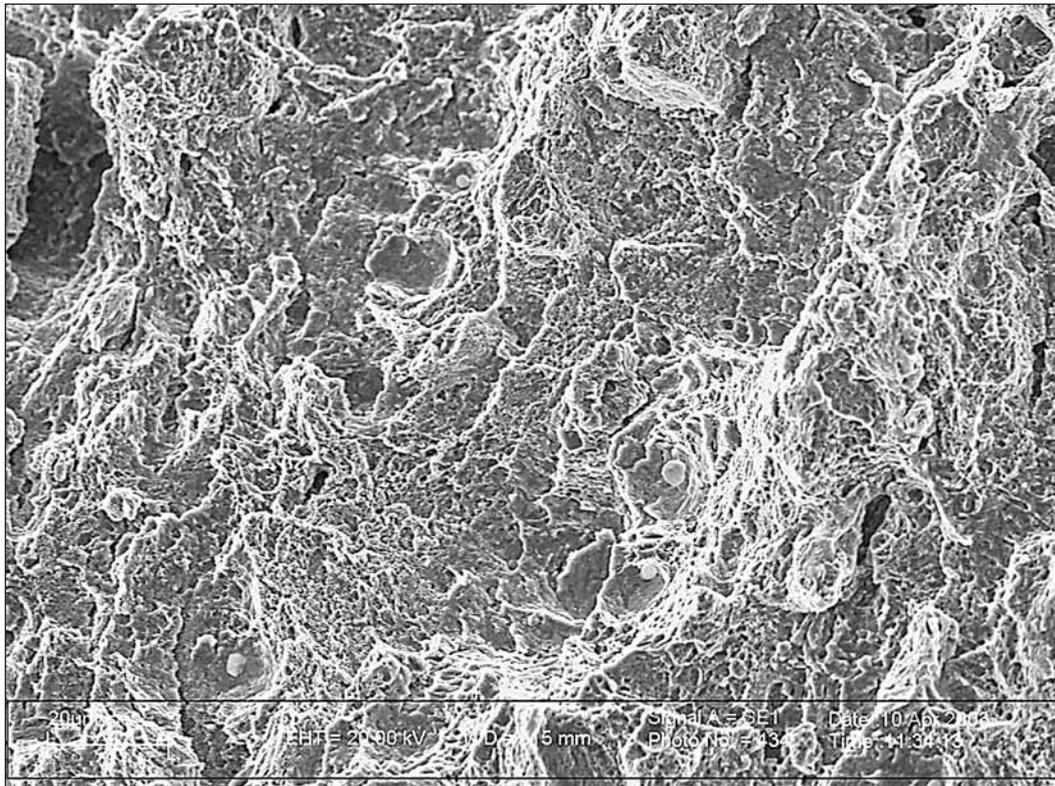
FIGURE 11:
Nick break fracture surface, vacuum remelted crankshaft (core material). The small spherical inclusion to the right of centre is a complex calcium, aluminium, magnesium oxy-sulphide

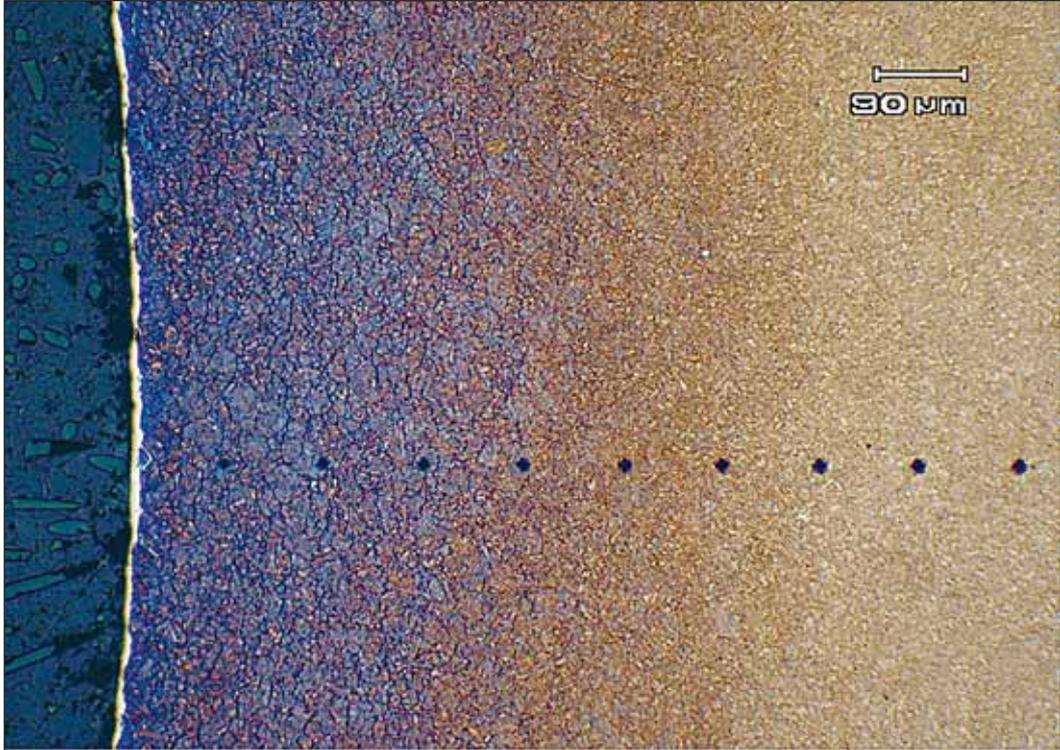
FIGURE 15:

Photomicrograph showing the nitrated case as delineated by a nital – sodium metabisulphate etch. The change in colour contrast occurs at a distance of approximately 0.4–0.5 mm (0.016–0.02 inches). The specified case depth based on macroetching is 0.018–0.026 inches

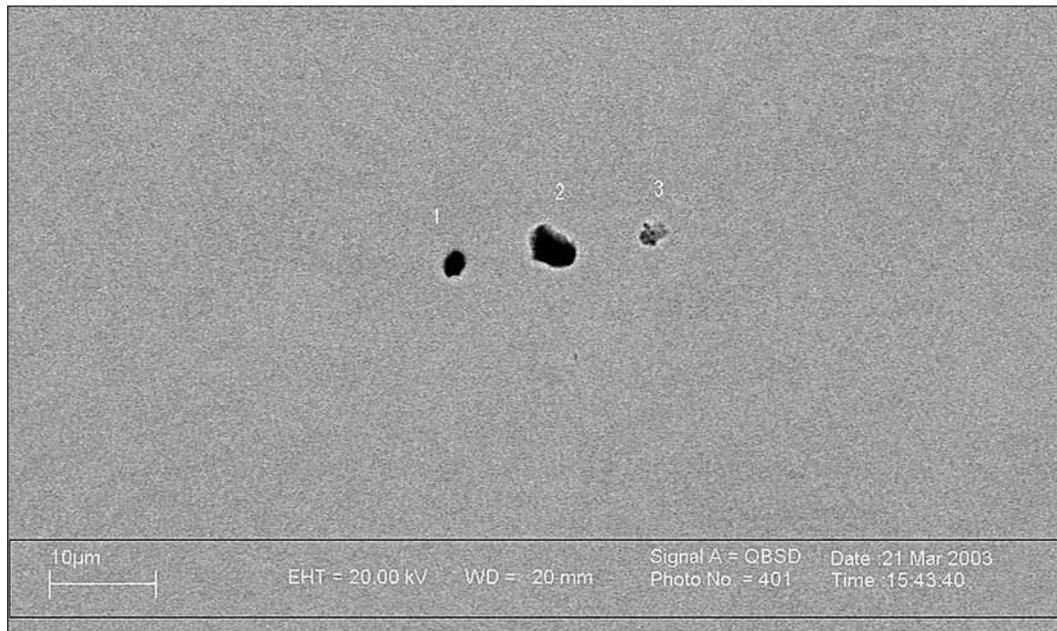
FIGURE 20:

The nature of the non-metallic inclusions present in crankshaft V537912936 can be characterised as a distribution of complex mixtures of silicates and sulphides of calcium aluminium and magnesium, well dispersed and small in size (maximum size observed was approximately 13 μm in diameter), and a smaller number of small, blocky, titanium, zirconium, vanadium nitrides. A series of scanning electron micrographs with accompanying energy dispersive Xray spectra obtained from the inclusions is presented in figs. 21 to 34.

Scanning electron micrograph showing inclusions from a small area of a metallographically prepared sample from the No. 5 connecting rod journal

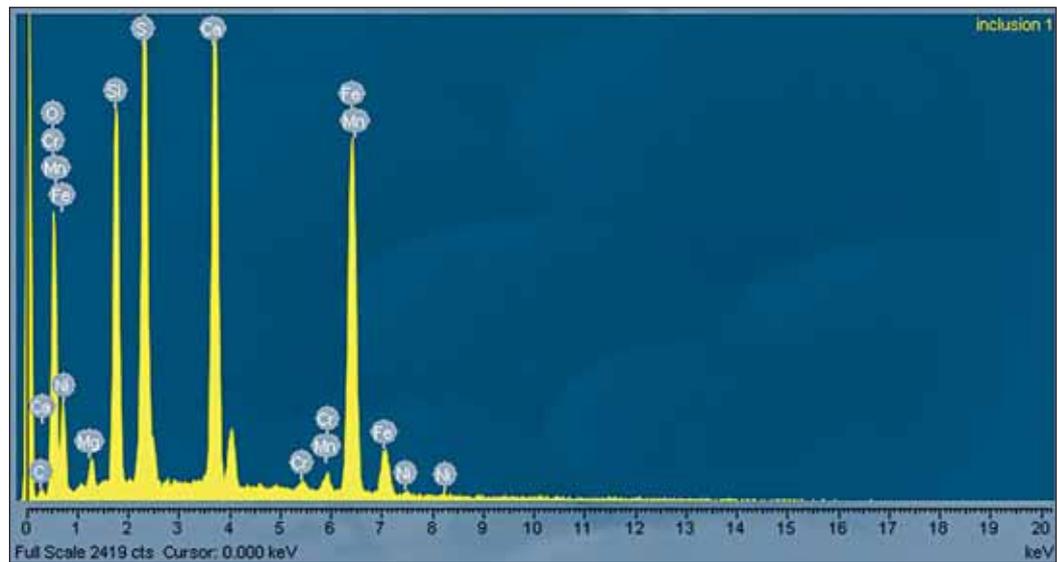
FIGURE 21:

Xray spectrum for inclusion marked 1 in fig. 20. The inclusion is a complex calcium, magnesium, silicate-sulphide

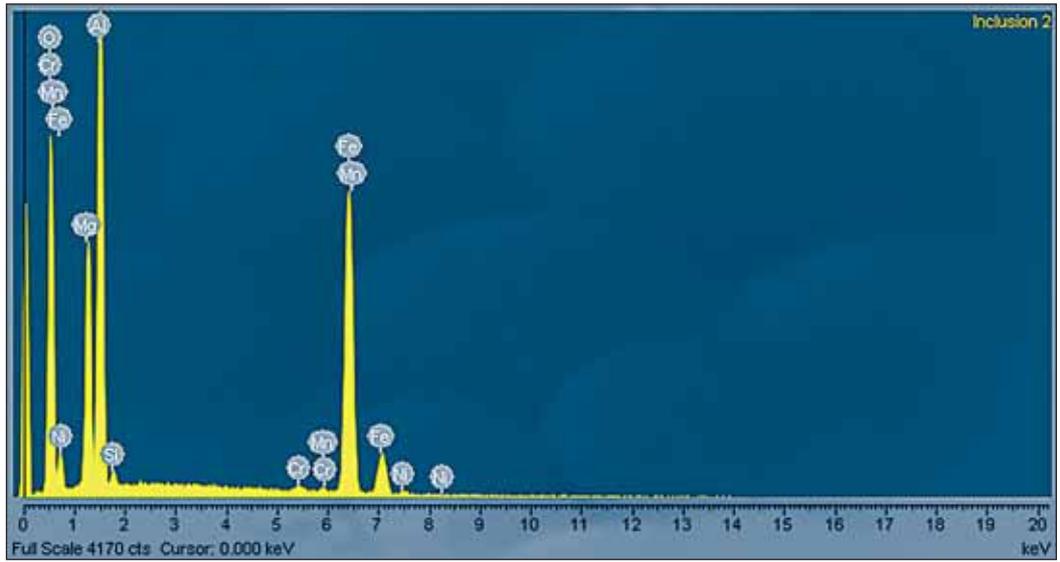
FIGURE 22:
Xray spectrum for inclusion marked 2 in fig. 20. The inclusion is an aluminium, magnesium oxide, silicate

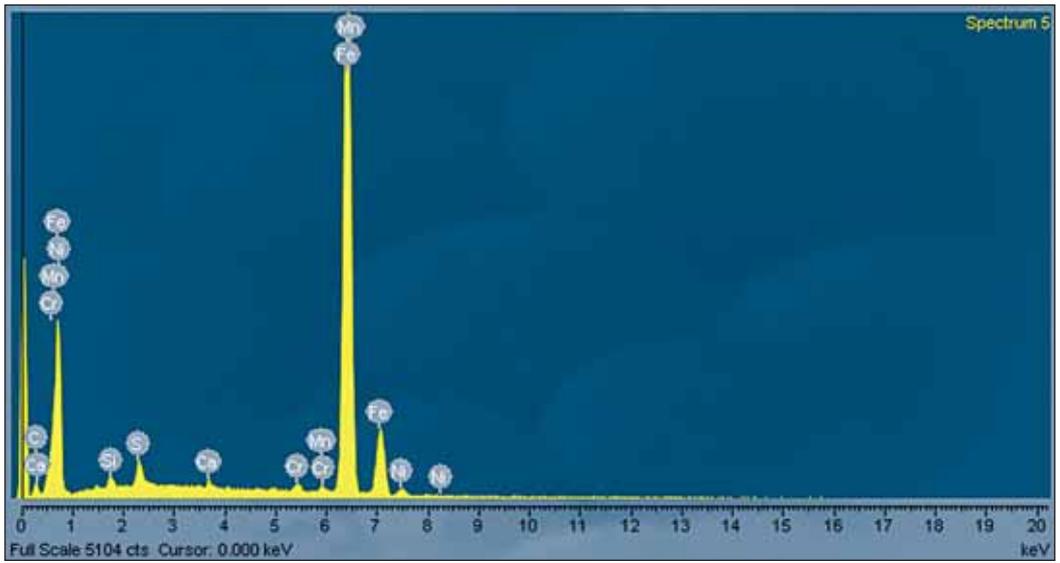
FIGURE 23:
Xray spectrum for the inclusion marked 3 in fig. 20. The inclusion is predominantly calcium sulphide

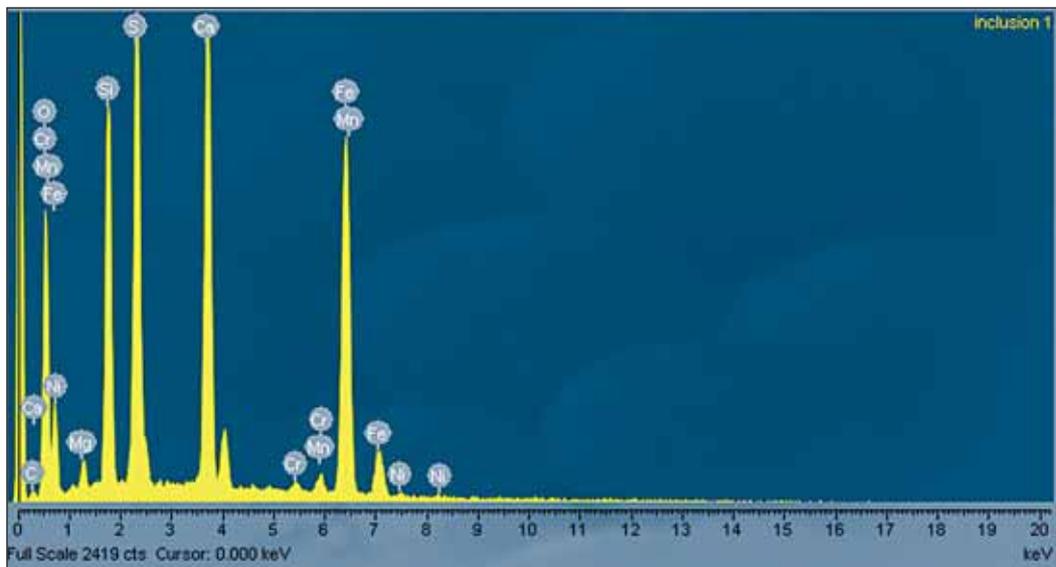
FIGURE 25:

Xray spectrum from the inclusion shown in fig. 24. The inclusion is a calcium, magnesium silicate-sulphide

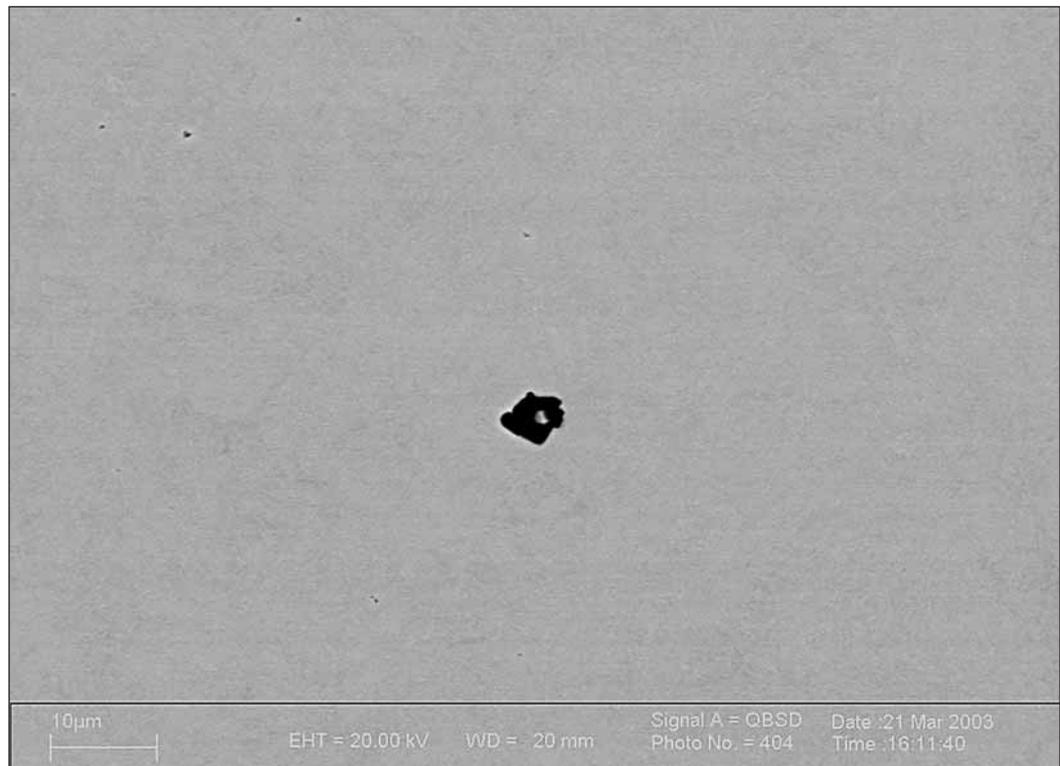
FIGURE 29:
Scanning electron micrograph showing an inclusion from a small area of a metallographically prepared sample from the No. 5 connecting rod journal

No non-metallic inclusions with dimensions and or composition outside of the range determined to be typical for the steel from which crankshaft s/n V537912936 was found in the volume of steel surrounding the fatigue crack initiation site during the serial metallographic polishing of both sides of the fracture surface, see for example fig. 29.

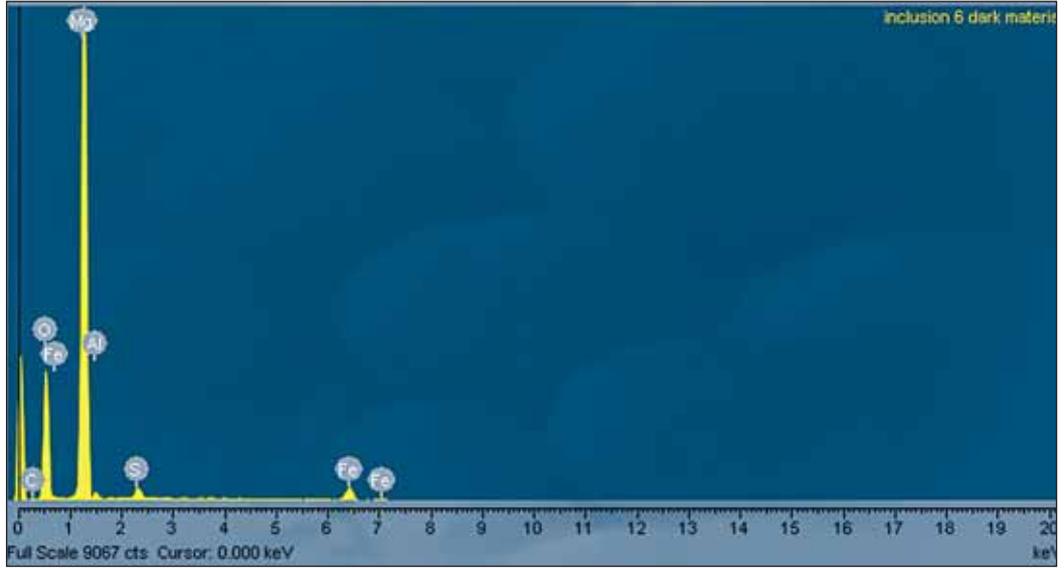
FIGURE 30:
Xray spectrum from the darker material of the inclusion shown in fig. 29. The material is predominantly magnesium oxide

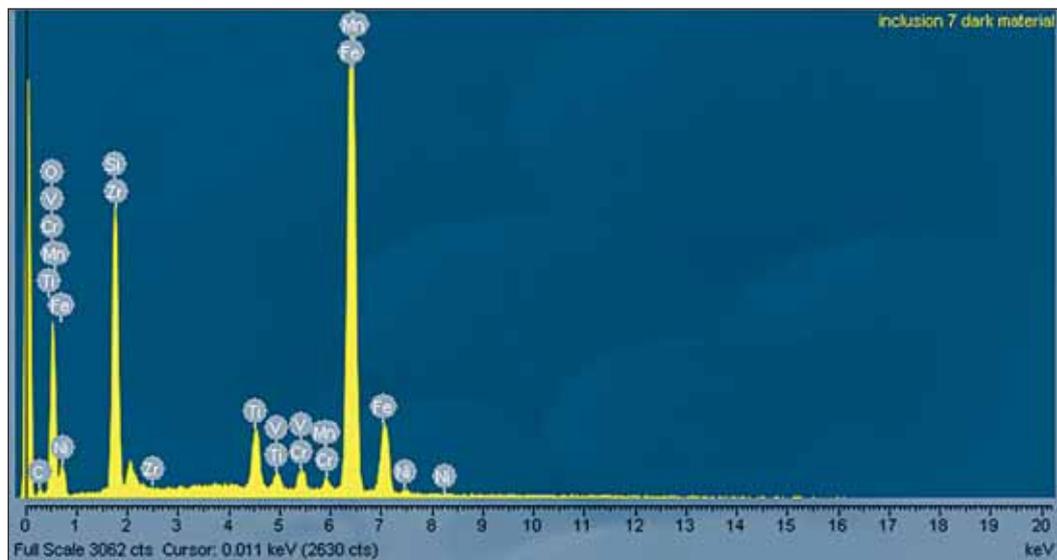
FIGURE 33:

Xray spectrum from the dark material of the inclusion shown in fig. 32. The material is a silicate in nature

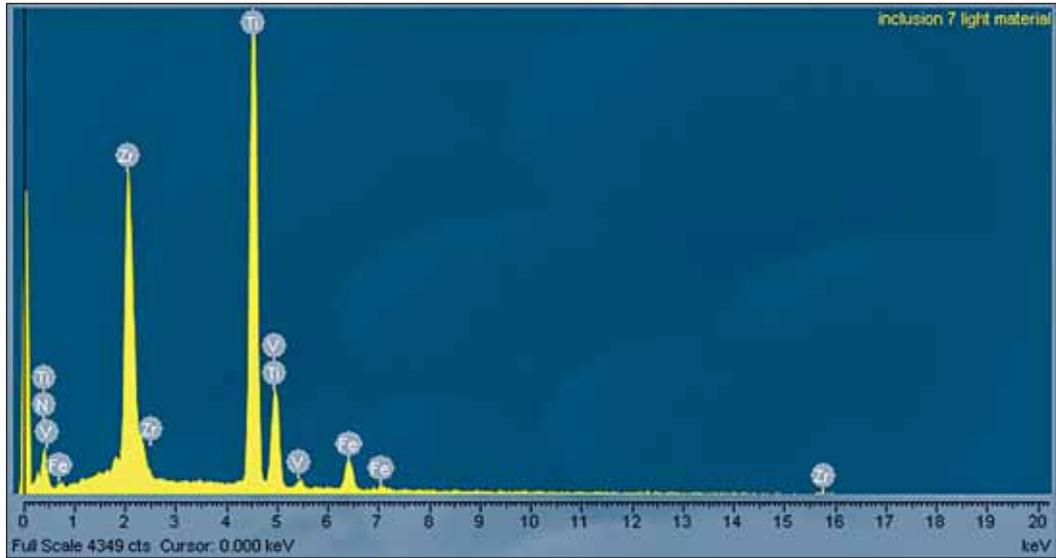
FIGURE 34:

Xray spectrum from the light 'blocky' material in the inclusion shown in fig. 32. The inclusion is a titanium zirconium vanadium nitride.

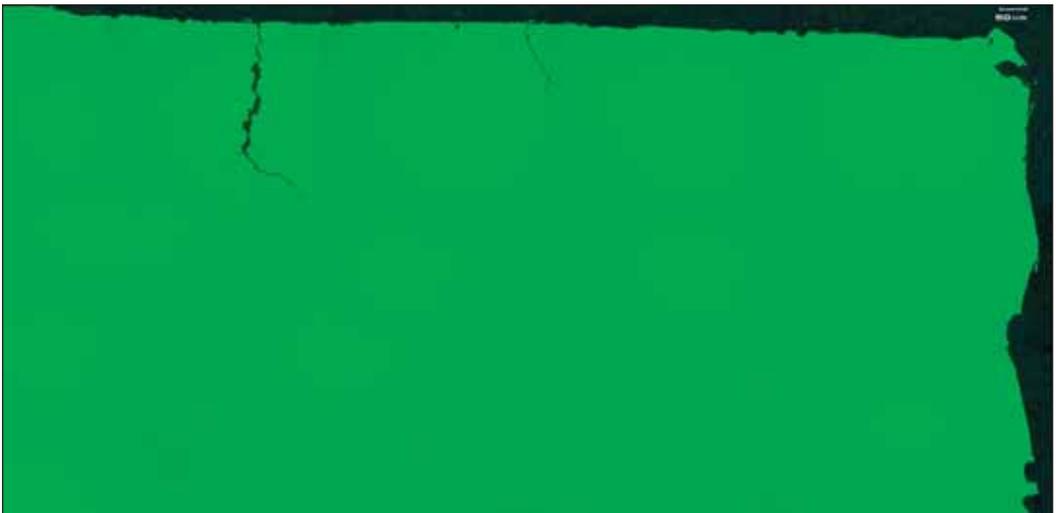
FIGURE 35:

Multiple image photomicrograph showing the metallographic section, unetched, prepared by removing 0.04 mm from the final section prepared by McSwain Engineering Inc

The section prepared by McSwain Engineering Inc. was taken through the step feature on the crankarm side of the fracture with the plane of section oriented parallel with the journal axis and perpendicular to the journal surface. The journal surface at the fillet radius is at the top of the figure and the fracture is at the right of the figure. The journal surface at this location had been damaged during the final failure process. The small cracks extending from the surface of the journal, oriented parallel with the plane of fatigue cracking have been created as a result of the final failure process. These cracks follow the microstructure of the case hardened zone in contrast to the nature of the fatigue fracture. Crack extension along microstructural features is a characteristic of deformation of the case hardened zone.

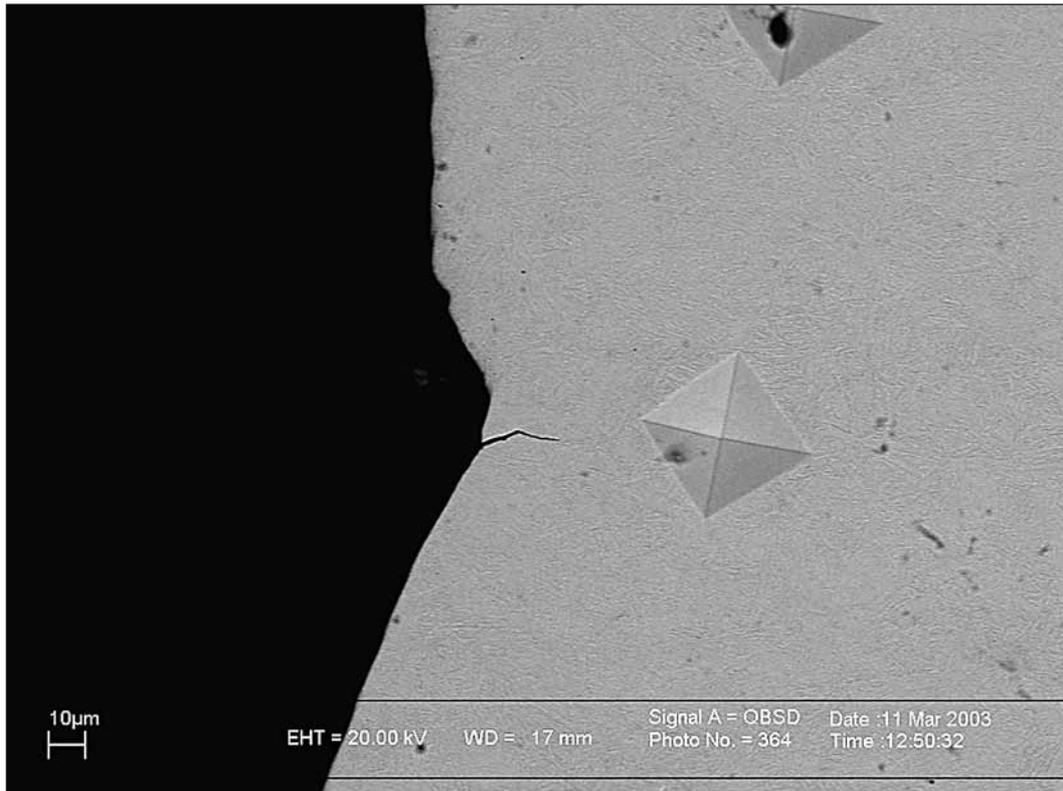
Serial metallographic polishing used to examine the volume of steel surrounding the site of fatigue initiation revealed that no unusual non-metallic inclusion was present. Sectioning did reveal the presence of cracking extending over a short distance, perpendicular to the plane of fatigue cracking, from the bottom of the step feature on the crankarm side of the fracture. The path of this cracking followed microstructural features.

FIGURE 40:
Metallographic section through the end of the step feature prepared by McSwain Engineering Inc. The plane of the fatigue fracture is from top to bottom in the micrograph

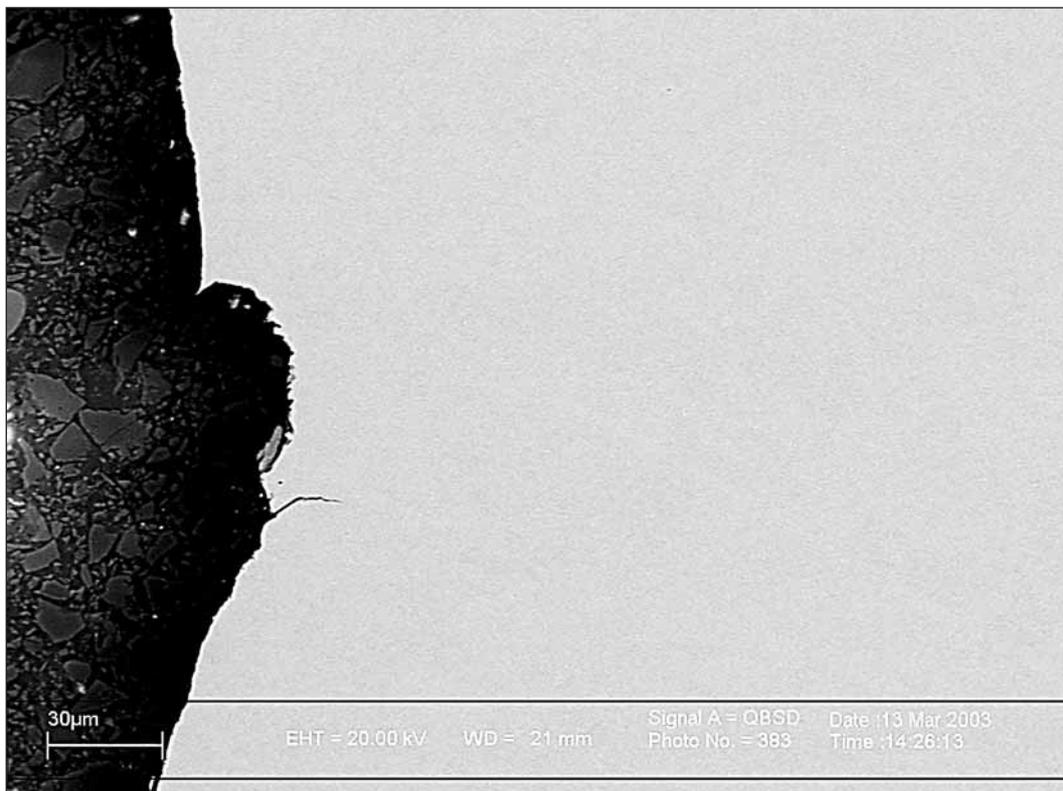
FIGURE 41:
Metallographic section prepared by ATSB, 0.04mm removed from McSwain section

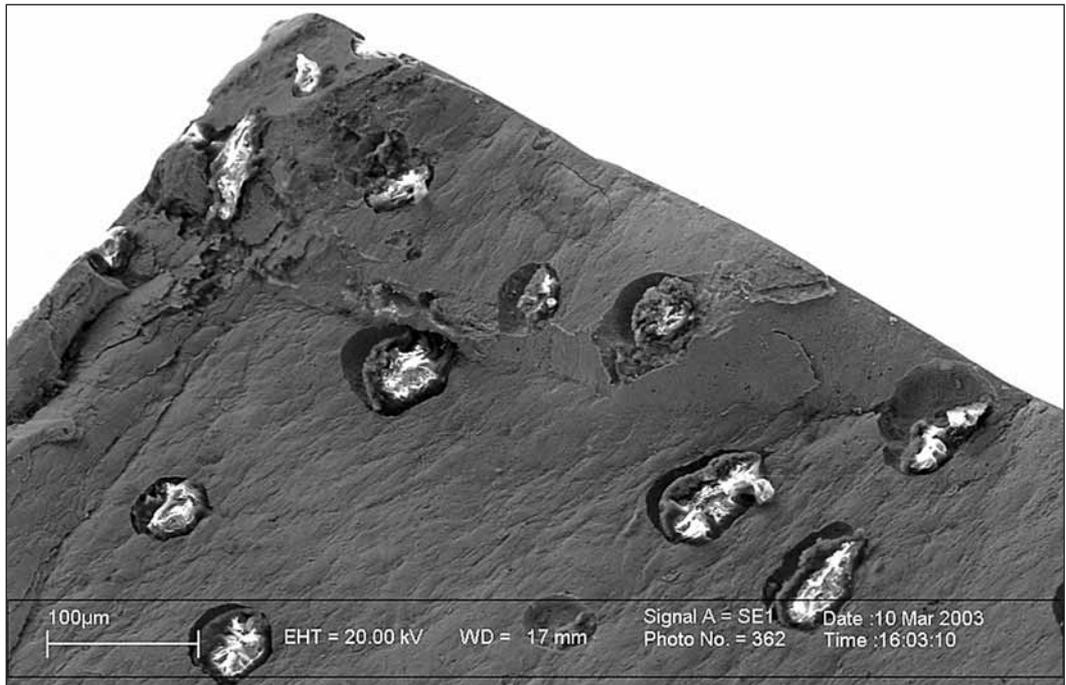
FIGURE 43:
The pits evident on the fracture surface were created by the sectioning process employed by McSwain Engineering Inc. The glowing residue in the pits is plastic material used to encapsulate the section during metallographic polishing

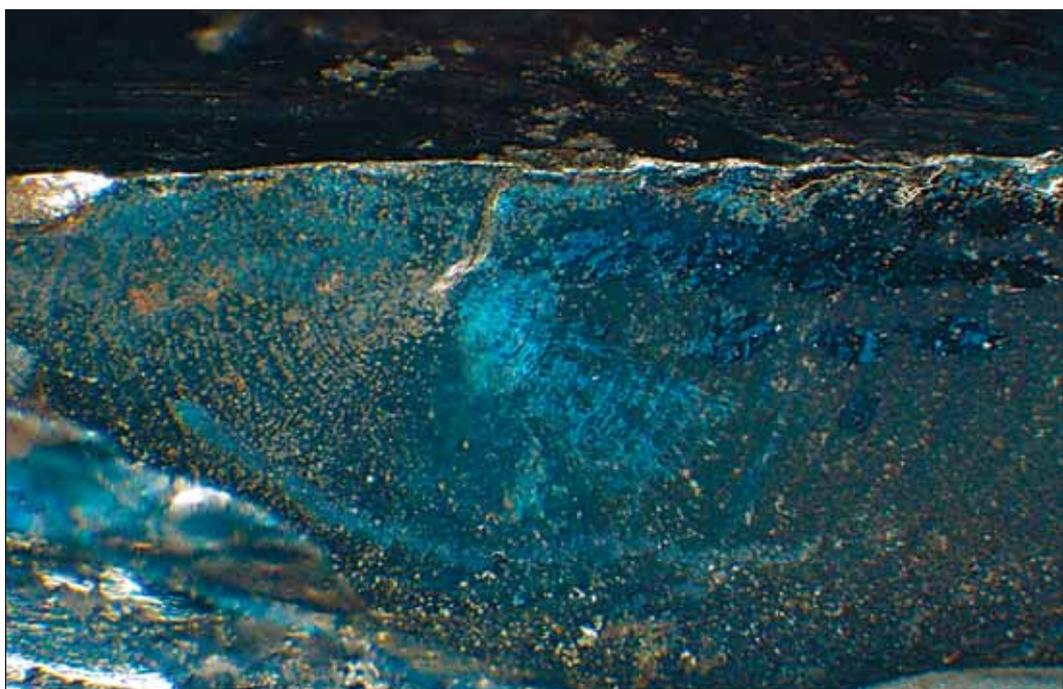
FIGURE 46:
The journal surface at the site of the step feature. The location of the step feature is arrowed

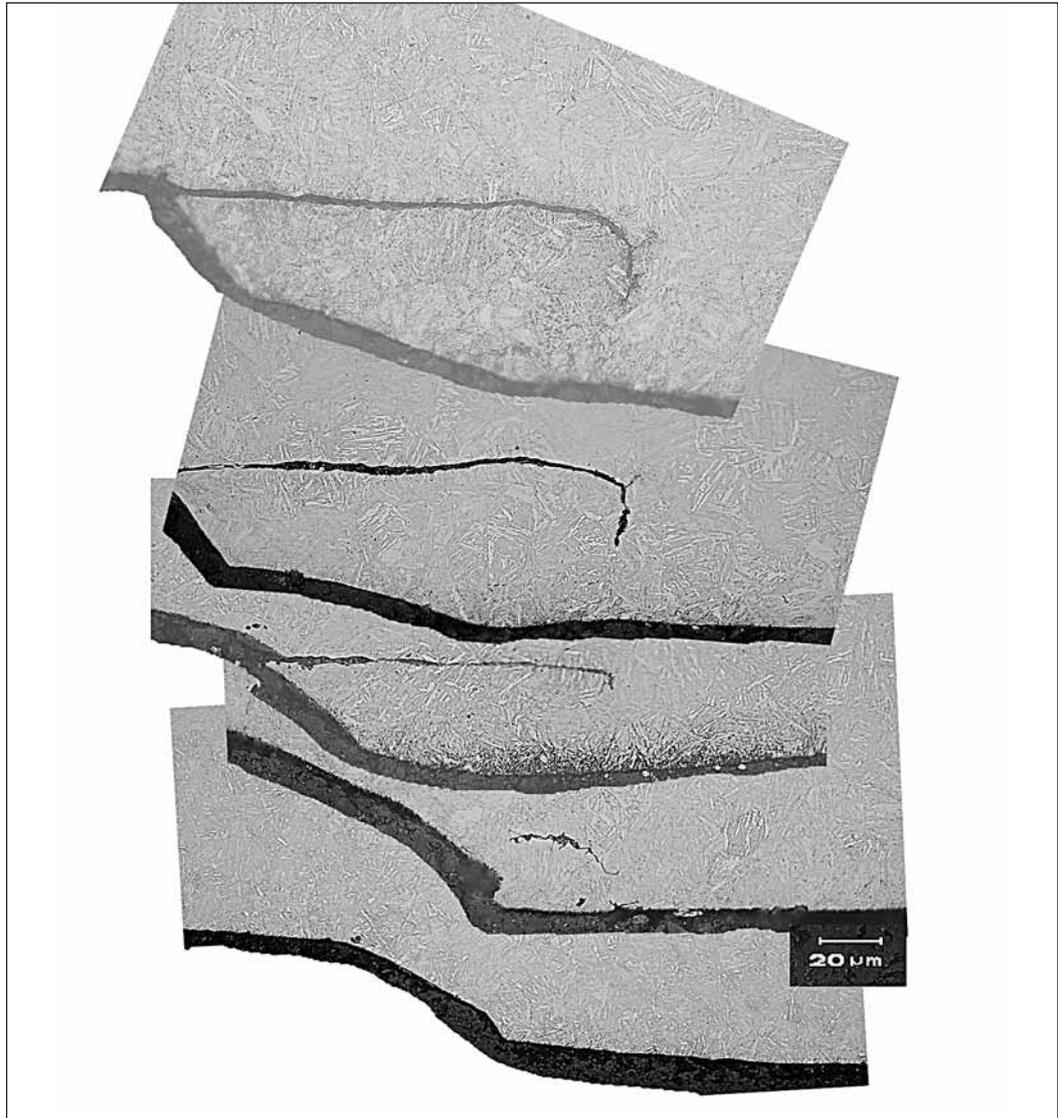
Figure 49:
Composite image showing the serial metallographic sections prepared from journal side of the fracture at higher magnification, etched in 1 per cent nital

It is evident from the nature of the features under the step that the feature is not a simple lap. The lack of correspondence of microstructural features across the lap, the deformation evident in the microstructure in the vicinity of the lap and the small cracks extending from the curved portion of the lap all indicate that the lap is not the result of overlapping fatigue crack growth.

The complex nature of the lap features and cracks under the step indicate that some form of cracking was present prior to final fracture deformation and this cracking was oriented parallel with the axis of the journal and its path followed microstructural features.

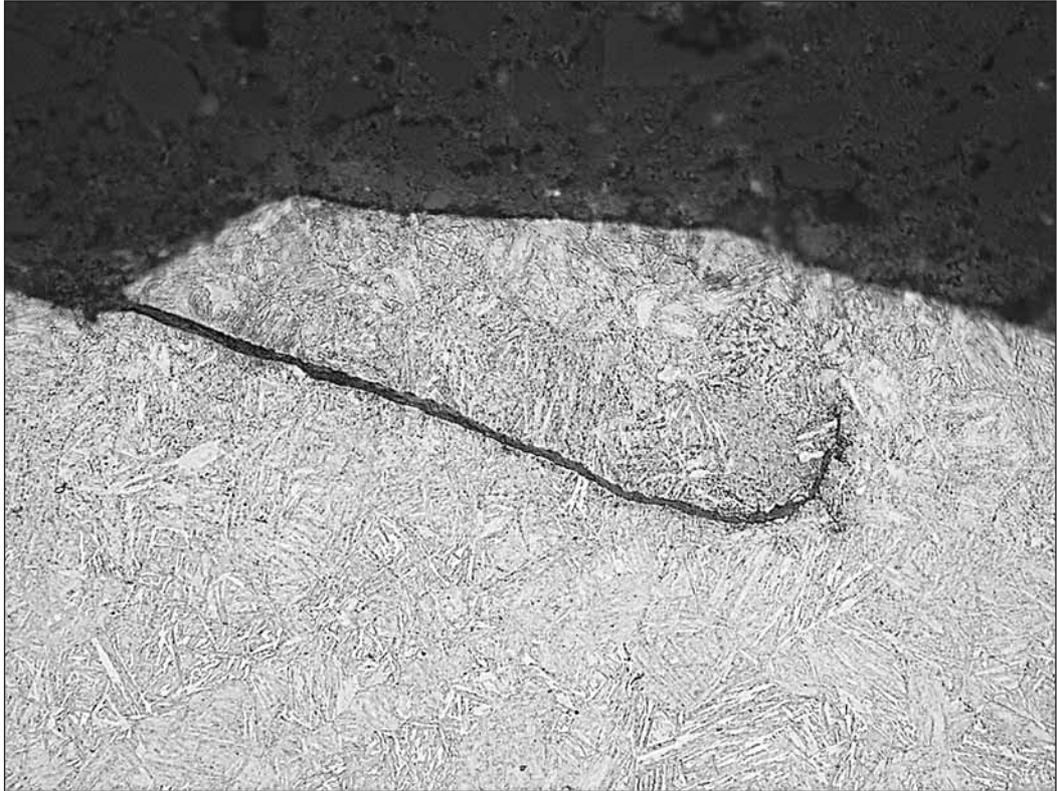
FIGURE 50:
Reflected light micrograph, 0.13 mm below the journal surface

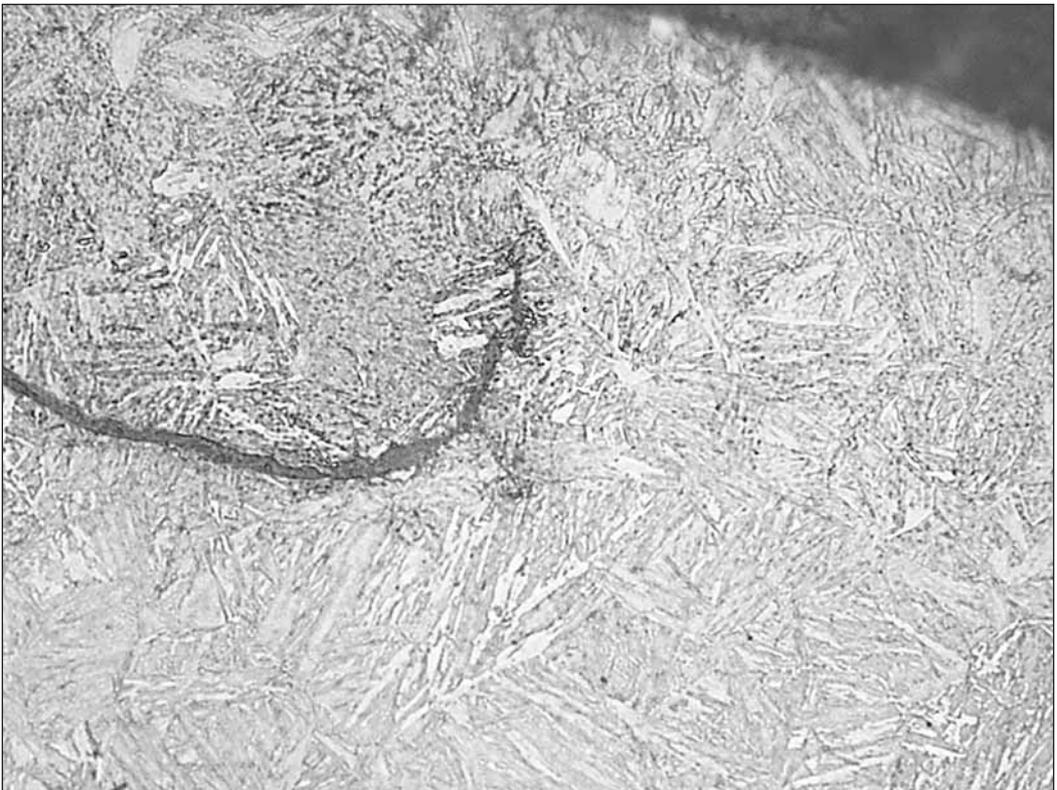
FIGURE 51:
Reflected light micrograph, 0.13mm below the journal surface

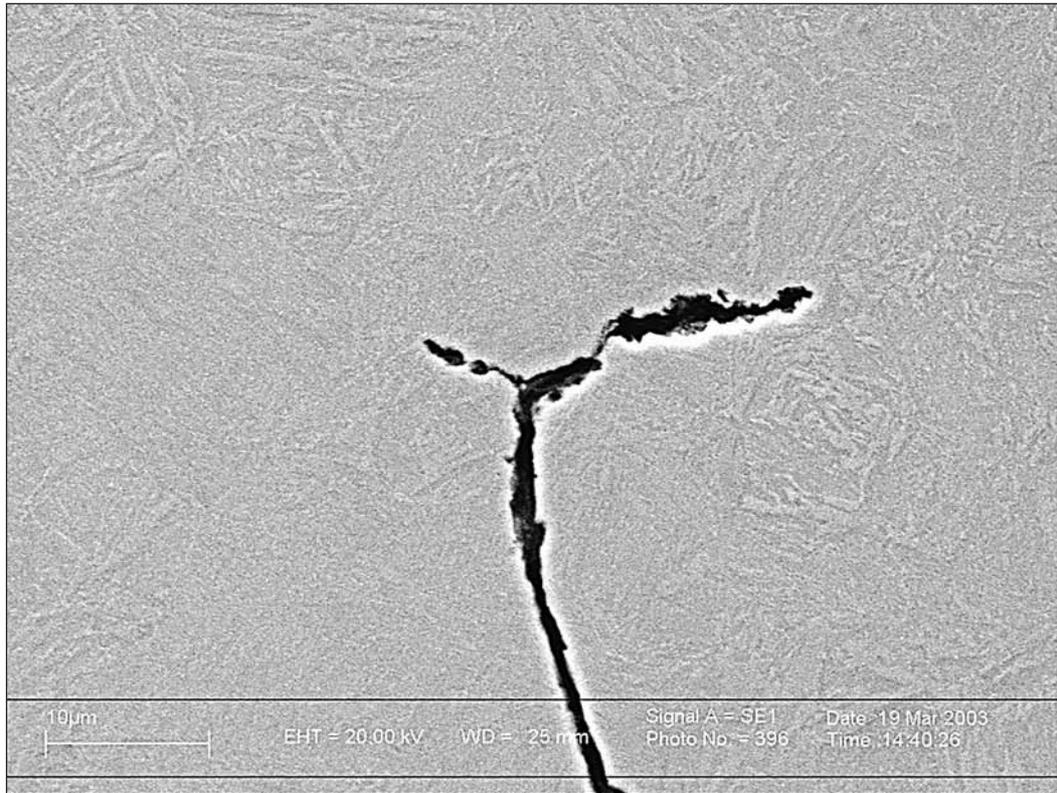
FIGURE 52:
Scanning electron micrograph, 0.17 mm below the journal surface

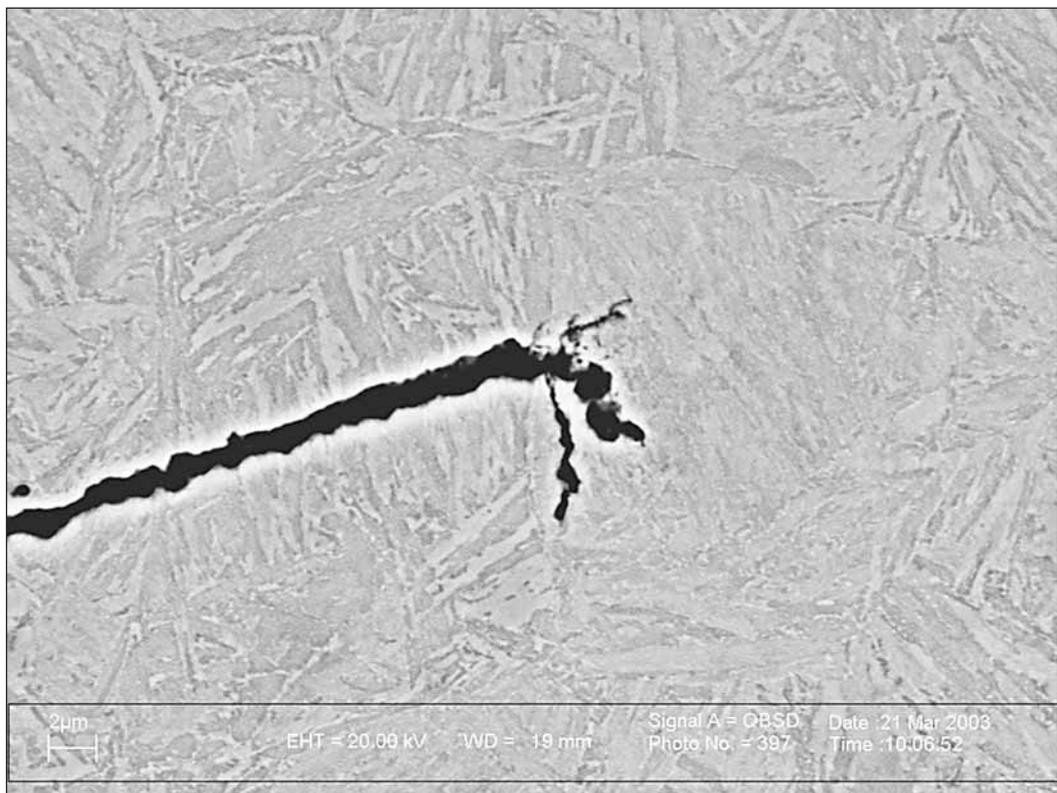
FIGURE 53:
Scanning electron micrograph, 0.28 mm below the journal surface
