Piper PA31-350 Chieftain VH-MZK Spencer Gulf SA

SUPPLEMENTARY
AVIATION SAFETY INVESTIGATION REPORT
200002157-A

Piper PA31-350 Chieftan VH-MZK
Spencer Gulf SA
31 May 2000

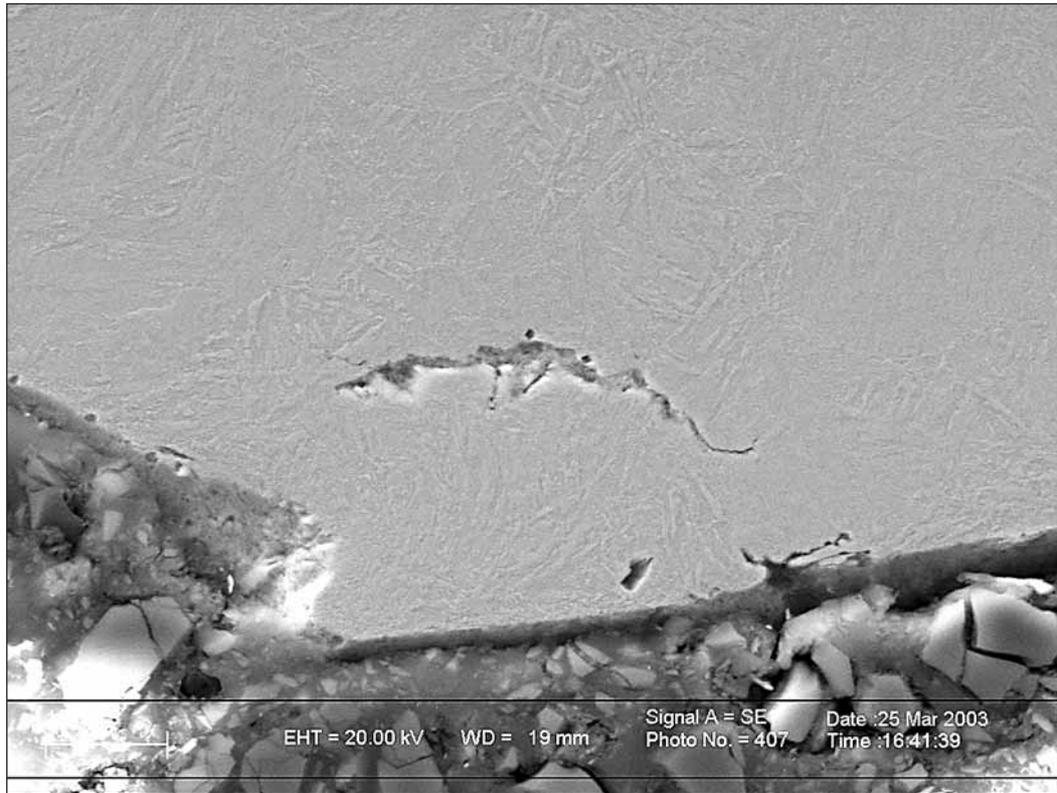
FIGURE 54:
Scanning electron micrograph, 0.34 mm below the journal surface

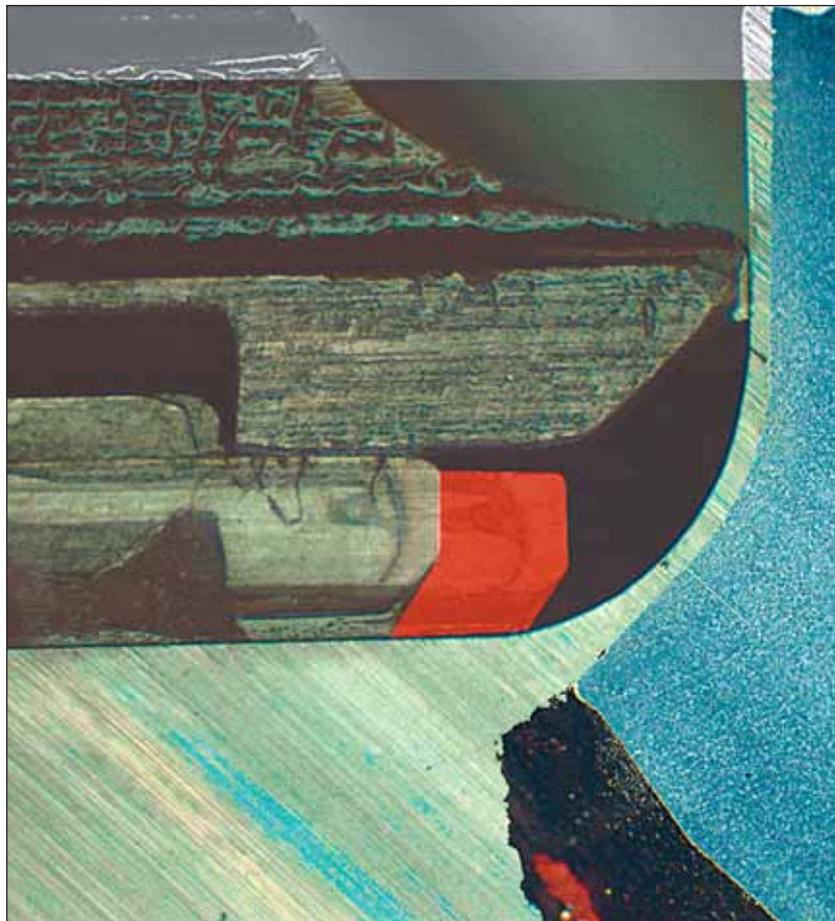
FIGURE 57:

The most likely engine component that could contact the connecting rod journal fillet near the transition from the journal to the fillet is the bearing insert. The range of axial movement of an insert to the point where the bolt clearance slot contacts the bolt guide surface will allow the bearing insert to contact the fillet radius in the location of the fatigue crack, see fig. 57.

A composite image; showing the section through the step feature at the fatigue initiation site, a bearing insert correctly located in the big end housing (tang/lug intact), the maximum axial displacement of a bearing insert (coloured red) following a loss of retention force and deformation of the tang/lug. Note the deformation of the journal fillet radius at the site of the fatigue crack.

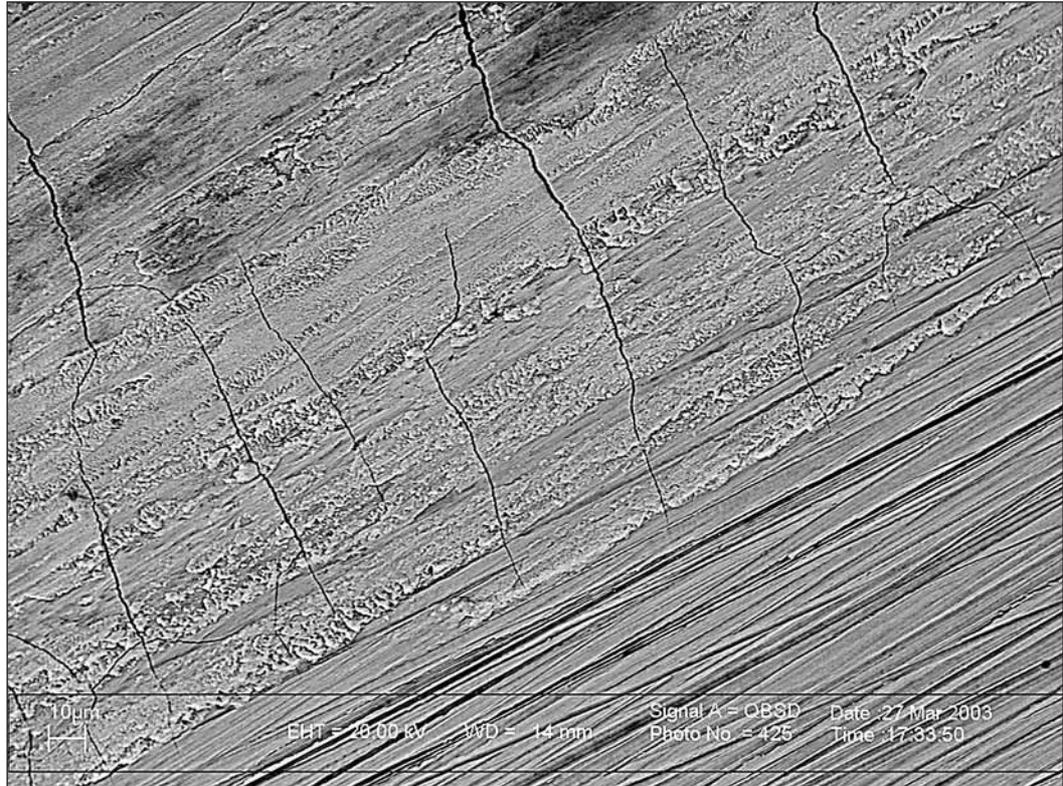
FIGURE 58:

Examination of the crankarm side fillet radius of the No. 6 connecting rod journal revealed that a small region on the outer side of the crank had not been damaged extensively by the final fracture and separation processes. Examples of thermal expansion cracks in the journal surface created by bearing surface contact were found, see figs. 58–60. Bearing contact was established by the detection of the metals used in bearing construction, aluminium and tin, in the metal smeared on the journal surface in the region of the cracks.

Scanning electron micrograph showing the smearing of bearing metal on the journal surface and the presence of small cracks aligned parallel with the axis of the journal. The as machined surface of the journal can be seen at the bottom of the micrograph

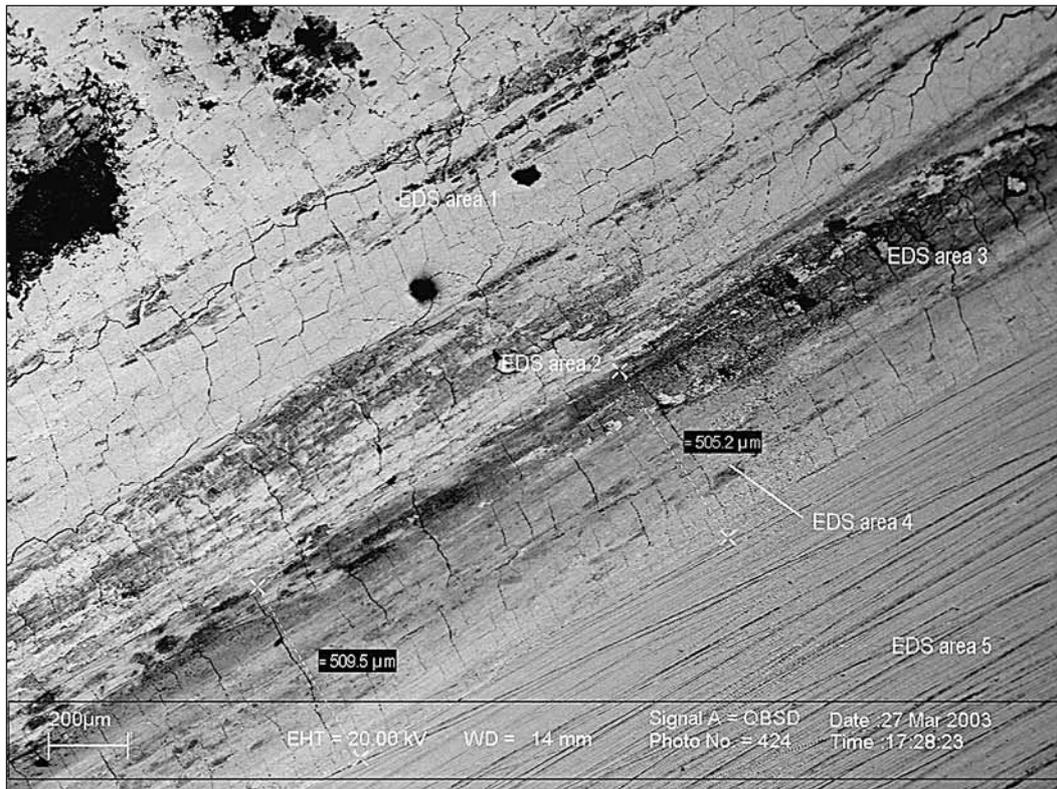
FIGURE 60:
Micrograph showing the location of energy dispersive Xray area scans figs. 61–65

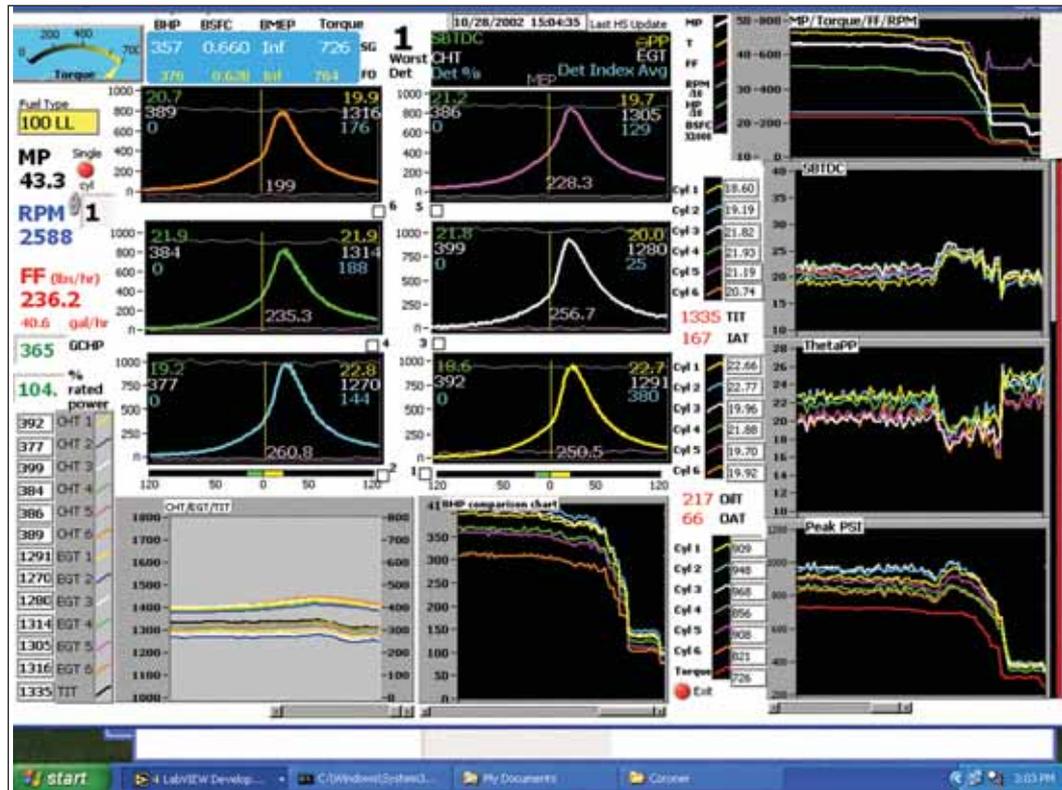
Figure 2:
 Showing engine producing 357 bhp at 2588 RPM, 43.3 inches MP, and full rich mixture. Note that very small changes in RPM and MP from those in Figure 1 resulted in a 2 percent power increase

A print out of engine test stand data provided by Mr Braly indicates that his TIO-540 engine was producing 357 brake horsepower (104 per cent rated power based on a gross corrected horsepower of 365) at 43.3 inches of manifold pressure and 2588 RPM (see Attachment D, fig 2). Mr Braly did not indicate that the engine was being overstressed when operated at this configuration and power setting.

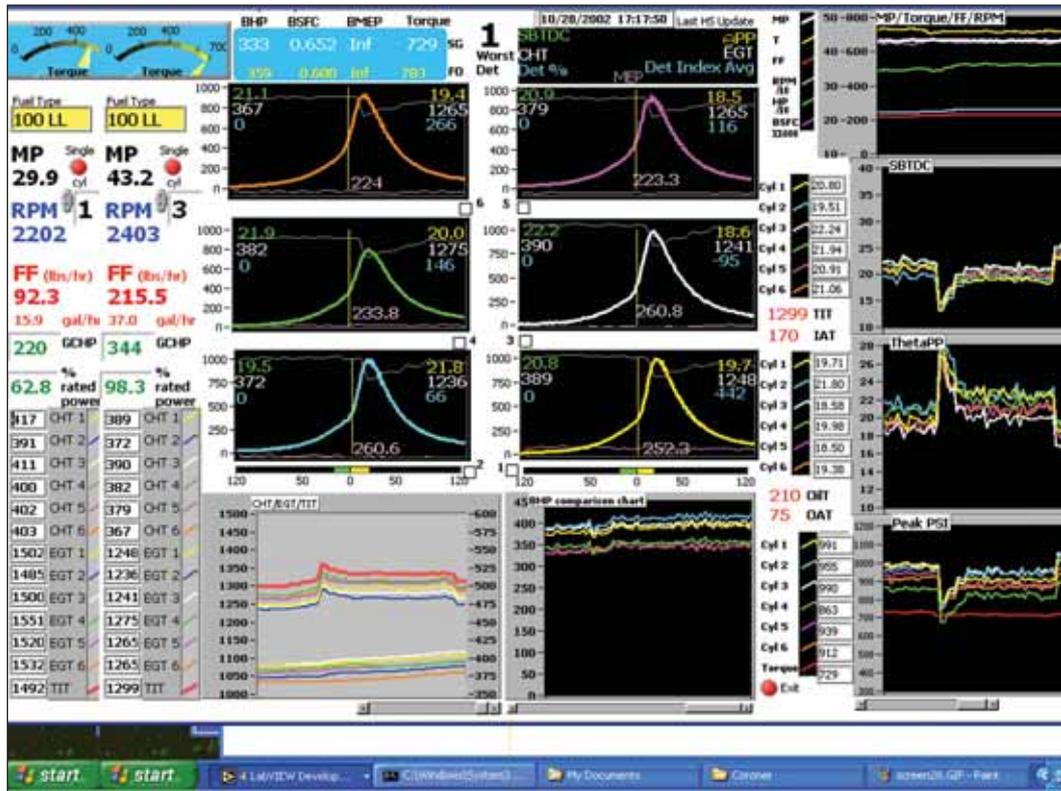
Mr Braly's evidence relating to brake horsepower at 2400 RPM is inconsistent with that observed using his engine test facility where at full rich mixture 43.2 inches MP delivered 333 bhp and 45.8 inches MP delivered 359 bhp (see Attachment D figs. 3 and 4).

scenario. I believe its stable at that condition, basically wide open manifold pressure 2400 RPM, 37 gallons. Is that what somebody was asking? The screenshot is numbered 29 [Figure 3].

Figure 3:
Showing engine producing 333 bhp at 2403 RPM, 43.2 inches MP, and full rich mixture

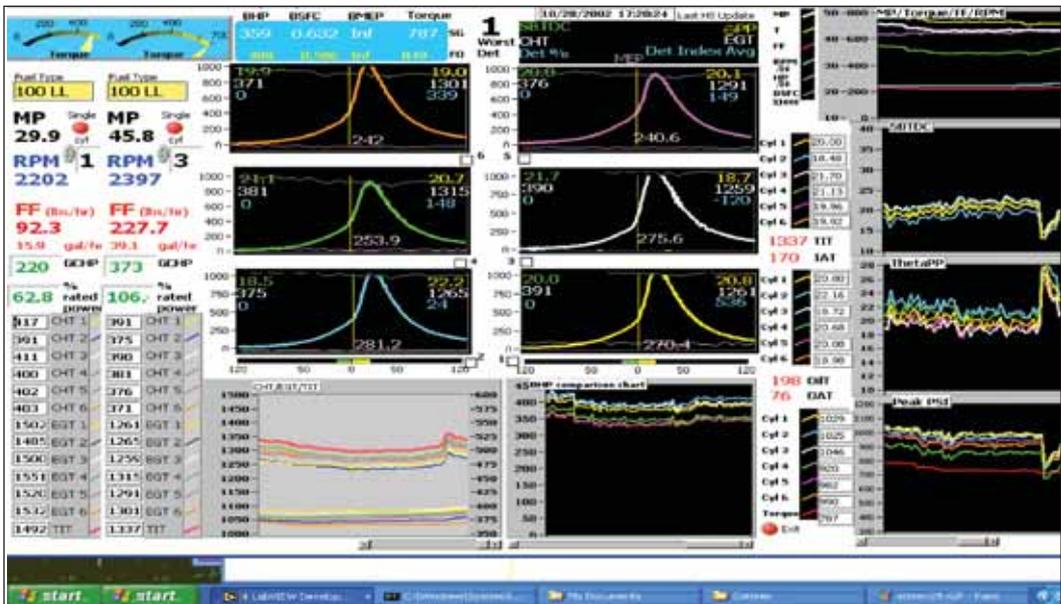
Mr Braly: Extremely high mean effective pressures at this at low RPM and peak cylinder pressure is now pushing 1050. The induction air temperature is 170. The screenshot of that is 30 [Figure 4]. I'm not real happy to be staying here. Does anybody have any reason why they want me to stay here?

1. Mr Braly was not keen to continue operating the engine in the conditions depicted in Figure 4, apparently because of the potential to damage the engine.
2. Leaning the mixture from the conditions in Figure 4 would increase the power output above 359 bhp. The situation then would be that:
 - The engine would be operating in a condition of significant detonation,
 - Cylinder head temperature would rise above the limit unless some cooling was applied, and
 - Severe engine damage was likely.

Figure 4:
Showing engine producing 359 bhp at 2397 RPM, 45.8 inches MP, and full rich mixture

The Coroner also observed the engine producing 359 brake horsepower (106 per cent rated power based on a gross corrected horsepower of 373) at 2397 RPM, 45.8 inches manifold pressure (see Attachment D, fig 4).

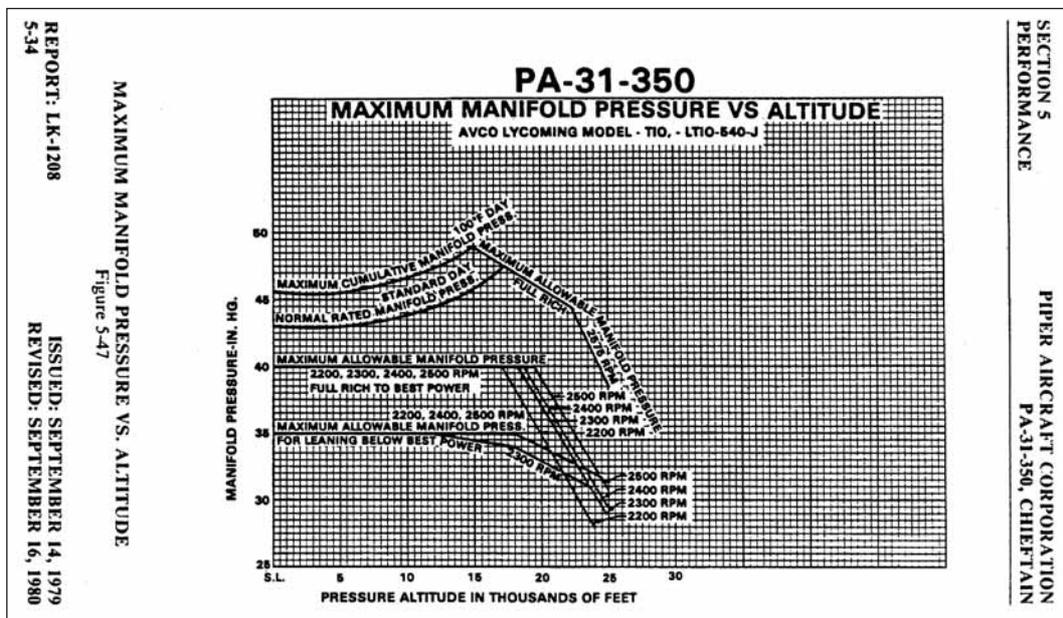
Figure 5-47: From the Piper POH (Report LK-1208)

As demonstrated in figure 5-47 above, the normal rated manifold pressure for the Lycoming TIO-540-J engine is 43 inches at sea level on a standard day with the engine operating at 2575 RPM and full rich mixture. The maximum manifold pressure allowed for engine operation at 2200, 2300, 2400 or 2500 RPM with mixtures between full rich and best power is 40 inches.

The engine would be overboosting if the manifold pressure was greater than 40 inches at 2200, 2300, 2400 or 2500 RPM even with a full rich mixture. It is significant that the chart shows the 40 inches manifold pressure limit as a straight line, indicating an artificial limit, as opposed to the line for normal rated manifold pressure that shows manifold pressure varying with altitude.
