AVIATION SAFETY INVESTIGATION  
200105618

**Beech Aircraft Corporation C90  
VH-LQH  
Toowoomba, Qld**

**Beech Aircraft Corporation C90**  
**VH-LQH**  
**Toowoomba, Qld**  
**27 November 2001**

June 2004

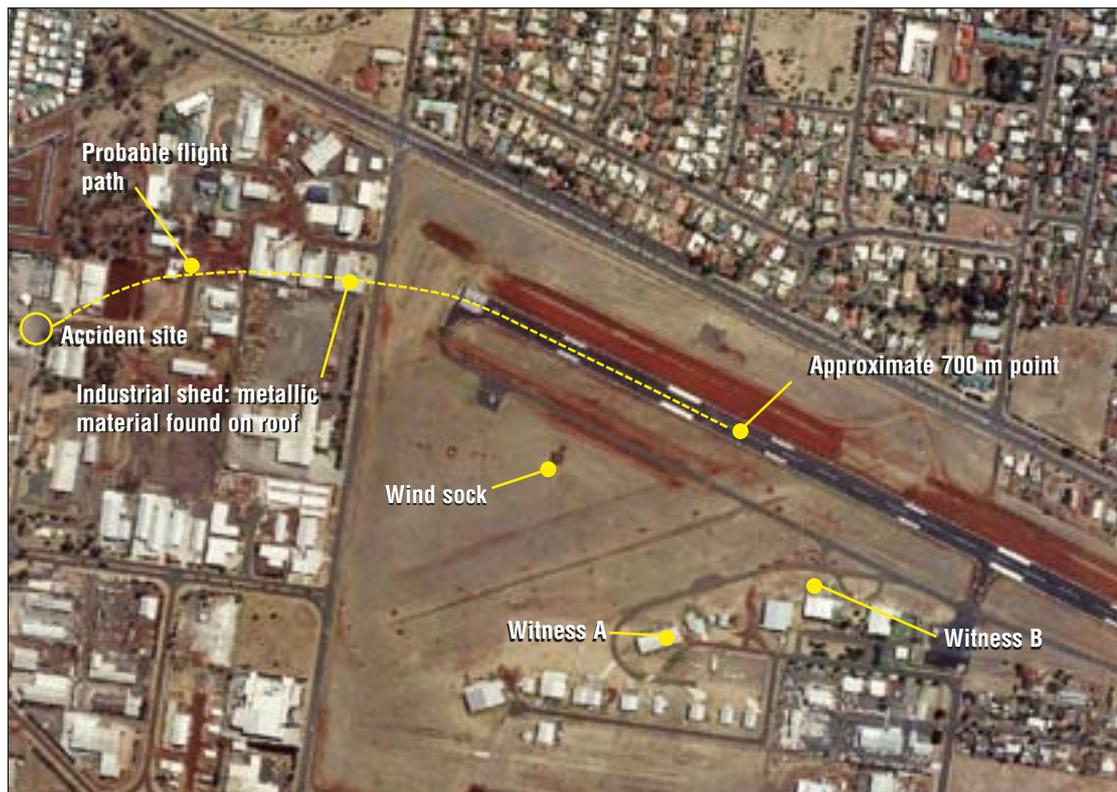
**FIGURE 2:**  
Aerial view showing the accident location and the runway

The location of the accident site is shown in Figure 2.

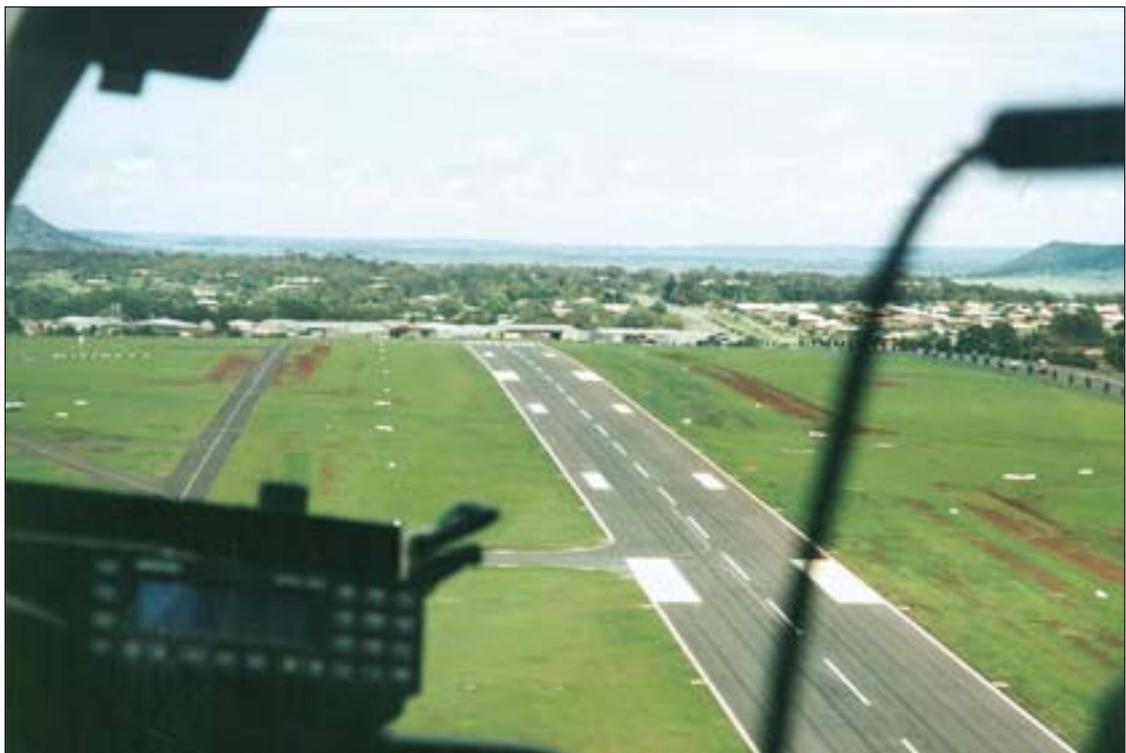
**FIGURE 4:**  
Aerial view of runway 29

Toowoomba aerodrome was situated 4 km west of the Toowoomba central business district and it was 2,086 ft above mean sea level. It was operated by Toowoomba City Council. Runway 11/29 (see Figure 4) was aligned 106/286 degrees magnetic, was 1,121 m long and 30 m wide, and had a bitumen surface. A second runway, 06/24, was aligned 062/242 degrees magnetic, was 660 m long and was not sealed.

Examination of Toowoomba City Council engineering diagrams indicated that for the first 170 m of runway 29 there was an upward slope in excess of 1.25 per cent. This slope gradually reduced until the peak of the runway, which occurred at a point 780 m from the runway 29 threshold. The runway then sloped downward to the west at a gradient of about 1.5 per cent for the last 40 m. The effect of the upward slope was to increase the take-off run of an aircraft (see Section 1.20.6).

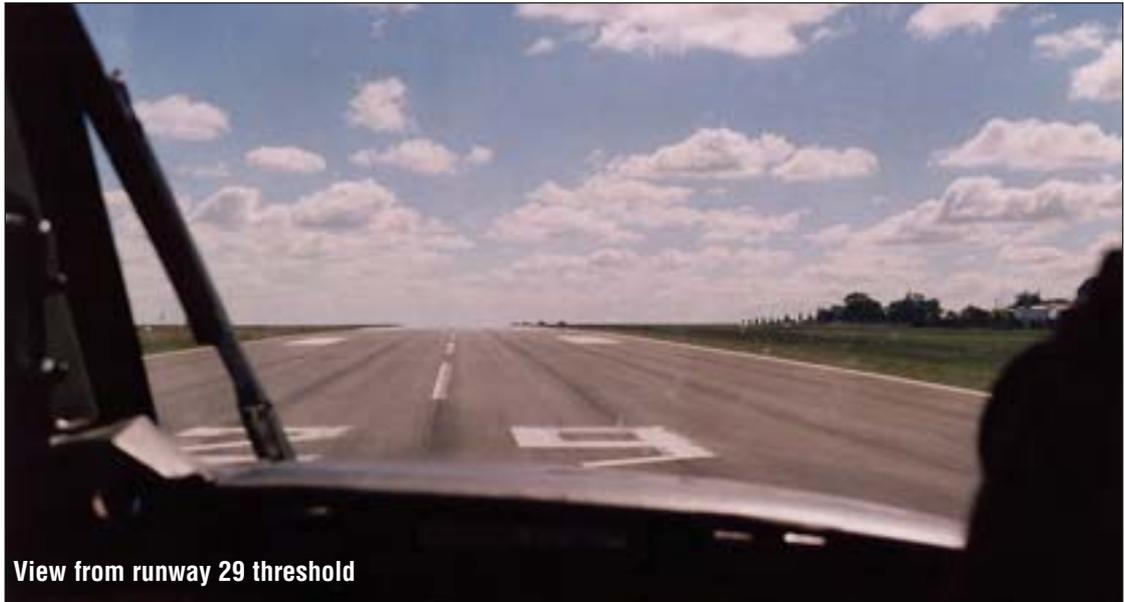
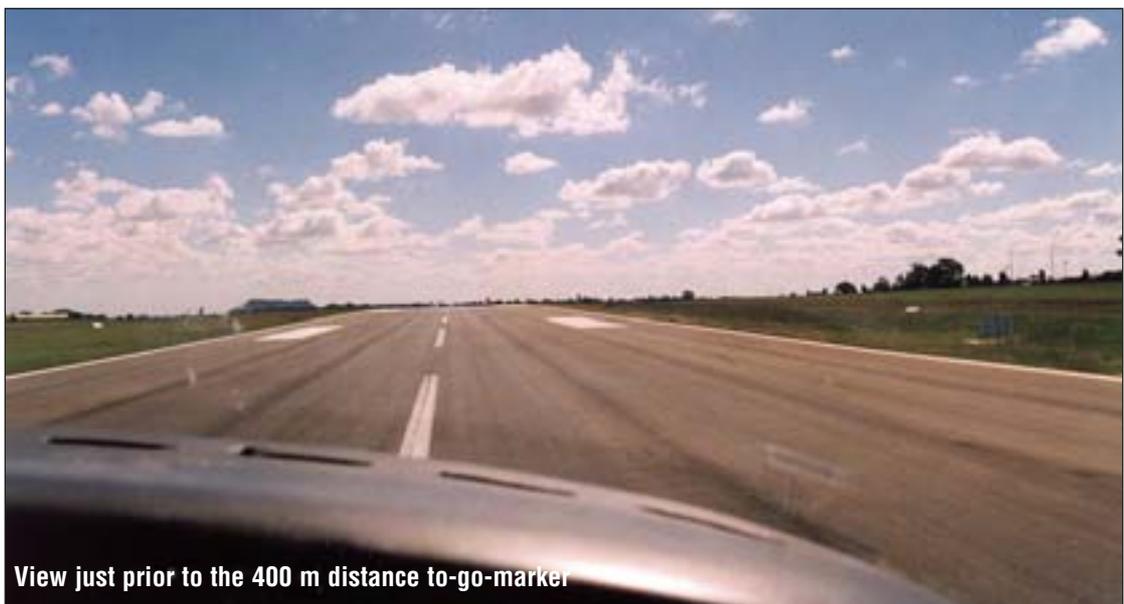
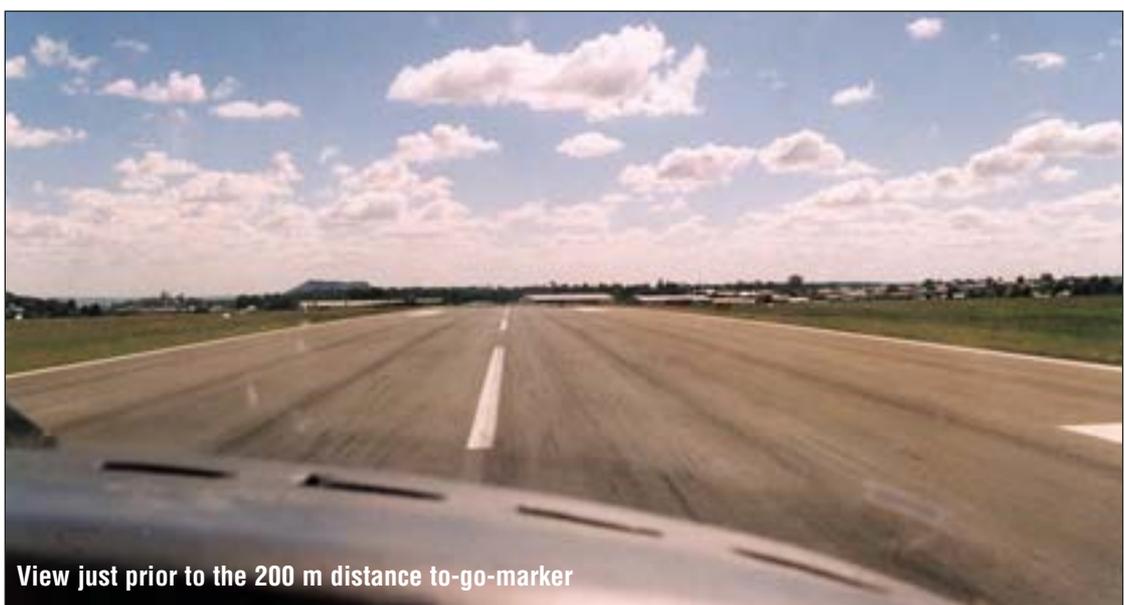
**FIGURE 5:**  
Views from a King Air cockpit on runway 29

The positive to negative change in gradient over the length of the runway created a visual limitation for pilots, such that one end of the runway could not be seen from the other.<sup>18</sup> During the take-off roll on runway 29, industrial buildings started to become visible, from the pilot's position in a C90 aircraft, when the aircraft was about 450 m from the end of the runway.<sup>19</sup> The end of runway 29 did not become visible until the aircraft was about 350 m from the end of the runway. The operator reported that the sudden appearance of the end of the runway late in the take-off roll could predispose pilots to believe that it was closer than it actually was. Views from the cockpit of a King Air aircraft at various points along runway 29 are shown in Figure 5.<sup>20</sup>

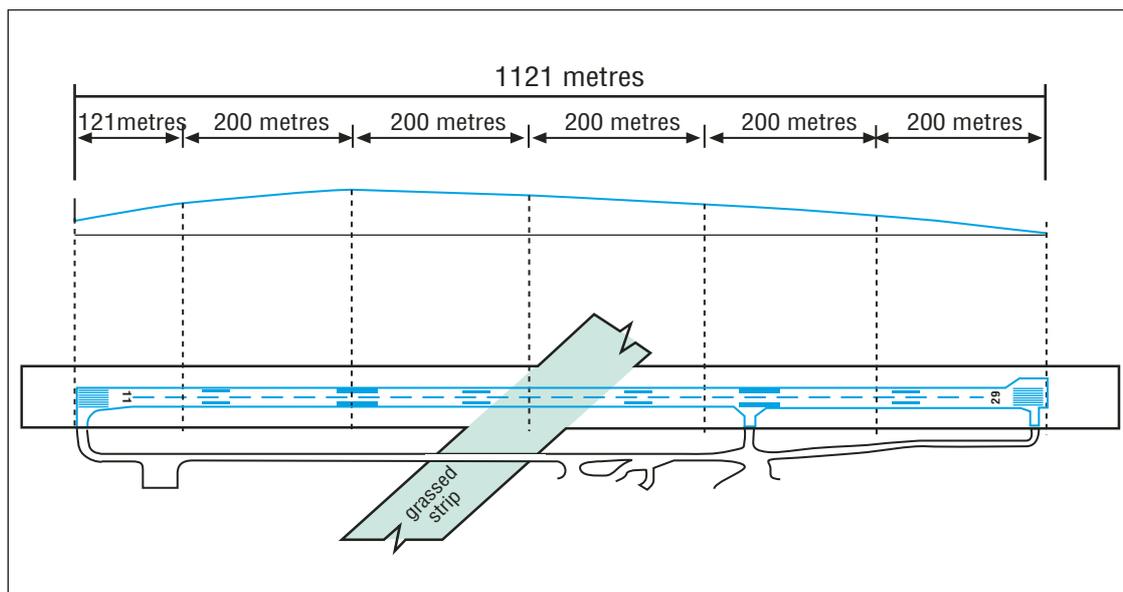
**FIGURE 6:**  
**Toowoomba aerodrome runway 11/29 dimensions and slope**

To assist in overcoming the visual limitation associated with the runway gradient, the aerodrome operator had installed distance-to-go markers at positions 600 m, 400 m and 200 m from the respective ends of runway 11/29. The runway dimensions and runway slope are shown in Figure 6.

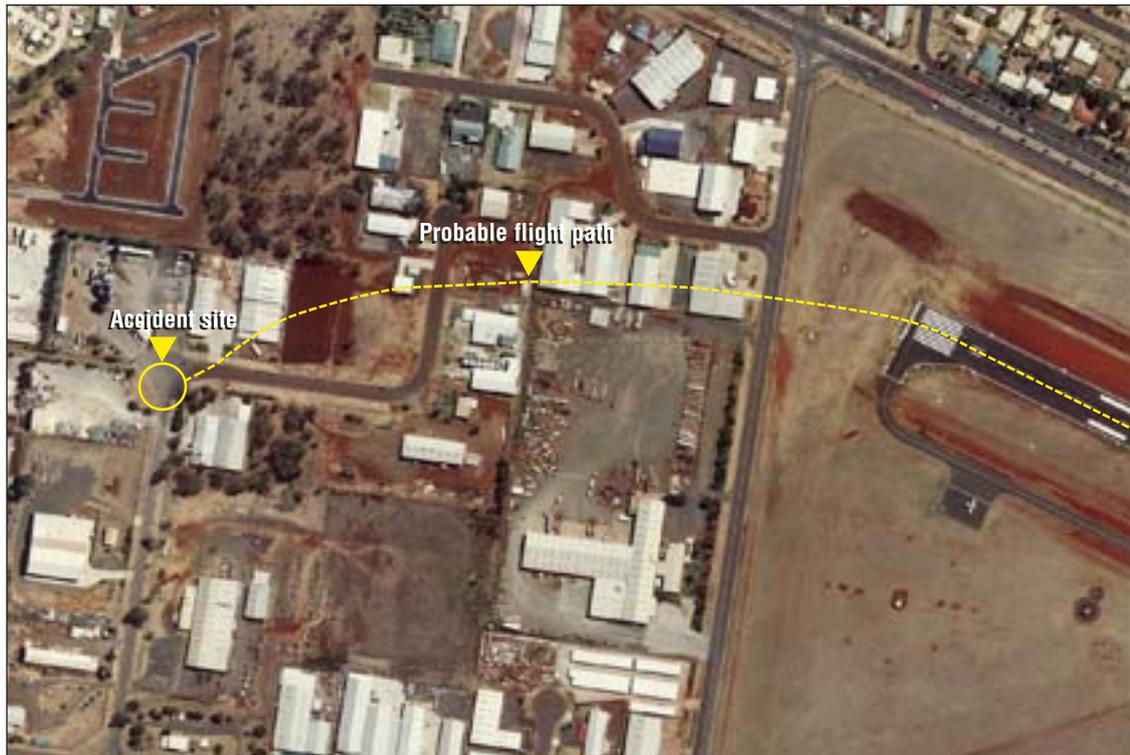
**FIGURE 9:**  
**Aerial view showing the accident location**

The location of the accident site in relation to the runway is shown in Figure 9.

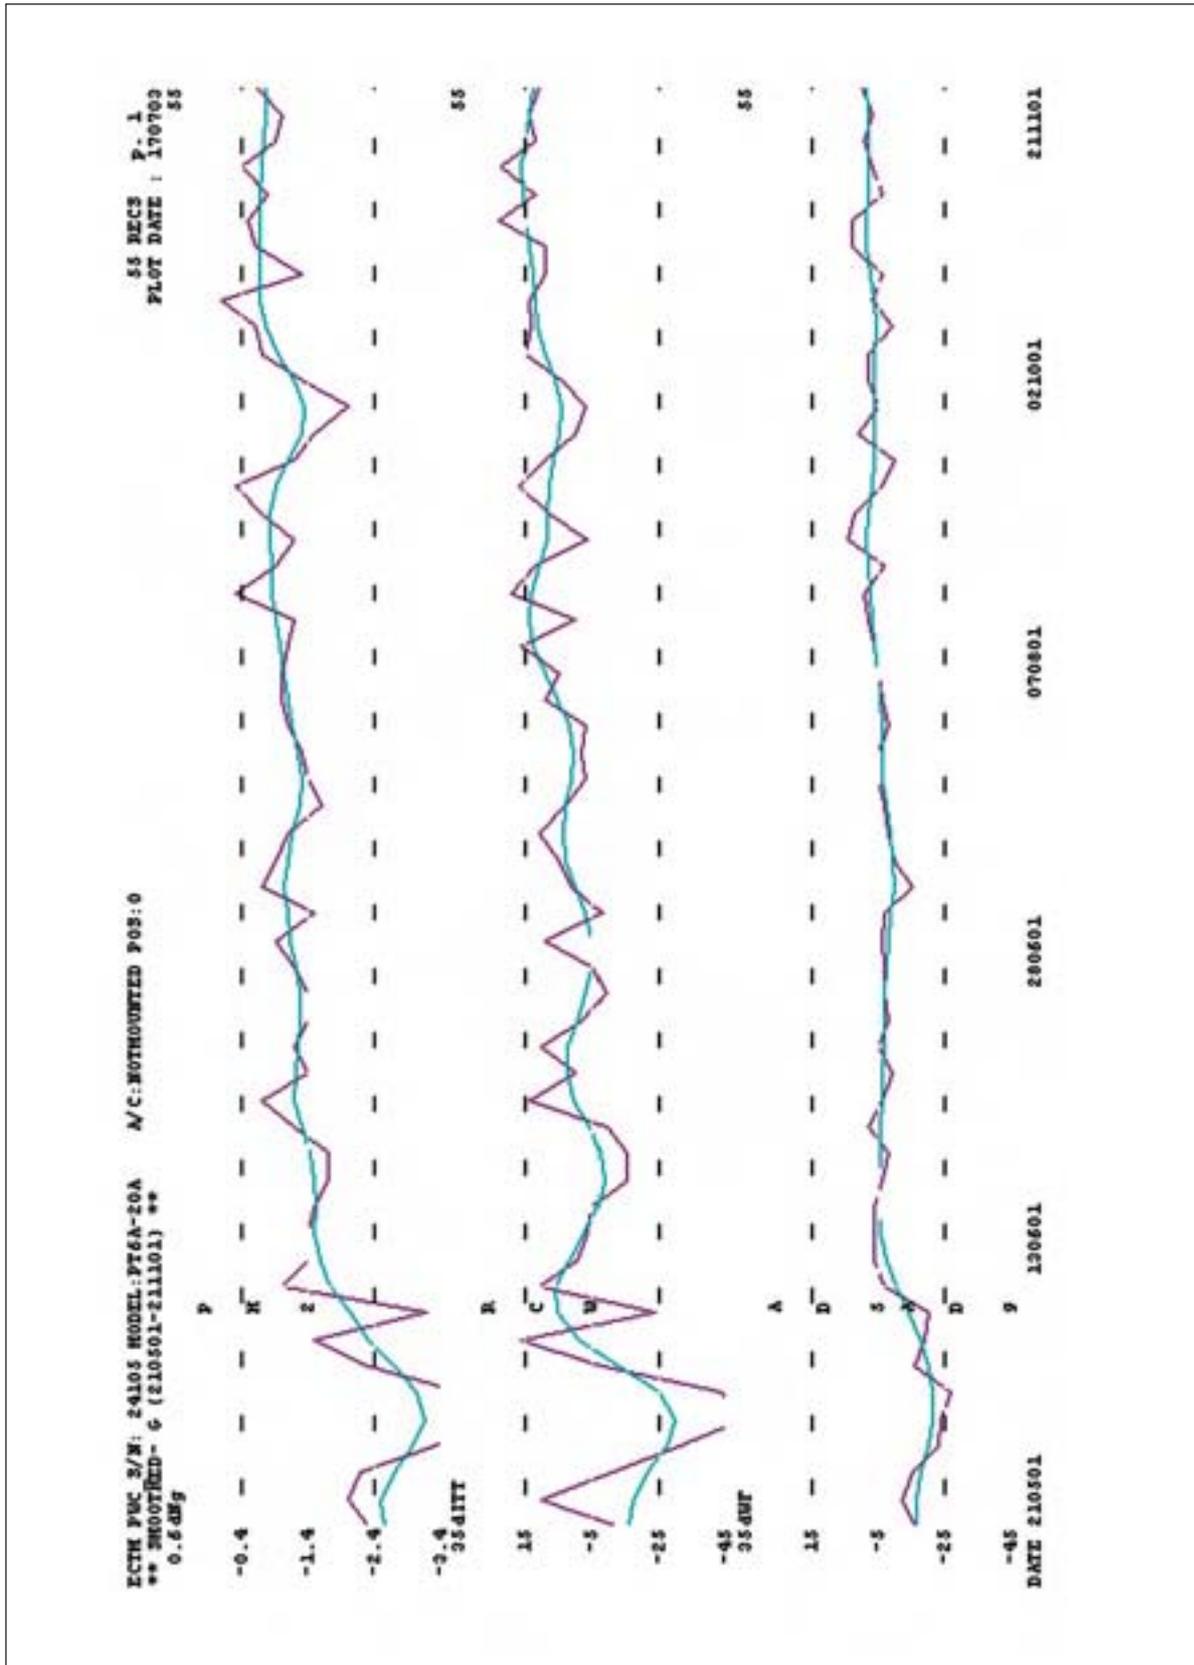
Left engine ECTM data graph

The data pattern for the left engine showed a gradual increase in the delta ITT trend line after the baseline was established. The delta ITT trend line reached 10 degrees above baseline on 1 August 2001 (see Figure 15). As noted in Section 1.17.1, the trend line is based on data points before and after a particular data point of interest. As discussed in Section 1.18.10, an external party had access to the data for LQH after 7 August 2001 and after 12 September 2001. The investigation reviewed the trend lines using only the data up to and including 7 August 2001 entered into the program. In that case, the delta ITT trend line reached about 8 degrees above baseline. Using data only up to 12 September 2001, the delta ITT trend line reached almost 20 degrees above baseline.

One data point in these sets of data, recorded on 3 September 2001, should not have been included as it was recorded at less than 8,000 ft and outside of the normal range of altitudes required by the operator for data recording (see Section 1.18.8). This value was not excluded prior to the trend lines in Figure 15 being developed. The delta value of ITT on the left engine for the 3 September data point was relatively high (21 degrees above baseline). When this data point was removed from the data set, the trend line for delta ITT as at 12 September (with all data after that date excluded) reached a level of about 12 degrees above baseline.
