ATSB TRANSPORT SAFETY REPORT

Aviation Occurrence Investigation AO-2007-061

**Collision with water (VFR into IMC)
Approx 24 km SE Inverloch, Vic.
17 November 2007
VH-CHU
Cessna Aircraft Company C337G**

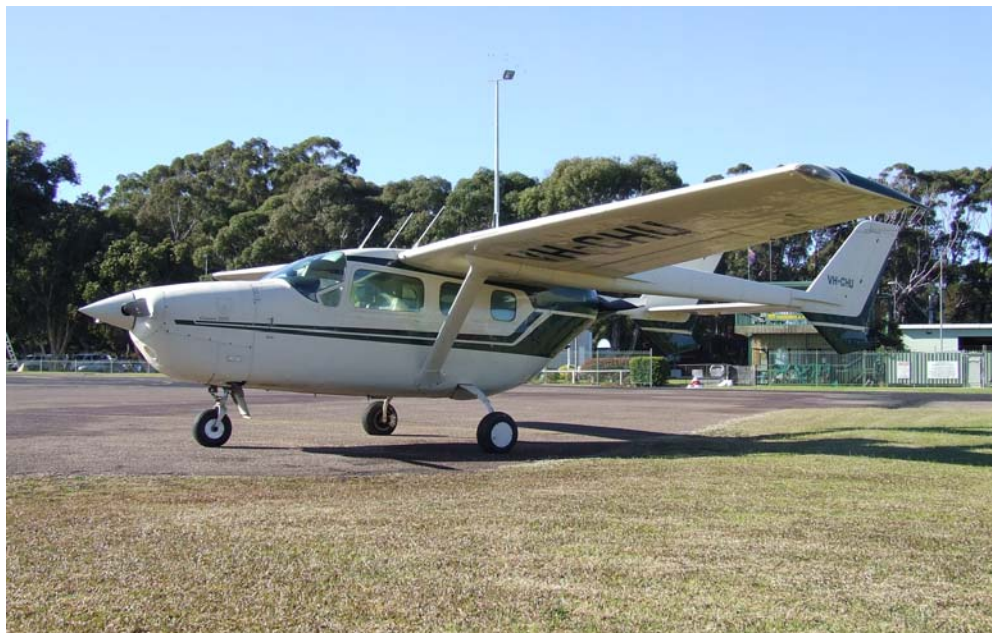
Figure 5: VH-CHU

The twin-engine, centre-line thrust aircraft (Figure 5) was manufactured in the US in 1977 and at the time of the accident had been operated for about 5,810 hours. The pilot purchased the aircraft in September 2007.

In addition to the standard VFR instrumentation, the aircraft was equipped with an artificial horizon, directional gyro and vertical speed indicator. The avionics included a Bendix/King KLN 90B GPS and a Cessna (ARC) 400A Navomatic Autopilot.

The current maintenance release was found in the sand near the wreckage on the beach. It was issued on 29 August 2007 at 5,799.9 hours aircraft total time in service. There were no recorded aircraft defects or overdue maintenance requirements. A review of the aircraft's maintenance records did not reveal any maintenance anomalies or discrepancies that were likely to have contributed to the accident.
