AVIATION SAFETY INVESTIGATION  
200304282

**Bell 407  
VH-HTD  
Cape Hillsborough, Qld**

17 October 2003

March 2005

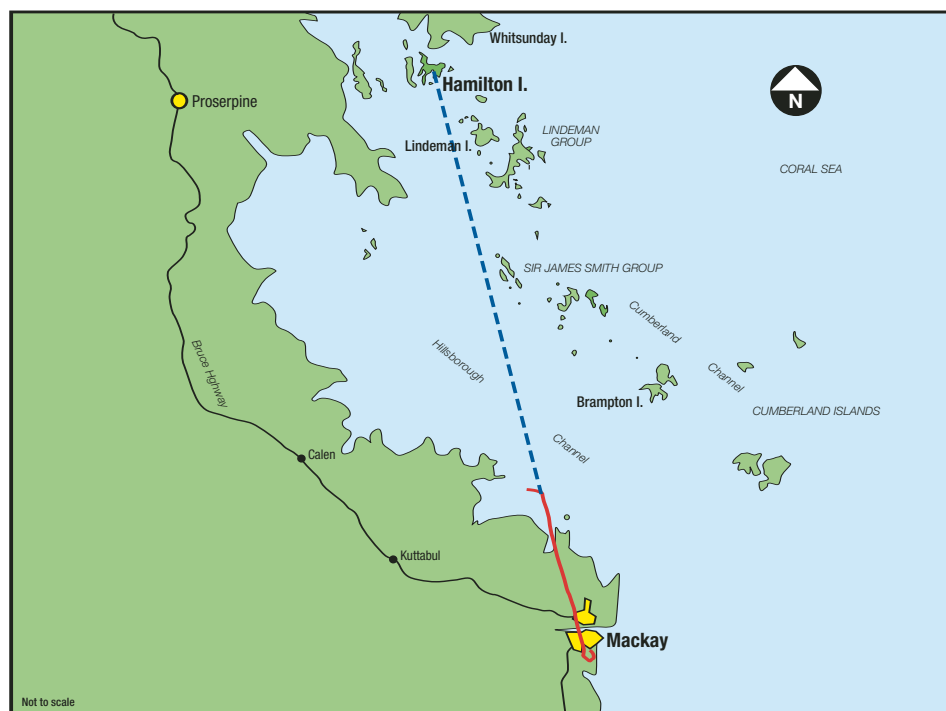
**FIGURE 1: Track to Hamilton Island**

At about 2132, a Bell 407 helicopter, registered VH-HTD (HTD) departed Mackay Airport enroute to Hamilton Island with the pilot, a crewman<sup>2</sup> and the paramedic<sup>3</sup> on board. The flight to Hamilton Island was conducted under the night Visual Flight Rules (VFR) rules. At 2137, the pilot contacted the ACC by radio and informed them that he was 'on case'. ACC personnel acknowledged this report. Shortly thereafter, the pilot again contacted the ACC and announced that they had departed Mackay enroute for Hamilton Island with three persons on board, with an estimated time of arrival of 2207. ACC personnel acknowledged his report. No other communication was received from the helicopter crew for the remainder of the flight. Figure 1 represents the projected helicopter track in blue and the actual track in red.

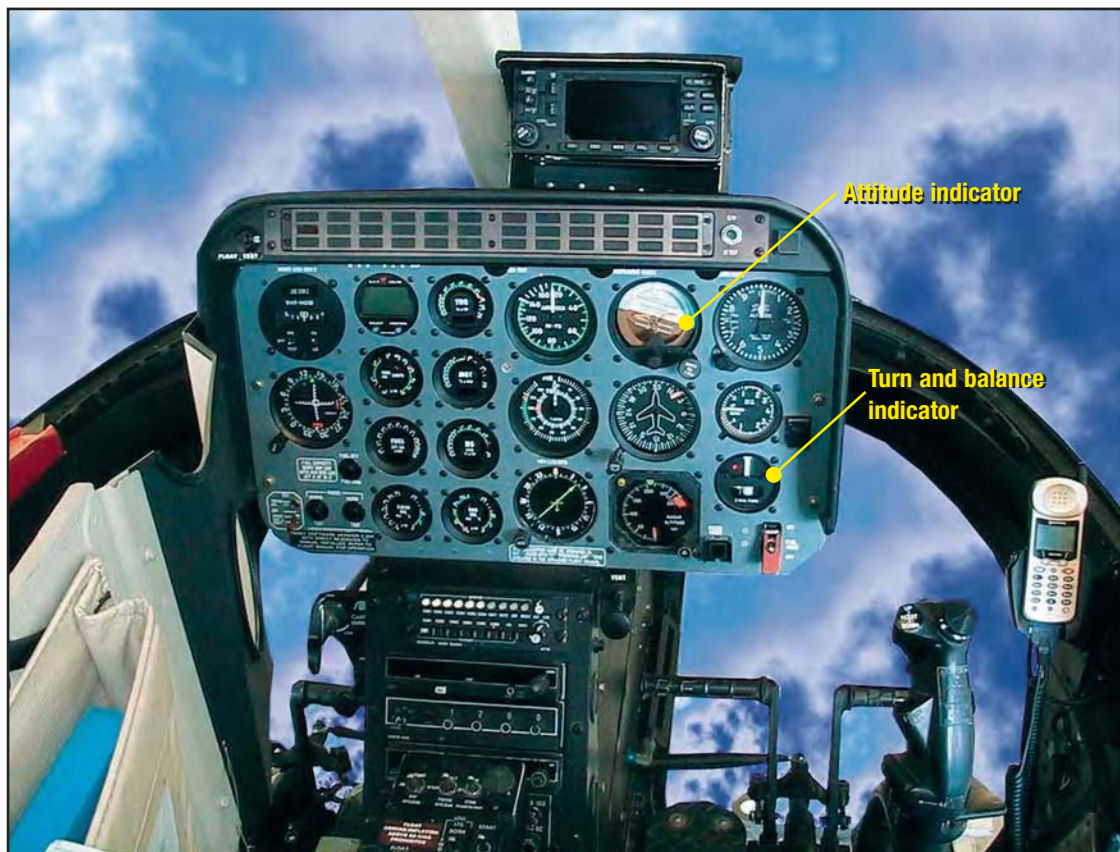
**FIGURE 7: HTD console<sup>25</sup>**

The helicopter was fitted with an attitude indicator, directional gyro, and turn and balance indicator, along with other flight instruments. The attitude indicator received electrical power from the DC essential bus. A display of the flight instrument layout of HTD is included at Figure 7 below.

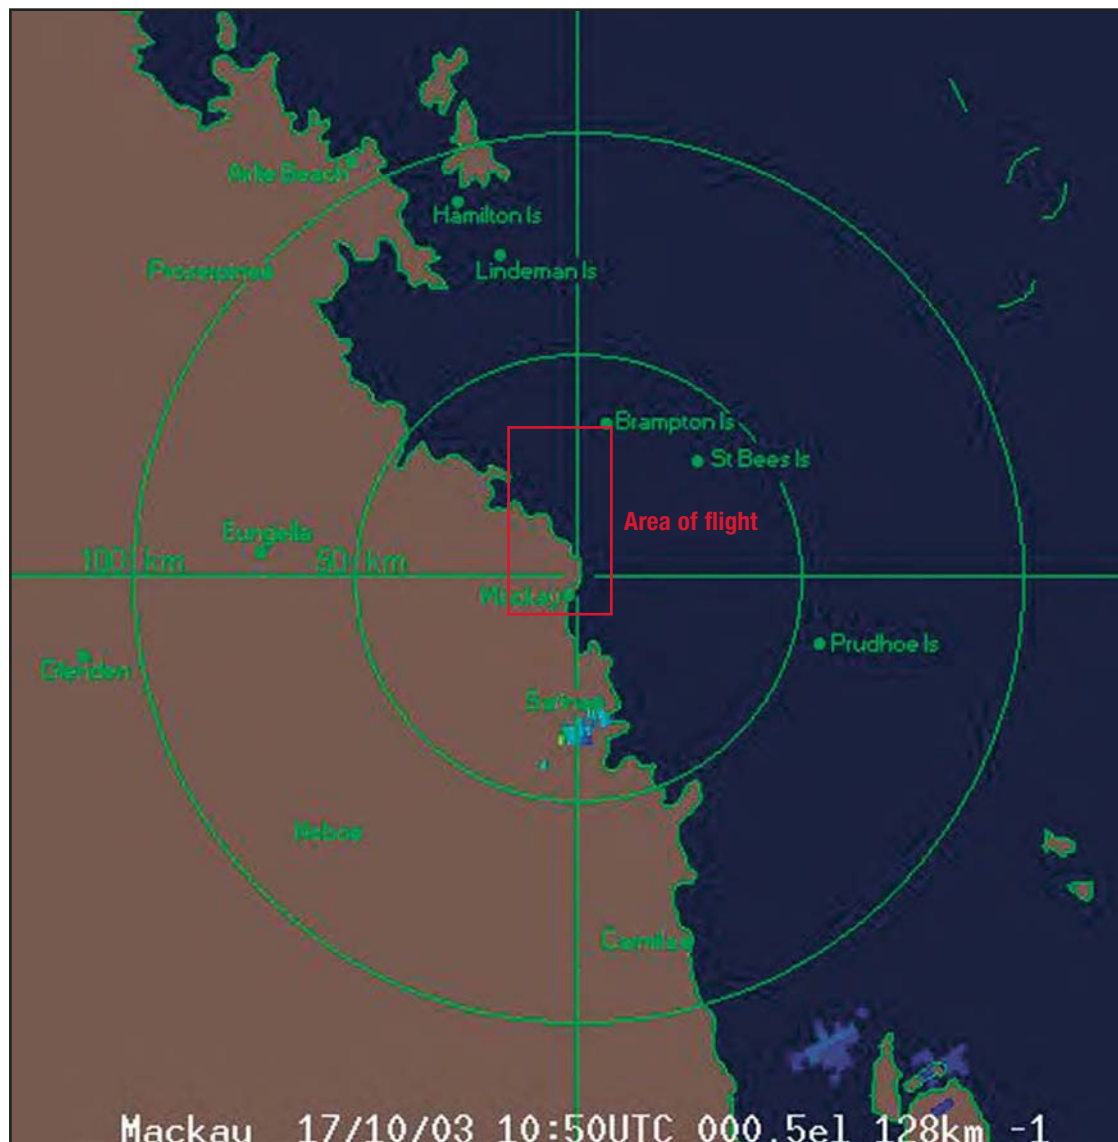
**FIGURE 8: Radar from Mackay at 2050 hours<sup>34</sup>**

weather imaging was not available. That normally occurred up to four times per day for approximately 1.5 hours for each interval. During these periods, the imagery displayed on the BoM website was the last radar image taken before shifting to wind find mode. The date and time of the image was included on the web page screen display. The BoM reported that on the 17 October 2003, the Mackay radar was taken out of weather find mode for the period 2050 to 2250 to allow the Bureau observer the use of the radar for a balloon flight and collection of the 2100 upper wind data. The last valid weather radar image display for this period indicated possible rain shower activity at Sarina to the south of Mackay. Figure 8 displays the Mackay radar image at 2050 hours.

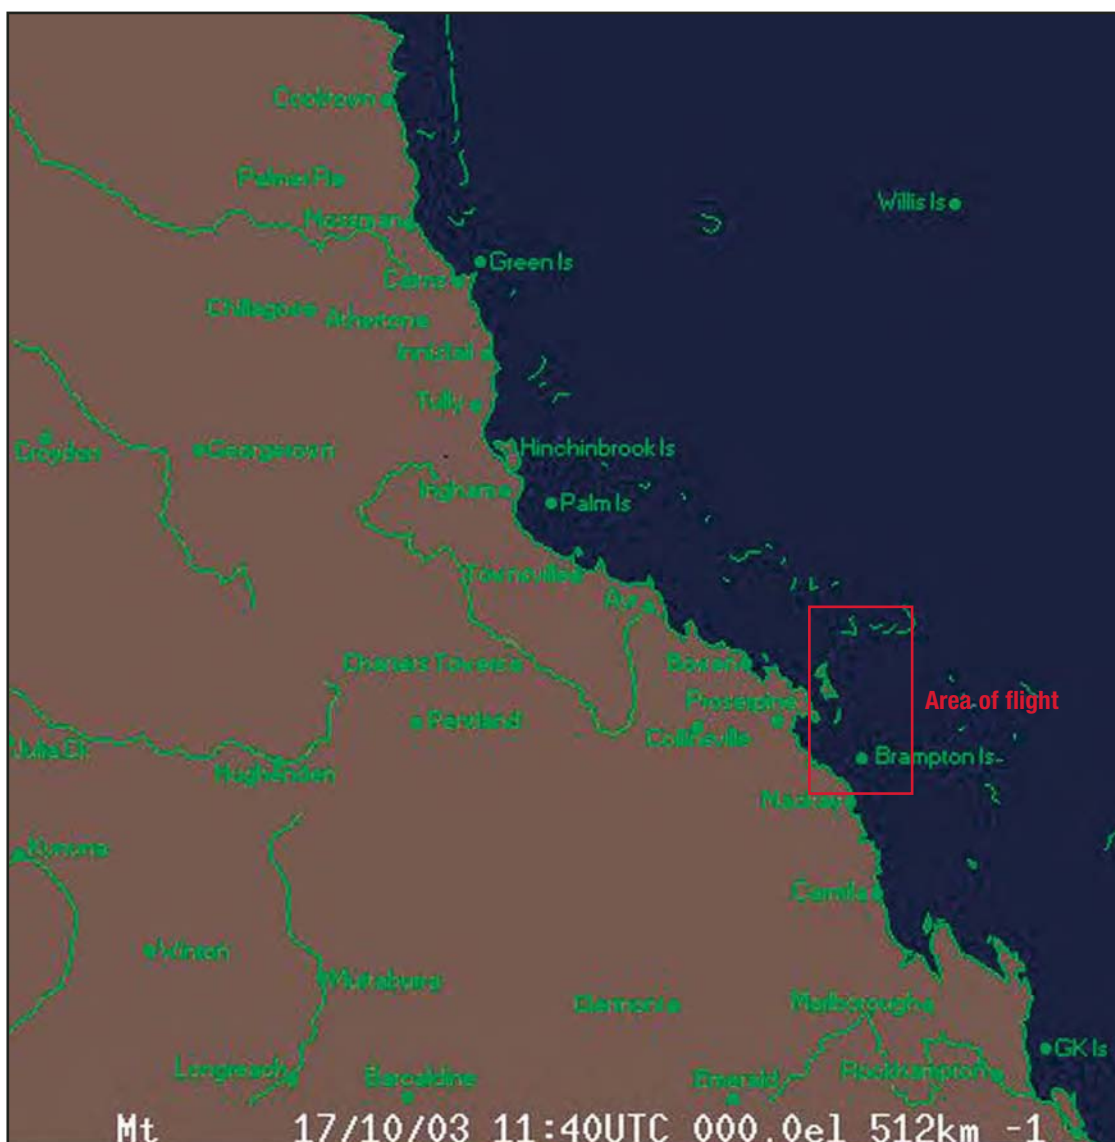
FIGURE 9: Radar from Mount Stuart at 2140 hours<sup>36</sup>

Following the accident, the radar data from the nearest available operational weather watch radar site was analysed. That site was located at Mount Stuart near Townsville, approximately 172 NM from Mackay<sup>35</sup>. The Mount Stuart weather radar image for 2140 indicated no shower activity in the area at the time of the accident. Figure 9 displays the Mount Stuart radar image for 2140 hours.

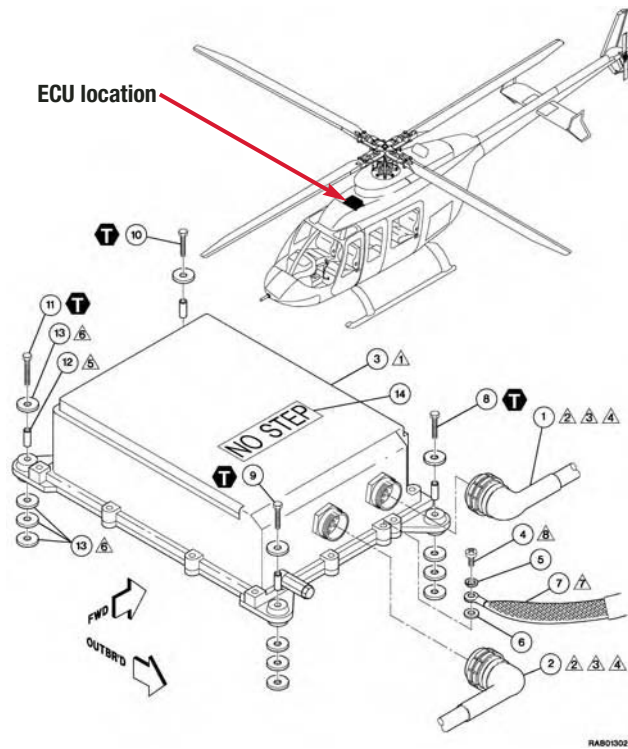
**FIGURE 17: ECU location** <sup>93</sup>

The ECU recorded engine information on a printed circuit memory board. The memory board contained an electronically erasable programmable read only memory (EEPROM) chip (printed circuit board) for use in the diagnosis of the engine health and serviceability. It also recorded excursions of any engine input parameters above defined levels and stored 15 seconds of data prior to any excursion event and 45 seconds after the event. Figure 17 displays the location of the ECU on the helicopter (located on the forward transmission deck).
