Australian Transport Safety Bureau

Piper Aircraft Corp PA-34-200, VH-CTT

Bankstown Airport, NSW

INVESTIGATION REPORT

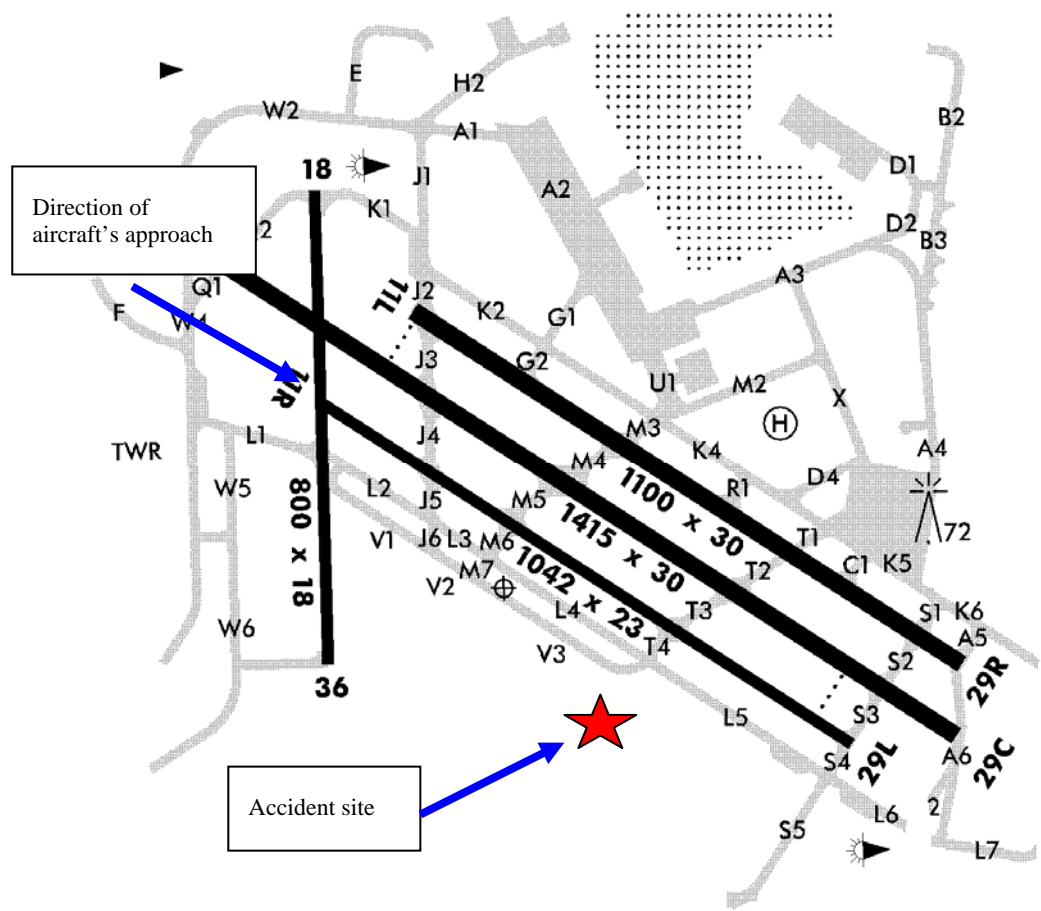
Figure 3: Bankstown Airport diagram and location of accident site

Relative to the threshold of runway 11R, the accident site was on a bearing of 21 degrees to the right of the runway centreline and 610 m from the threshold. The site was located approximately 229 m south-west of the runway centreline.
