**ATSB TRANSPORT SAFETY REPORT**

Aviation Occurrence Investigation – AO-2007-018

**Total power loss  
Cecil Park, NSW  
5 February 2007  
VH-HYY, Cirrus SR22**

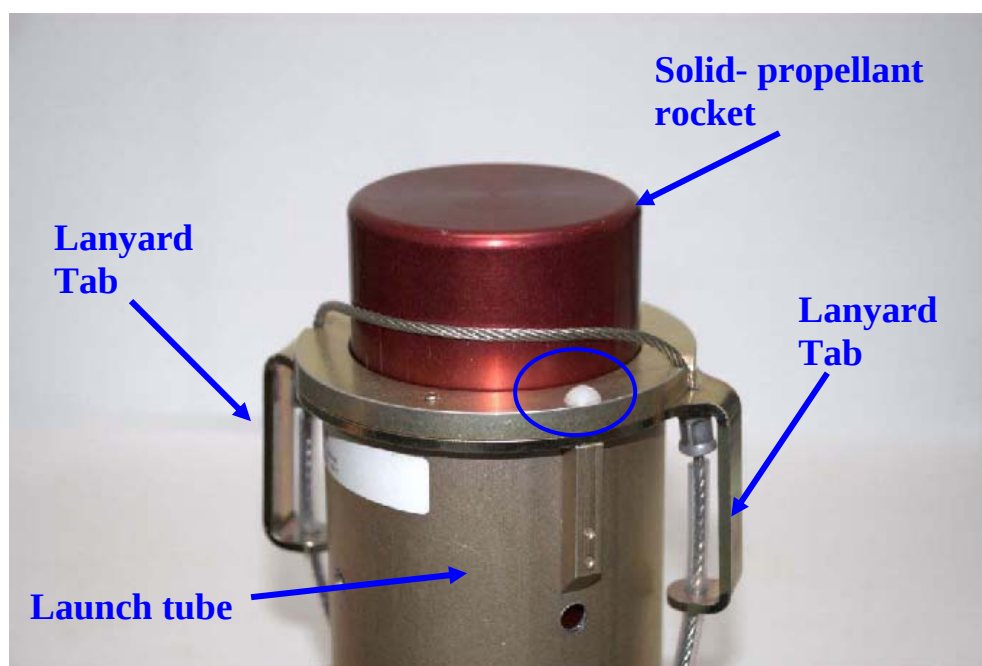
The CAPS solid-propellant rocket was located inside a steel launch tube attached to a cross beam on the airframe. A pick-up collar assembly, consisting of a steel pick-up collar with integral lanyard tabs and an alloy pick-up collar support, was attached to the top of the launch tube by two nylon tension screws that held the collar in the correct position relative to the rocket (Figure 13). These screws were designed to shear on rocket activation when the raised rim around the base of the rocket contacted the pick-up collar assembly.

**Figure 13: Pick-up collar and pick-up collar support correctly positioned on launch tube; showing nylon tension screws (circled)**
