Aviation Occurrence Investigation AO-2007-061

Preliminary

Collision with water
Approx 24 km SE Inverloch, Vic.
17 November 2007
VH-CHU
Cessna Aircraft Company C337G

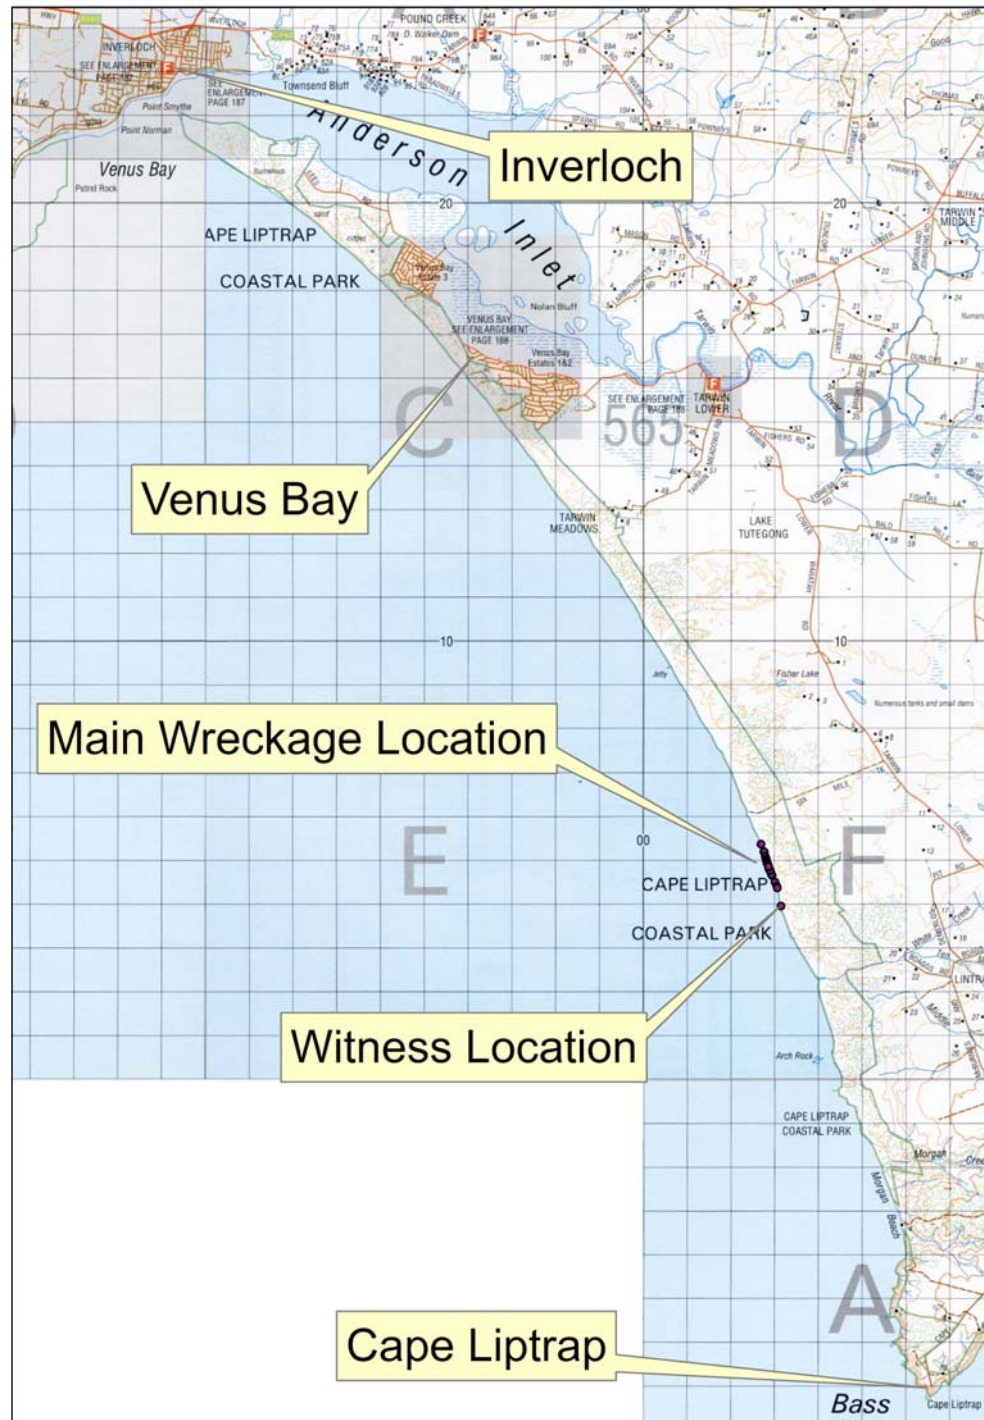
Figure 1: Map showing location of areas where aircraft was observed

When the aircraft did not arrive at Merimbula as expected, the Australian Maritime Safety Authority was advised and a search was initiated. On 19 November 2007, wreckage of the aircraft and three of the deceased occupants were found washed up on the beach between Venus Bay and Cape Liptrap, Vic (Figure 1). There were no survivors.

apparent problem with the engines and the aircraft appeared to be under control. About 2 seconds after the aircraft disappeared from view they heard a 'bang'. There were no further noises associated with the aircraft.
