ATSB TRANSPORT SAFETY INVESTIGATION REPORT  
Rail Occurrence Investigation 2007/003  
Final

# Derailment of Train 3MR2 near Roopena, South Australia

22 May 2007

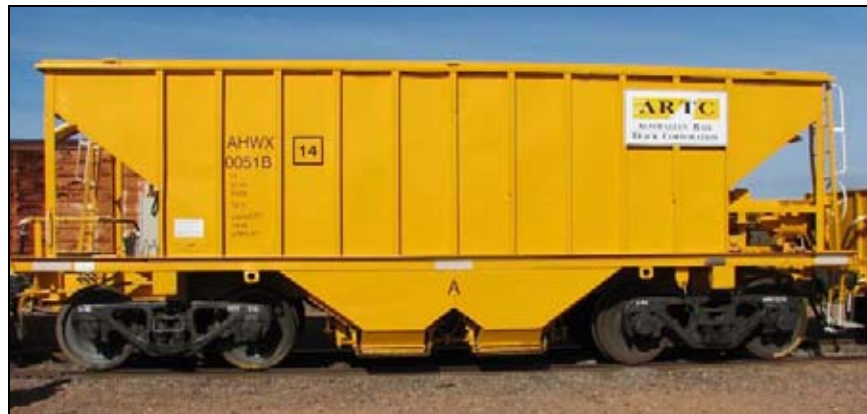
**Figure 2: AHWX class wagon**

The AHWX class wagon is an open top hopper style wagon designed to carry track ballast. Loaded wagons are usually hauled to a worksite where ballast is discharged through discharge chutes located in the base of each wagon. The wagons ride on three-piece 'Ride Control' bogies with gap/friction style side bearers. The AHWY class wagon is an AHWX class wagon that has been modified to accommodate constant contact side bearers (CCSB). At the time of the derailment, only one wagon in the train had been modified with CCSB's as a 'proof of concept' (AHWY-13). Due to dynamic behaviour limitations, AHWX class ballast wagons are not permitted to exceed 80 km/h. Each of the 35 ballast wagons in the train had been recently refurbished with a remote door operating system replacing the original manual system.

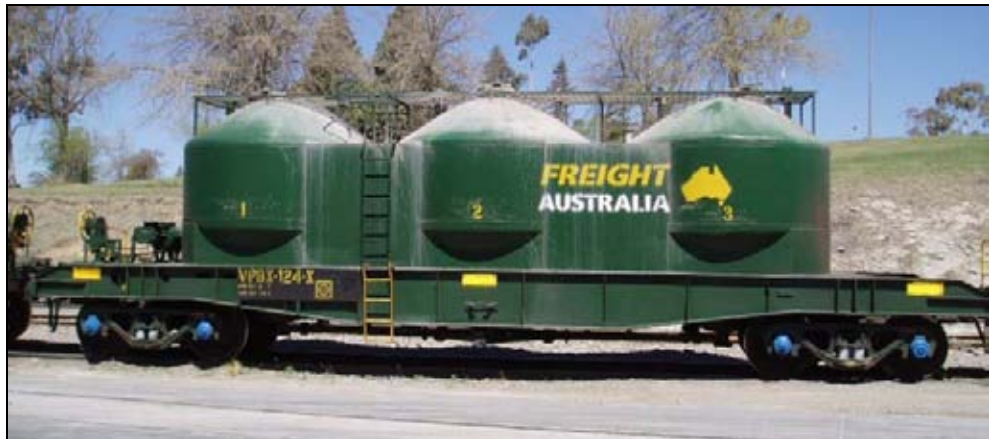
**Figure 12: VPBX class wagon**

On 23 September 2004, Train 4VM9-V derailed while travelling southwards between Glenrowan and Benalla, Victoria<sup>16</sup>. The train consisted of a single locomotive hauling 15 wagons loaded with dry bulk cement, four of which derailed while travelling at about 75 km/h. The wagons were a covered hopper style construction (VPBX class wagon) that have a very rigid body structure and are rated for a maximum speed of 80 km/h.

The section of track where the derailment occurred was rated for a track speed of 115 km/h. Due to uneven track and a number of pronounced dips, a temporary speed restriction of 80 km/h had been applied. However, since the cement wagons were rated for 80 km/h, there was no requirement to reduce the speed of train 4VM9-V.

The investigation concluded that the combination of wagon stiffness and deteriorated track condition associated with track twist created conditions where the cement wagon sustained roll-induced wheel unloading and subsequent flange-climb followed by derailment.
