MARINE SAFETY INVESTIGATION REPORT
No. 200

Independent investigation into the grounding of
the Bahamas registered passenger ship

Astor

in Platypus Channel, Townsville, Queensland
26 February 2004

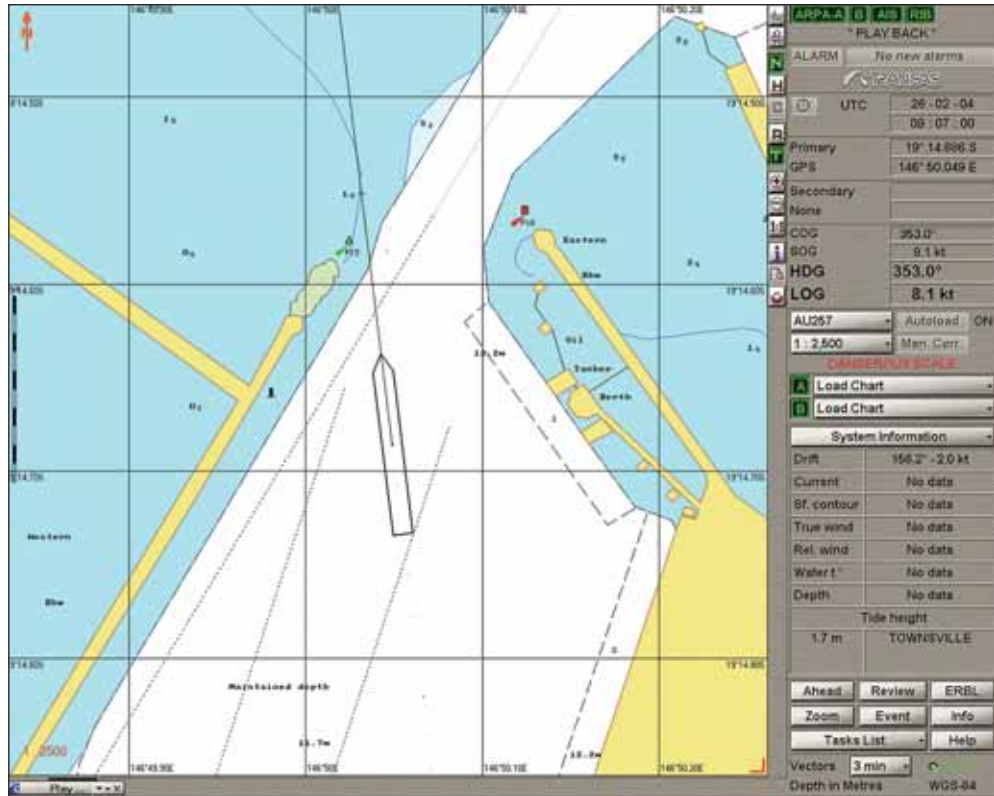
FIGURE 7:
GBR pilot's plot 1907 hours

The GBR pilot's electronic chart printouts (Figures 7 to 10) display the geographical position of its GPS aerial, the time and course and speed of the ship over the ground. The system uses a single GPS aerial, and thus no heading data is available from the pilot's electronic chart playbacks. The ship's track information is stored within the system at ten second intervals. The aerial was rigged on the port bridge wing, about 10 m from the centreline of the ship and just forward of the theoretical pivot point. (Note: The ship image on the printouts in the following figures should be disregarded as this is not an indication of ship type or dimensions. Interest should be directed to aerial location and the vector for the course made good).

The ship's ECDIS printout was compared with the GBR pilot's chart printout by overlaying the two. The two courses were identical; however, the GBR pilot's trace of the ship's route was offset to port from the ship's trace by about 18 m. This is accounted for by *Astor's* GPS aerial, which is used for the radars and chart GPS receiver, being offset some nine metres to starboard of the ship's centreline.

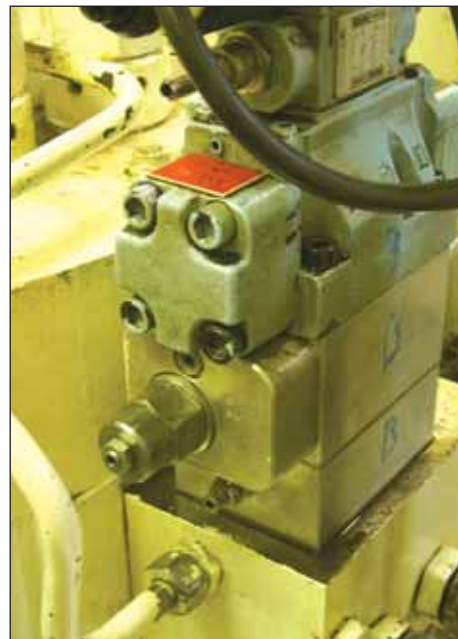
FIGURE 12:
Valve block arrangement

The fractured pieces of the component were reported as having been taken from an automatic stop valve on number two hydraulic system (SV1 in Fig. 13), which supplied the port steering rotary vane unit. However, the components, although similar, were not consistent with the drawing supplied to the vessel by the manufacturers in the steering gear operating manual. To be able to correctly analyse the hydraulic system, the ATSB obtained a more up-to-date hydraulic system drawing from the steering gear manufacturer.

With regard to the out-of-date hydraulic system drawings on board the ship, *Astor's* managers, in submission, wrote that the manufacturers replaced the original stop valves and blocks in 1995 and the original diagrams were not replaced.
