A U S T R A L I A N T R A N S P O R T S A F E T Y B U R E A U

MARINE SAFETY INVESTIGATION

Independent investigation into the collision
between the Hong Kong flag bulk cargo vessel

off the south coast of Western Australia
on 18 January 2001

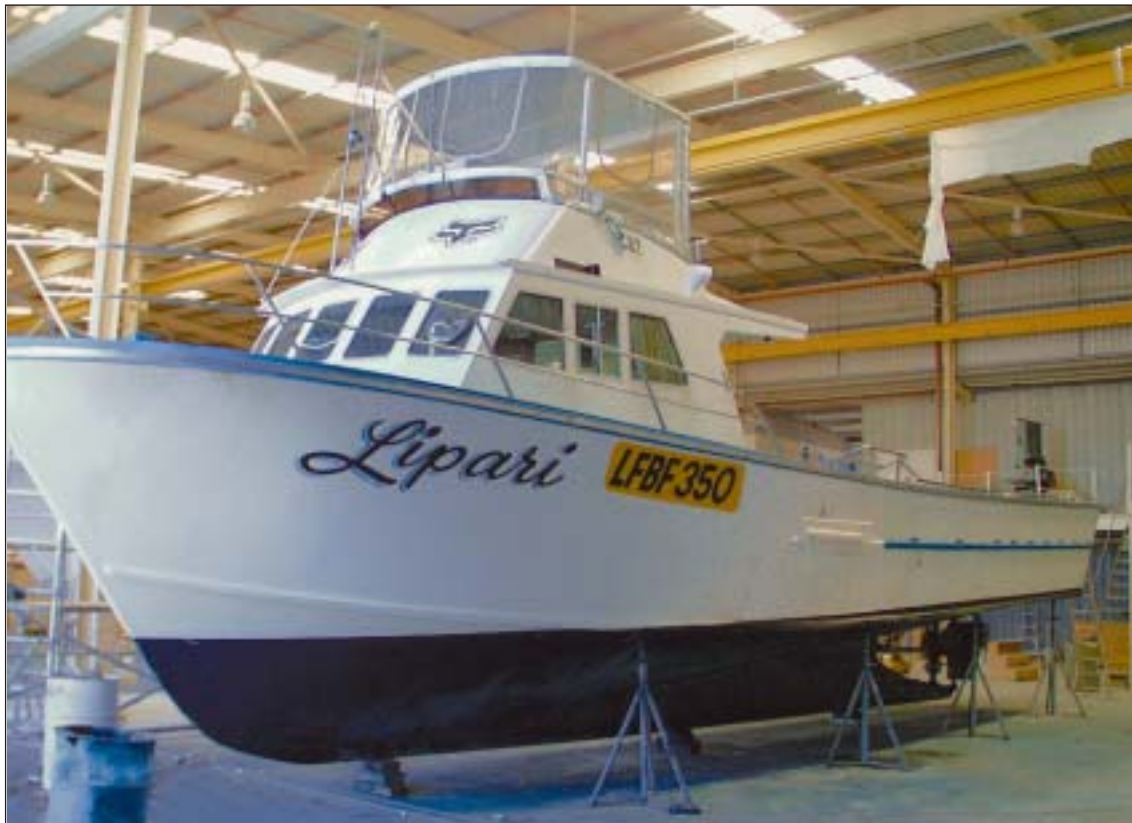
FIGURE 1:
Lipari

Lipari (figure 1) is a 15.65 m timber rock lobster fishing boat of 21.28 GRT (gross registered tons) based in Fremantle, Western Australia. The vessel is registered with Transport, Marine Safety, Western Australia as a class 3B² vessel with the registration number F 350.

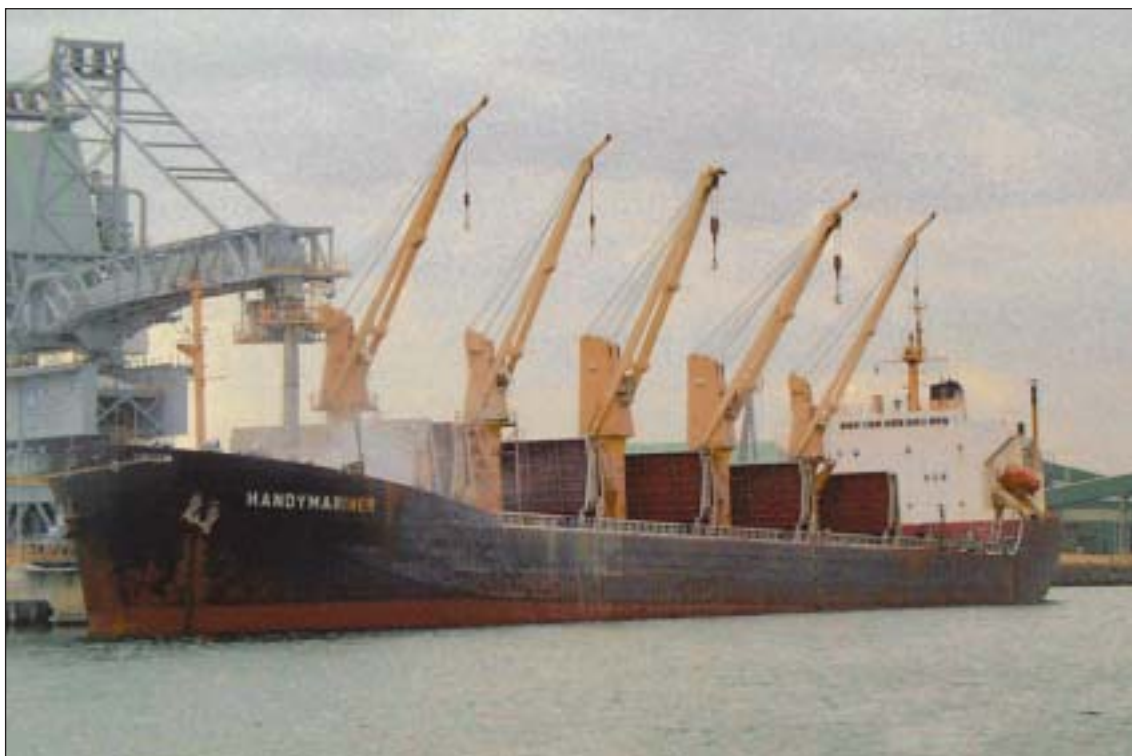
FIGURE 2:
Handymariner

Handymariner (figure 2), (formerly *Durhambrook-80*) is a Hong Kong flag geared bulk carrier of 31 200 deadweight tonnes at its summer draught of 10.33 m. The vessel is owned

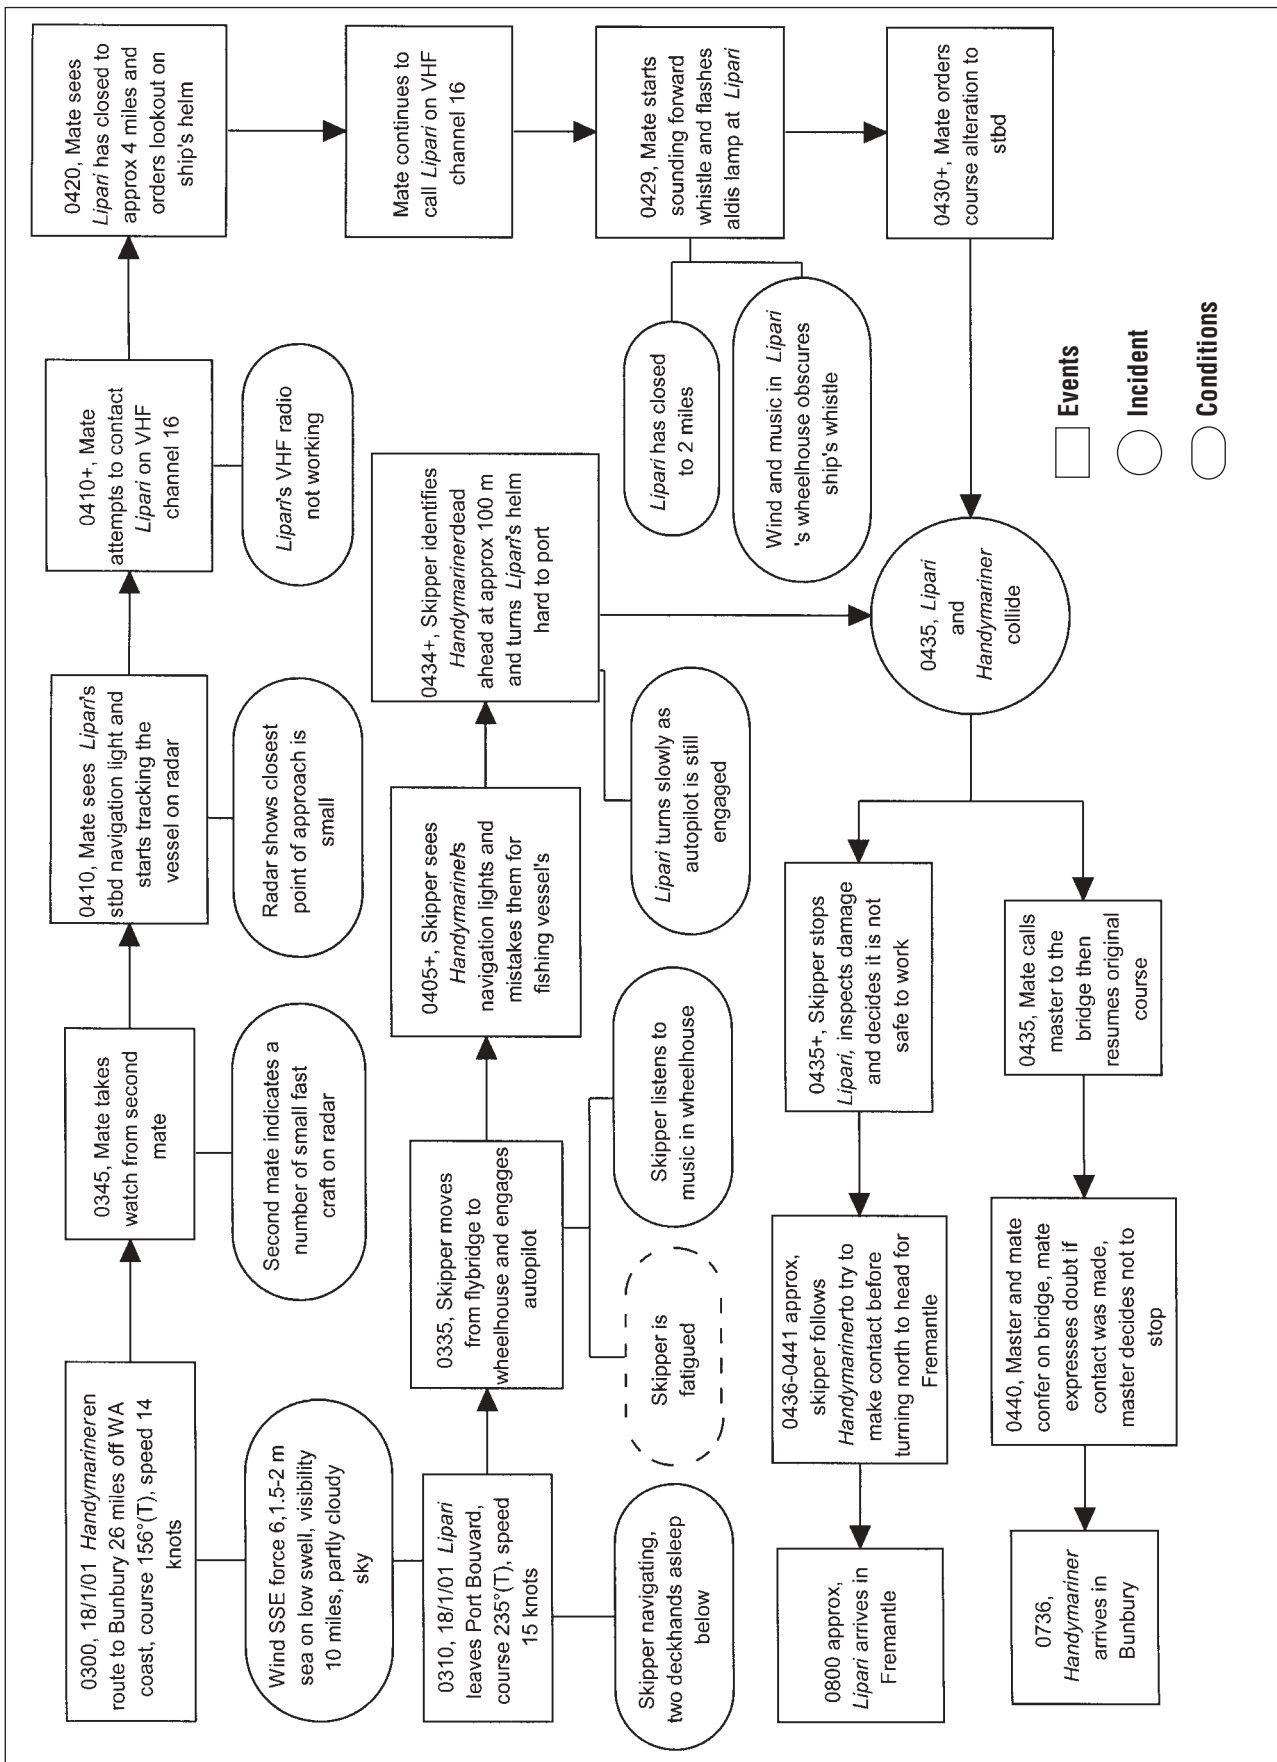
FIGURE 6:
Collision: *Handymariner/Lipari* events and causal factors chart

5. It is unlikely that a decision to slow *Handymariner* when it became reasonably apparent that *Lipari* was not going to give way would have been effective in preventing the collision.
6. The visual and radar look-out on *Handymariner* was effective in that a risk of collision with *Lipari* was identified 25 minutes before the collision.
7. Both vessels should have stopped and established contact as soon as possible after the collision.
