MARINE SAFETY INVESTIGATION
No. 195

**Independent investigation into
collision between the Panamanian
registered ship *Asian Nova*
and the Queensland registered
fishing vessel *Sassenach*
off Townsville, North Queensland
on 29 May 2003**

February 2005

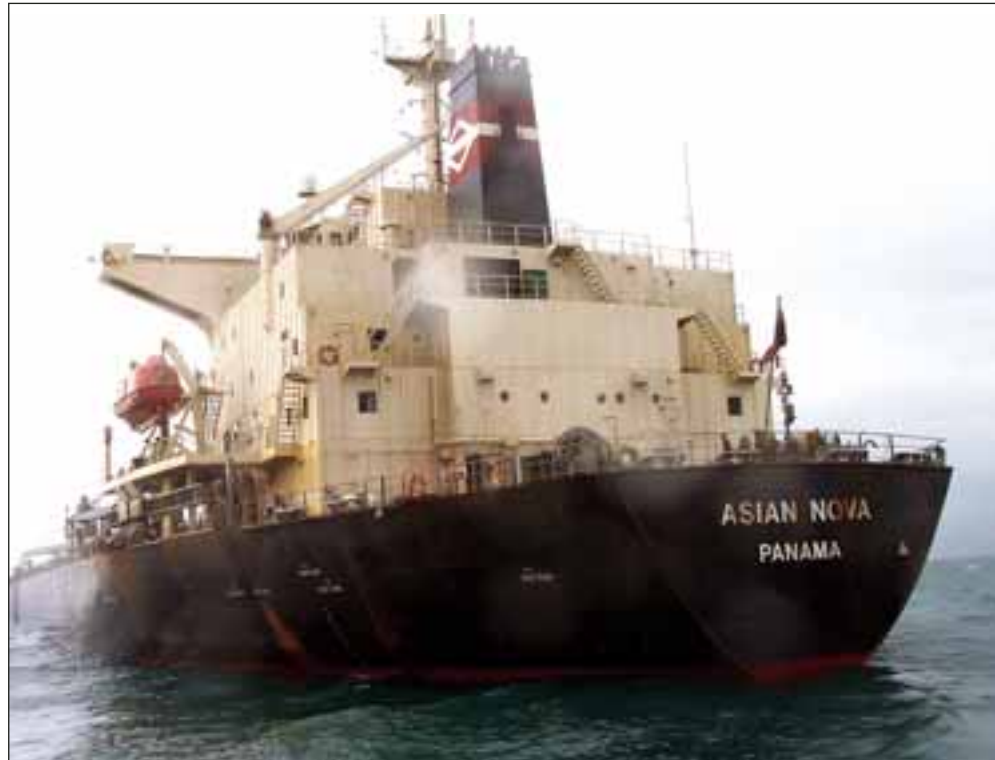
FIGURE 1:
Asian Nova

Asian Nova (figure 1) regularly trades between New Caledonia and Townsville. It is a geared 'panamax' bulk carrier of 69 925 tonnes deadweight at a summer draught of 13.291 m. It is owned by Mars Shipping Company, Panama and managed by First Marine Services, Japan. The ship is currently classed by Nippon Kaiji Kyokai (Class NK).
