ATSB TRANSPORT SAFETY REPORT
Aviation Occurrence Investigation
AO-2009-077
Final

**Visual flight into instrument
meteorological conditions
Dorrigo, NSW
9 December 2009
VH-MJO, Bell Helicopter 206L-1
LongRanger**

**Visual flight into instrument meteorological
conditions
Dorrigo, New South Wales
9 December 2009
VH-MJO
Bell Helicopter Company 206L-1 LongRanger**

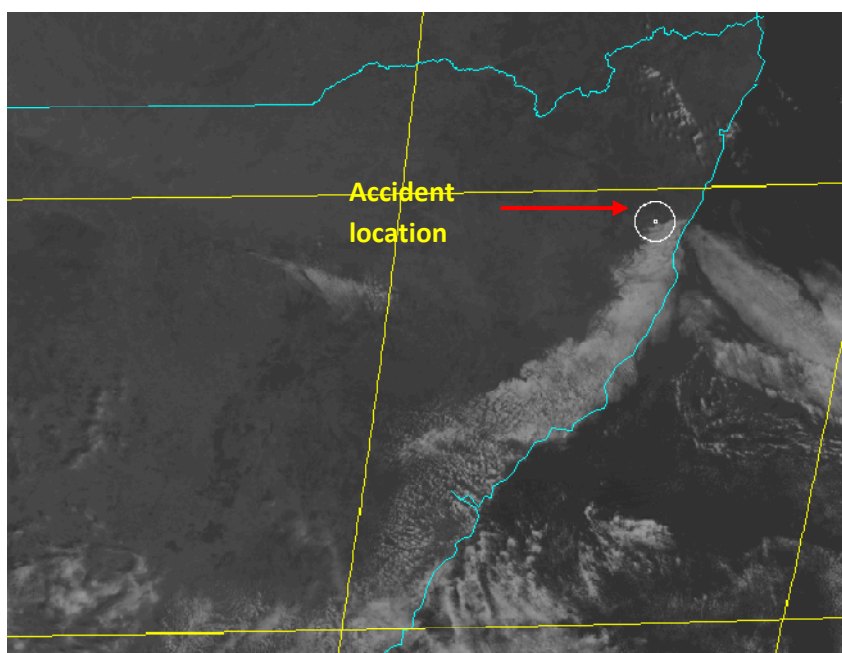
Figure 2: Satellite image at 1030 on 9 December 2009

The moist south to southeast air stream (in the area south of the trough axis) produced widespread low cloud over the NSW coasts and the adjacent ranges prior to and at the time of the incident as indicated by the satellite image in [Figure 2]. The high-resolution visible satellite image shows the presence of a sharp boundary of cloud near the incident location. This is most likely due to the moist south to southeast air stream being advected^[10] through the valley southeast of the incident location, forming low cloud as it lifted over the ranges. As the air descends and warms on the leeward side of the ranges, the low cloud dissipated.

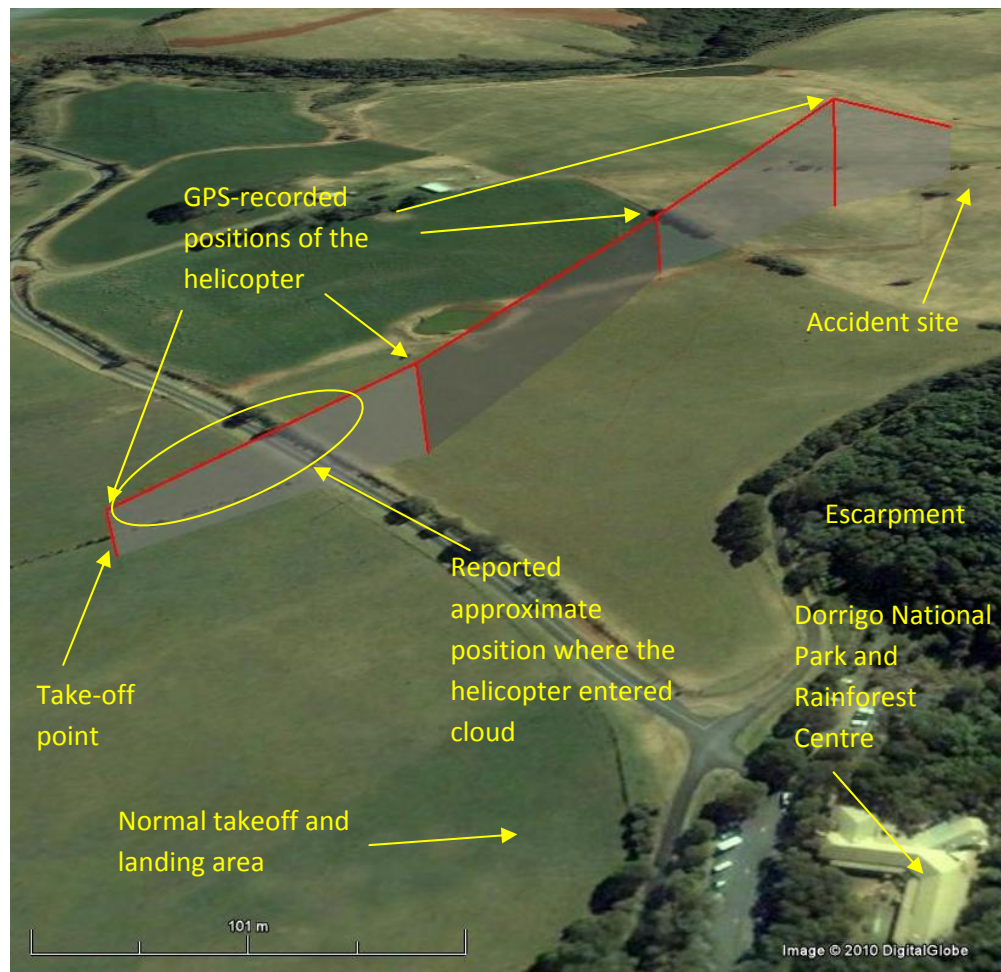
Figure 3: Recorded GPS positions

The GPS indicated that the duration of the flight once the helicopter departed the vicinity of the take-off point was about 1 minute and 20 seconds. During that time, the helicopter travelled a distance of about 550 m. The GPS recorded five positions during the flight, which are overlaid onto a Google Earth map of the area at Figure3. The red vertical lines in the figure show the recorded positions of the helicopter during the flight. The interconnecting lines do not necessarily illustrate the actual position of the helicopter at any point between those positions.

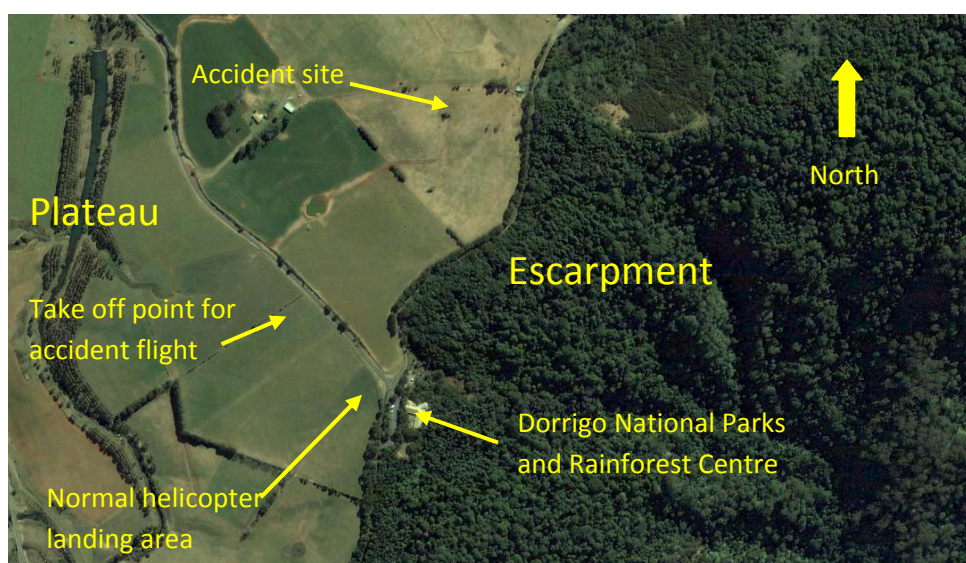
Figure 7: Helicopter operating area at Dorrigo

The NPWS helicopter operations at Dorrigo were conducted in and out of a plateau adjacent to the Centre, which was built on the edge of an escarpment (Figure 7). The helicopter landing area consisted of a privately-owned open grass field that was located to the west and adjacent to the Centre's car park.

NPWS Centre employees indicated that reduced visibility in the form of low cloud or fog was prevalent for parts of, or all day about 20% of the year in the area around the Centre. One employee advised that, when the Centre was affected by reduced visibility, it could quite often be clear about 2 km to the west of the centre, towards the Dorrigo Township.
