ATSB TRANSPORT SAFETY REPORT
Aviation Occurrence Investigation
AO-2008-059
Final

**Midair collision
3 km NW of Moorabbin Aerodrome, Victoria
27 August 2008
VH-UPY, Cessna Aircraft Company A150M
VH-CGT, Piper Aircraft Corp PA-28-161**

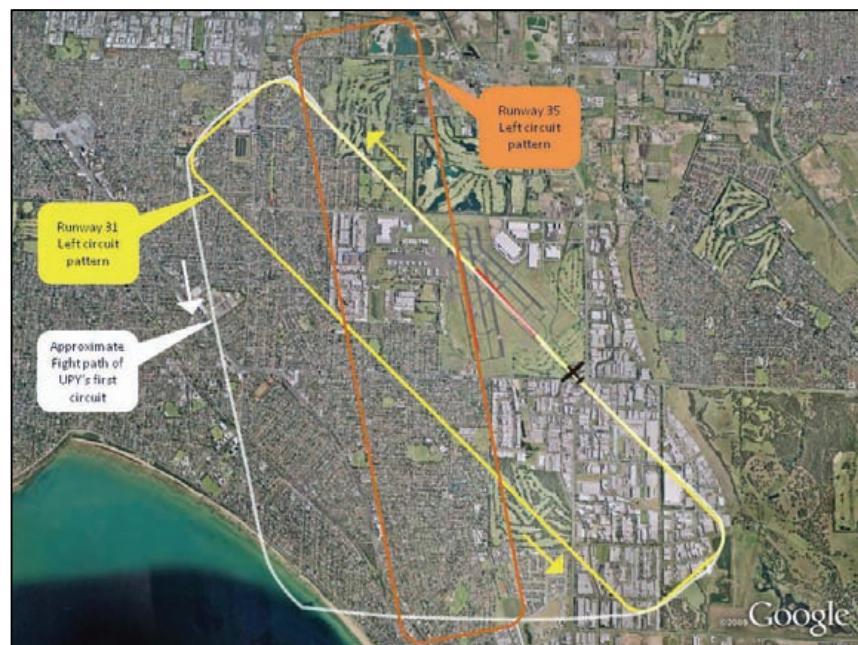
The student pilot of UPY was carrying out a number of circuits, which included touch-and-go landings², as part of his third solo flight. The student misaligned the downwind leg of the first circuit, tracking parallel to runway 35 left (35L) instead of the intended runway 31L (Figure 1). The effect was that the aircraft diverged from the intended circuit pattern by about 34°. A number of radio transmissions from the student pilot indicated that he was unable to locate a Cessna 152 aircraft, registered VH-CUL (CUL) that he was instructed to follow by the aerodrome controller – west (ADC W) at the commencement of the downwind leg.

Figure 1: UPY's first circuit from runway 31L³ (actual circuit legs flown by the student pilot annotated in white)

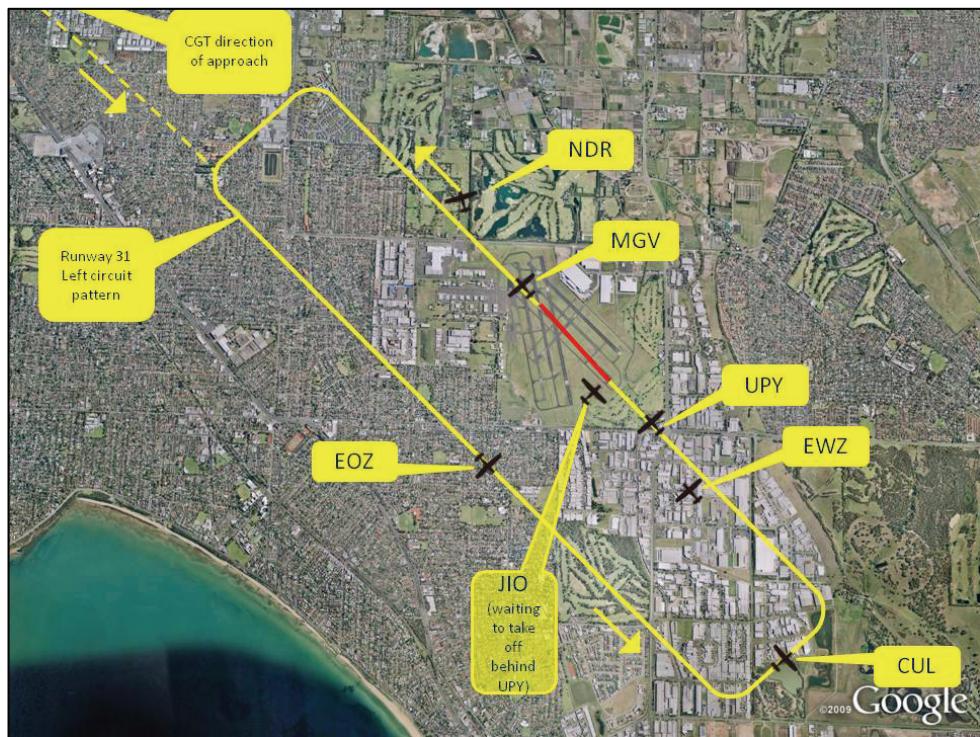
The pilot of NDR was cleared for a touch-and-go and the student pilot of UPY continued the approach following NDR for a third touch-and-go. Shortly after, another aircraft, a Piper PA-28 registered VH-MGV (MGV) was cleared to line up on the runway for takeoff between NDR and UPY (Figure 2). The ADC W had to issue repeated take-off clearances to the pilot of MGV before the pilot acknowledged and complied with the clearance.

Figure 2: Circuit pattern shortly before UPY conducted a touch-and-go to commence a fourth circuit.

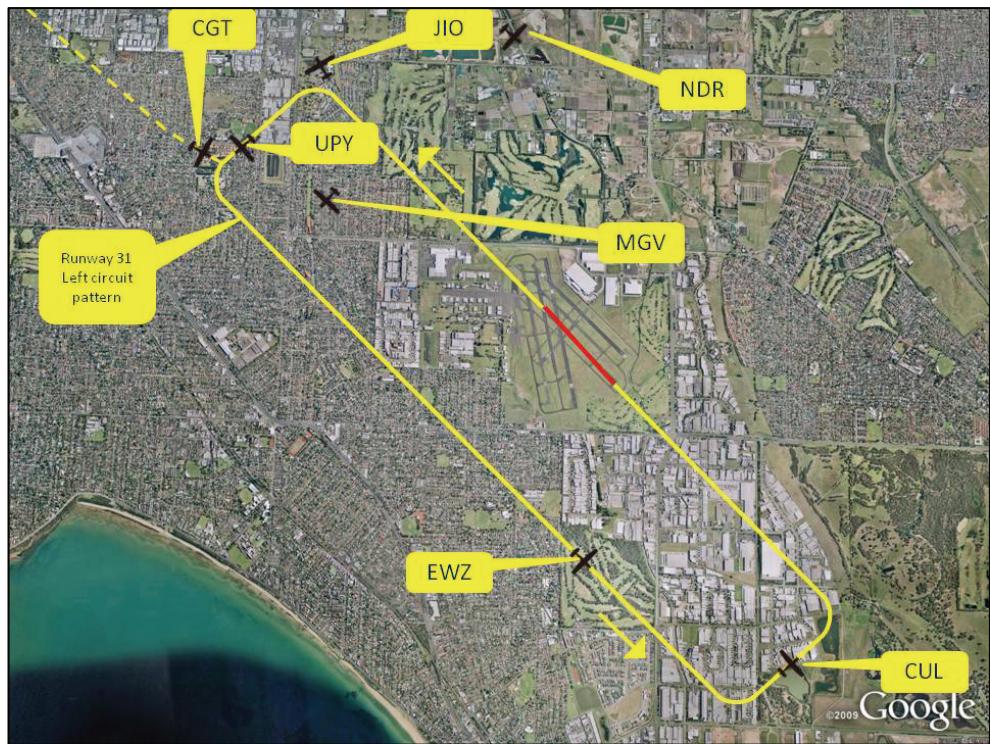
During this period, the instructor in CGT told the student pilot in that aircraft to extend one stage of flap to slow the aircraft. That action was based on the instructor's understanding of the implied number of aircraft in the vicinity as a result of the amount of radio traffic as he tracked for downwind, and in response to a PA-28 aircraft (probably MGV) that was climbing on his left (Figure 3).

Figure 3: Circuit pattern immediately before the collision

Almost immediately after, the ADC W noticed three aircraft in close proximity on late crosswind and advised the pilots in CGT that ‘...traffic is several in the circuit there, um some ahead of you some behind you’ (Figure 3). CGT and UPY collided very shortly after that radio transmission.

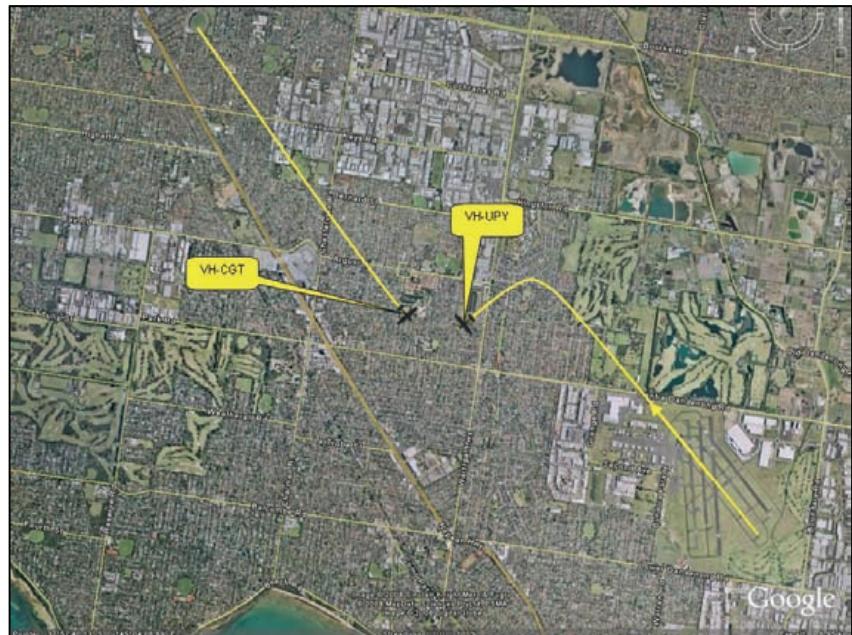
Figure 4: Position of CGT and UPY shortly before the collision

The student pilot of CGT, who was seated in the aircraft's left seat and was flying the aircraft, reported seeing UPY very close and climbing on his left (Figure 4). The student pilot responded to what he felt was a collision course by turning hard right and descending in an effort to avoid a collision. The flight instructor in CGT did not see UPY prior to the collision.

The relative positions of the converging aircraft was estimated based on the standard performance of the aircraft types, the normal track of an aircraft on the crosswind leg of the circuit, the recorded radar track of CGT and the observed wind conditions. On that basis, it was concluded that the two aircraft were probably approaching each other at a relative velocity of about 110 to 120 kts at an angle of about 115° between the respective flight paths (Figure 4).

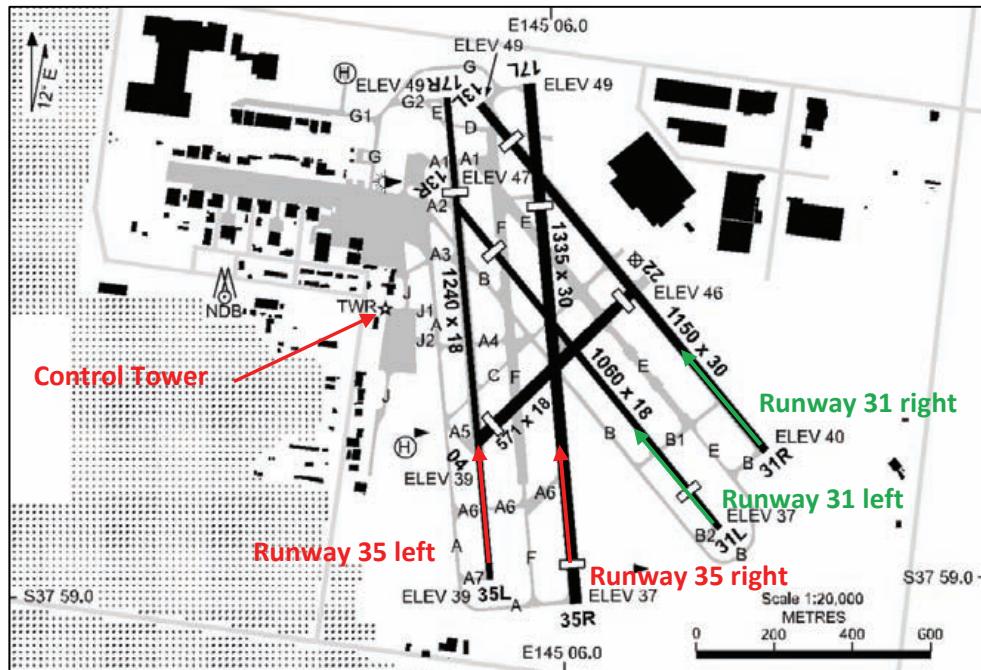
Separation between aircraft operating from parallel runways was established by the use of contra-rotating circuit patterns for aircraft operating from each runway. The control tower was located to the west of the runways. Circuit operations were normally conducted from the eastern runway (runway 35R/17L or 31R/13L). Arrivals and departures to the west were conducted from the western runway (runway 35L/17R or 31L/13R). Arrivals and departures to the east were conducted from the eastern runway (runway 35R/17L or 31R/13L) (Figure 7).

Figure 7: Map of Moorabbin aerodrome

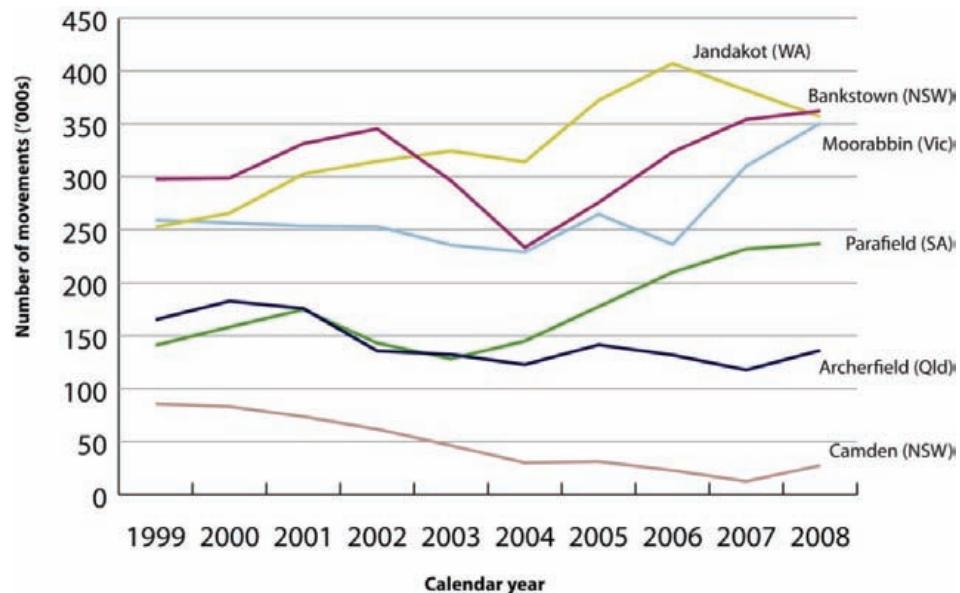
Airservices recorded monthly traffic movement data for Moorabbin Aerodrome, and published the data on its website. In the 2 years before the collision, Moorabbin experienced a 40% increase in aircraft movements, greater than at any other GAAP aerodrome (Figure 15), although there had also been major increases at other GAAP

Figure 15: Aircraft movements at GAAP aerodromes, 1999 to 2008⁸

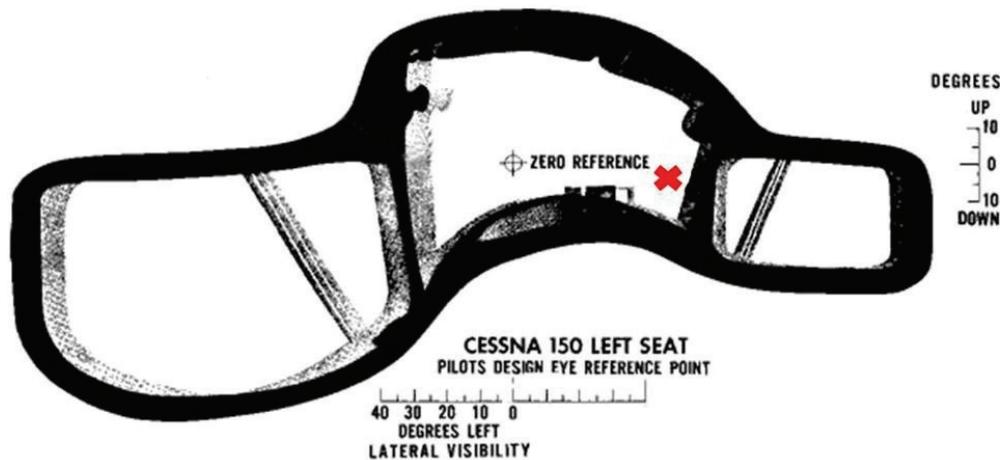
It is likely that CGT would have been low in the windscreens of UPY, as UPY would have been flying with a high nose attitude as the aircraft climbed. The likely position of CGT in the field of view of the pilot in UPY is represented by the red cross in Figure 16.

Figure 16: UPY cockpit visibility diagram. The red cross indicates the likely position of CGT as the aircraft closed on each other

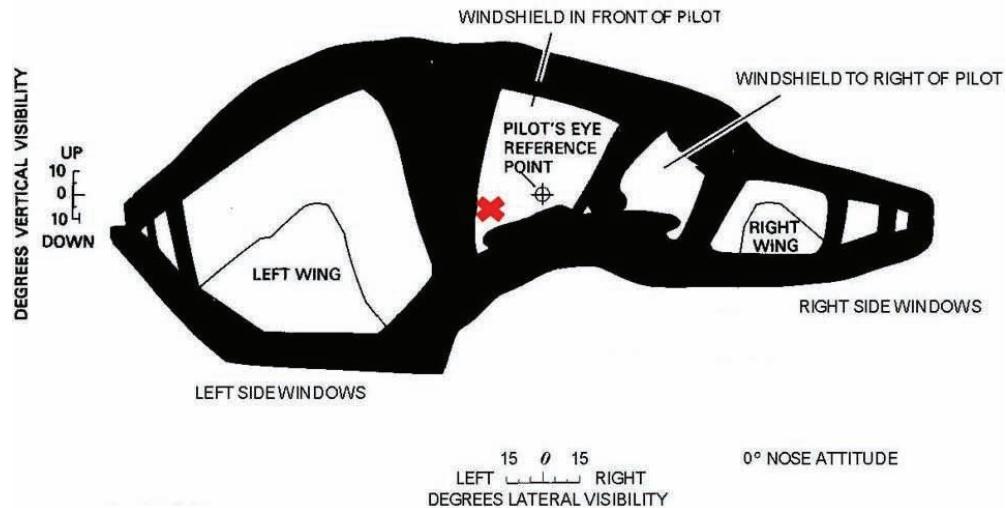
It is likely that the view of UPY to the student pilot would have been low or at the same height in the windscreens of CGT, as UPY was either still climbing, or at the same height as CGT (Figure 17).

Figure 17: CGT cockpit visibility diagram. The red cross indicates the likely position of UPY as the aircraft closed on each other
