**ATSB TRANSPORT SAFETY REPORT**  
Aviation Occurrence Investigation  
AO-2009-031  
Final

**Collision with terrain**  
**120 km west of Paraburdoo**  
**Western Australia**  
**25 or 26 June 2009**  
**VH-HXO**  
**Robinson Helicopter Company R22 Beta II**

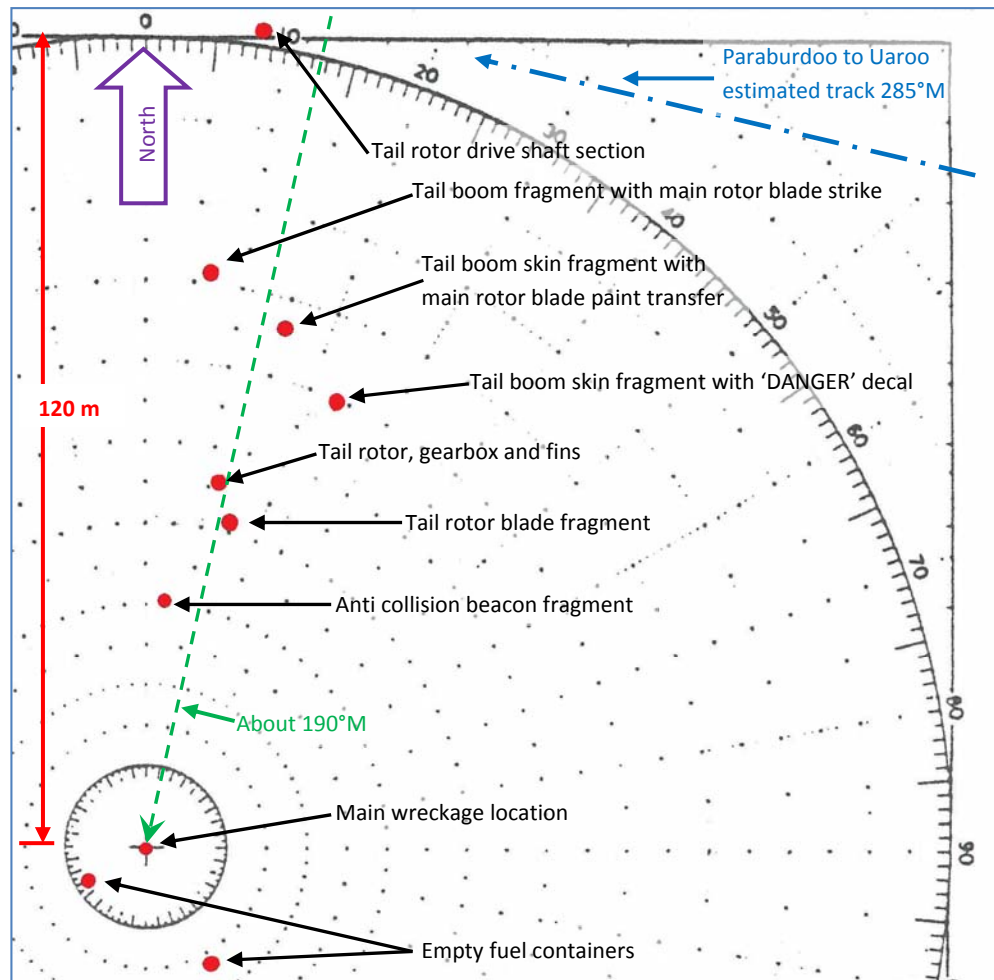
**Figure 3: Wreckage site map**

The wreckage, including pieces of the tail boom skin, tail rotor driveshaft and tail rotor, was dispersed over a distance of about 120 m on an approximate bearing of 190° magnetic. Pieces of the tail boom, including the fin, tail rotor and tail rotor gearbox were located to the north of the main wreckage (Figure 3).
