Departmental investigation into cargo hold bulkhead failure aboard the Malaysian flag bulk carrier GIGA 2 on 5 November 1996

Report No. 101

### GIGA 2

#### on 5 November 1996

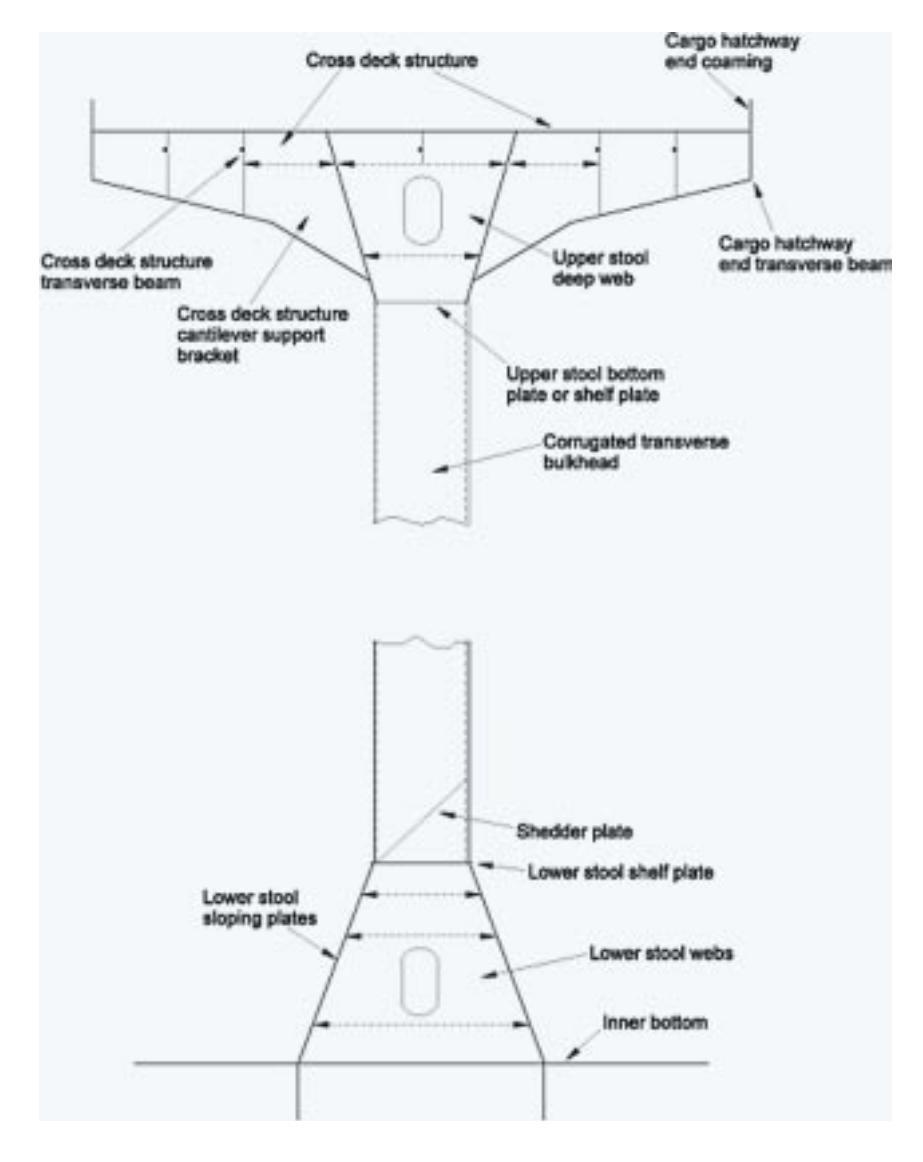
# Starboard bulkhead at frame 193 viewed from No. 5 hold

Note: Flattening of corrugations at lower half and detachment of shedder plates. Horizontal line along bulkhead indicates level of water in Nos. 4 and 5 holds
