REPORT OF THE PRELIMINARY INVESTIGATION
INTO THE CIRCUMSTANCES OF THE COLLISION BETWEEN
THE M.V. IRON CUMBERLAND AND THE F.V. SALTFIORD
IN APPROXIMATE POSITION 140° 06.0'S 144° 07.3'E
IN THE AREA OF PRINCESS CHARLOTTE BAY
ON 6 JULY 1985

OUTLINE OF INCIDENT

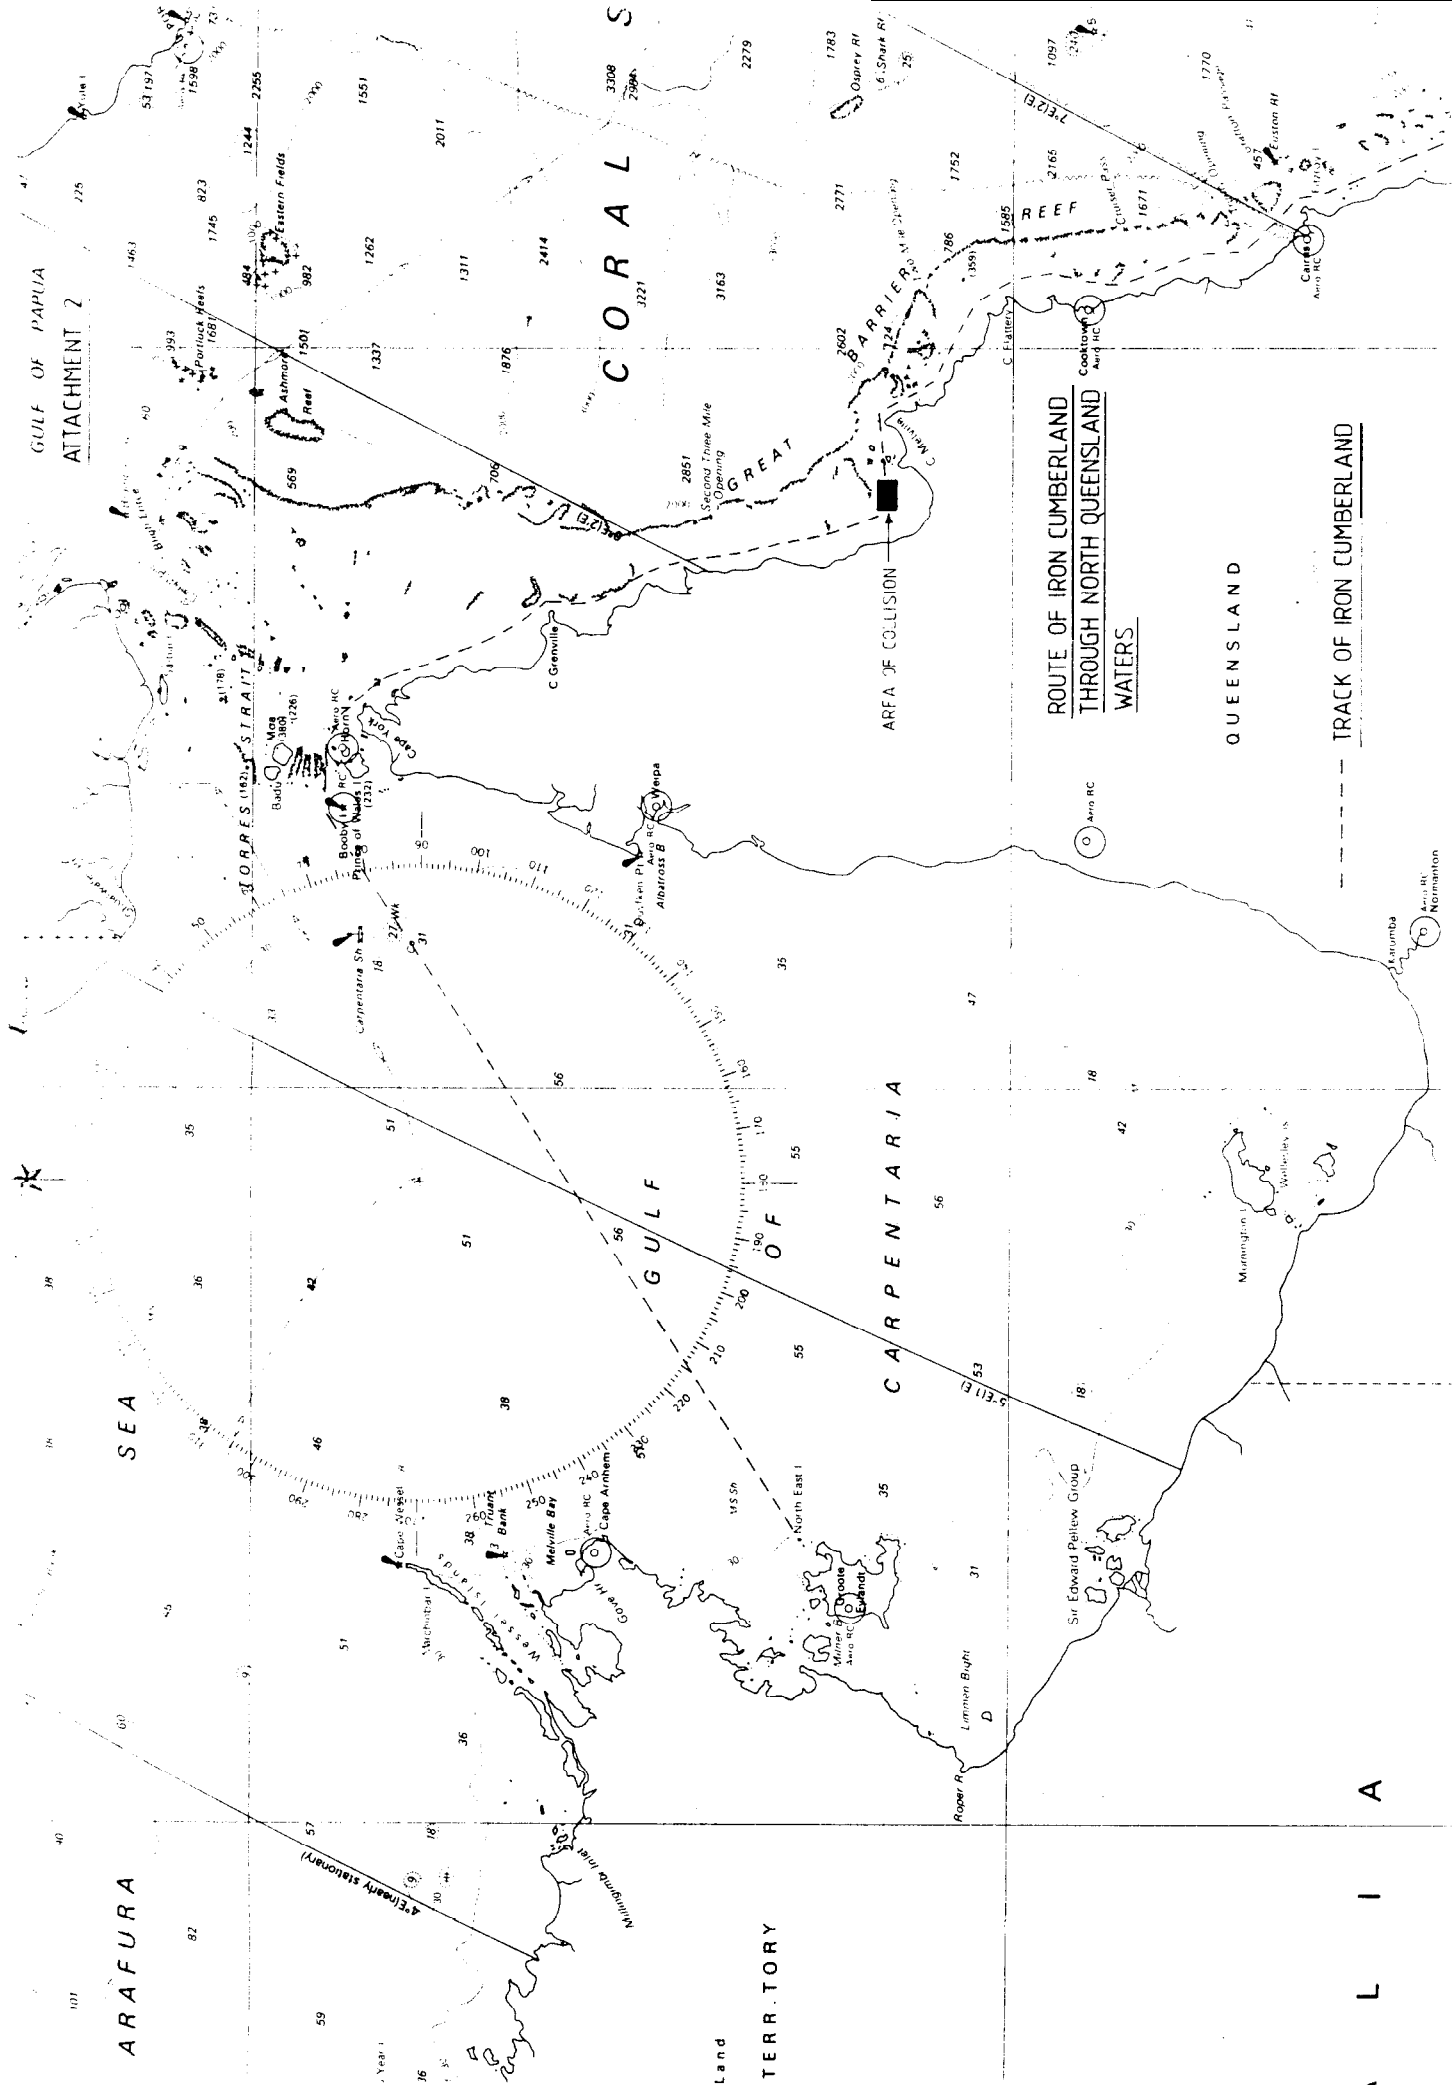
RELIABILITY DIAGRAM AND NOTES ON TWO WAY ROUTE
FROM AUS 833

The chart reliability diagram clearly indicates that it would have been safe to deviate from the route. Furthermore, the chart notes referring to the recommended two-way route inform mariners that the route is not a traffic separation route and that the International Regulations for Preventing Collisions at Sea apply. That is to say it is not a prescribed traffic separation scheme to which the special requirements of Rule 10 apply. Accordingly, as a power driven vessel, the IRON CUMBERLAND was not only obliged to keep clear of a vessel engaged in fishing (Rule 18(a)(iii)) but was also obliged to pass at a safe distance (Rule 8(d)) which, in the case of a fishing vessel, would need to take into account outlying fishing gear. By neither taking action prior to the Master assuming responsibility at 2033(A) nor calling the Master or pilot at an earlier stage, if in doubt, I find the Third Officer failed to discharge this obligation.
