In-flight engine malfunction and air turn-back 120km SW of Brisbane Airport 10 November 2009

Abstract

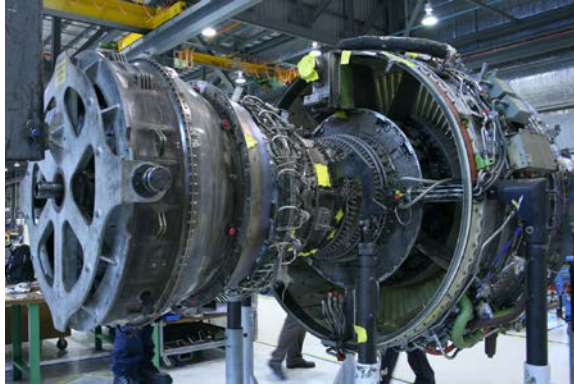
Figure 1: Right engine from VH-TJY

Preliminary borescope inspection by the operator's engineering staff revealed significant damage to the low pressure turbine (LPT) assembly. The CFM56-3C-1 engine (Figure 1) was subsequently returned to an overhaul facility in Melbourne, Australia for disassembly and inspection, overseen by Australian Transport Safety Bureau (ATSB) investigators.

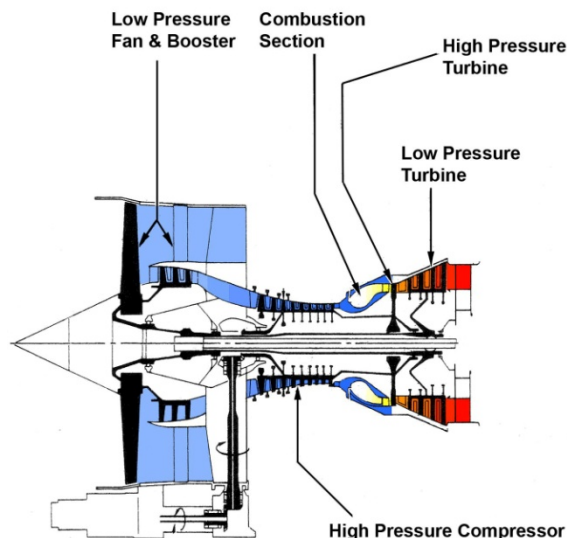
Figure 2: Cross-section of CFM56-3 series engine

The CFM56-3C-1 is a high-bypass, dual-rotor, axial-flow, turbofan engine (Figure 2). Separation of the LPT major module (Figure 3) revealed that all of the stage-1 LPT blades had fractured between the blade platform and mid-span (Figure 4).

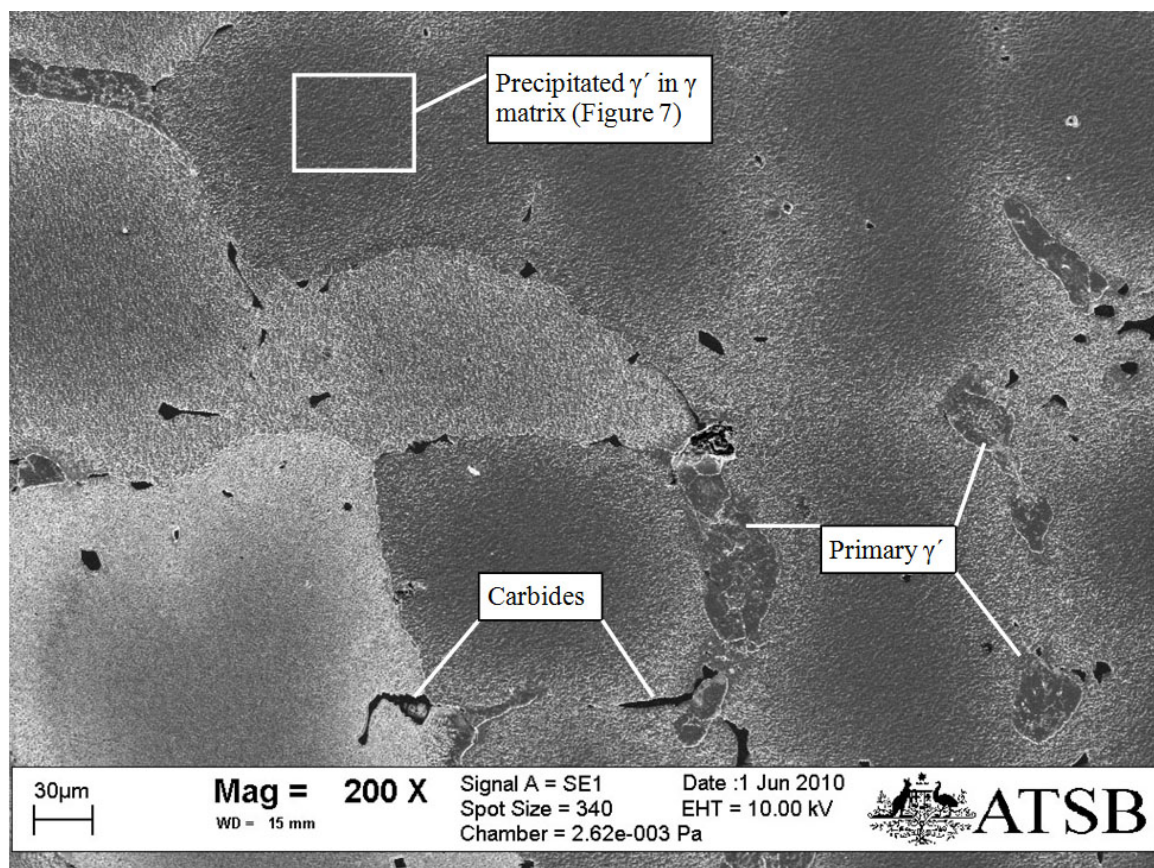
Figure 6: Typical turbine blade root, baseline microstructure (Kalling's No.2 etch, 200x mag)

Baseline microstructures (representative of the as-cast part) of all blade root sections featured a finely-dispersed gamma-prime (γ') precipitate within a gamma (γ) matrix containing a dispersion of larger primary γ' islands and carbide particles (Figure 6).
