ATSB TRANSPORT SAFETY REPORT
Rail Occurrence Investigation
RO-2011-002
Final

Collision between suburban passenger trains G231 and 215A in Adelaide Yard, South Australia

24 February 2011

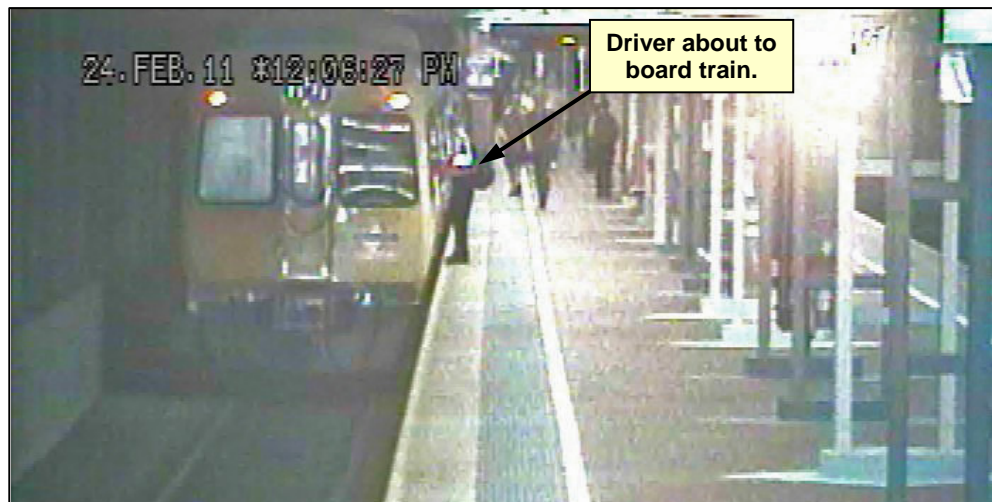
Figure 6: CCTV replay 1206:27 - driver boarding train G231

At 1206:27 CCTV footage (Figure 6) shows the incident driver about to board train G231 about 1 minute and 33 seconds before the scheduled departure time of 1208.

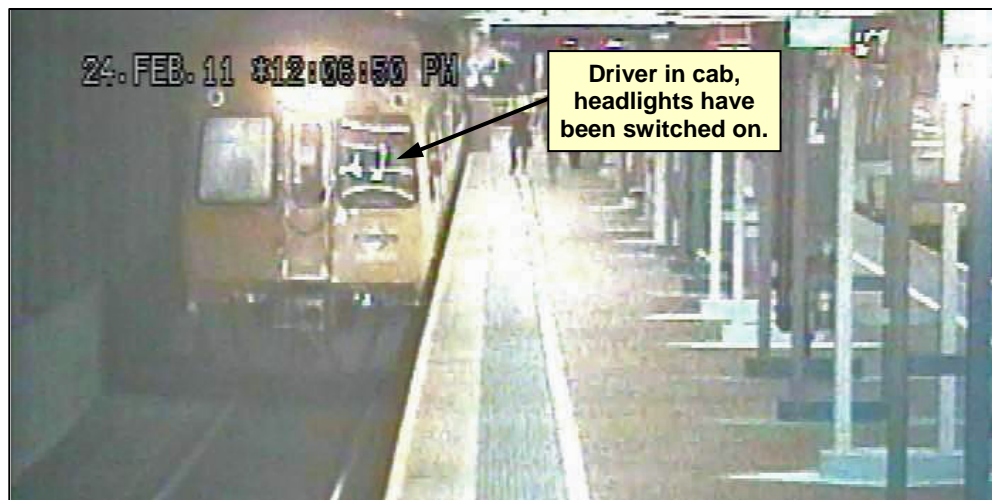
Figure 7: CCTV replay 1206:50 - driver in cab turned on headlights

At 1206:50 CCTV footage (Figure 7) shows the driver as having just entered the driver’s cab and then switching on the train headlights 1 minute and 10 seconds before the scheduled departure time of 1208. He then commences pre-departure checks.

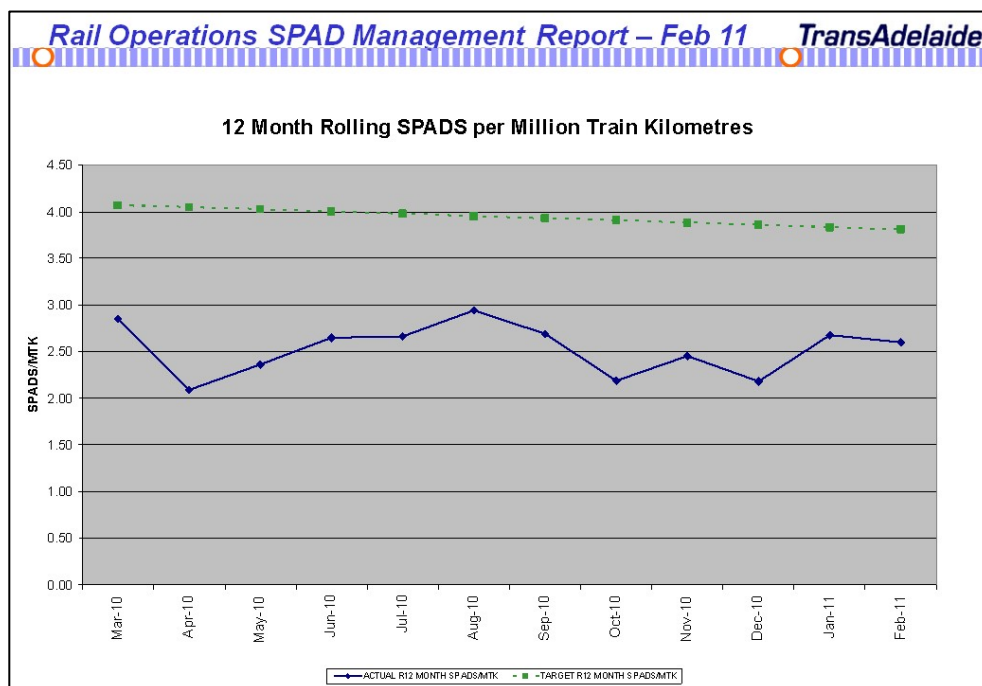
Figure 15: Twelve month rolling SPAD report

- Recent SPAD incidents. The report summarises each individual event and identifies findings.
- Trends. A range of graphs (three graphs shown at Appendix C - Figure 15, Figure 16 and Figure 17) designed to illustrate trends with respect to SPAD occurrence.
- SPAD management activities and progress against plan. Details recent engineering and administrative controls with actions intended to mitigate the risk of SPAD events.
- Signal sighting assessments. The PTS has a program for reviewing signal conspicuity. Where sighting is identified as a potential risk, action is taken to enhance the conspicuity of a signal as necessary and appropriate.
