# Summary

A little before 1700 on 12 January 1995, the Australian flag tanker Conus sailed from the tanker berth, Townsville Harbour, under the direction of a pilot.

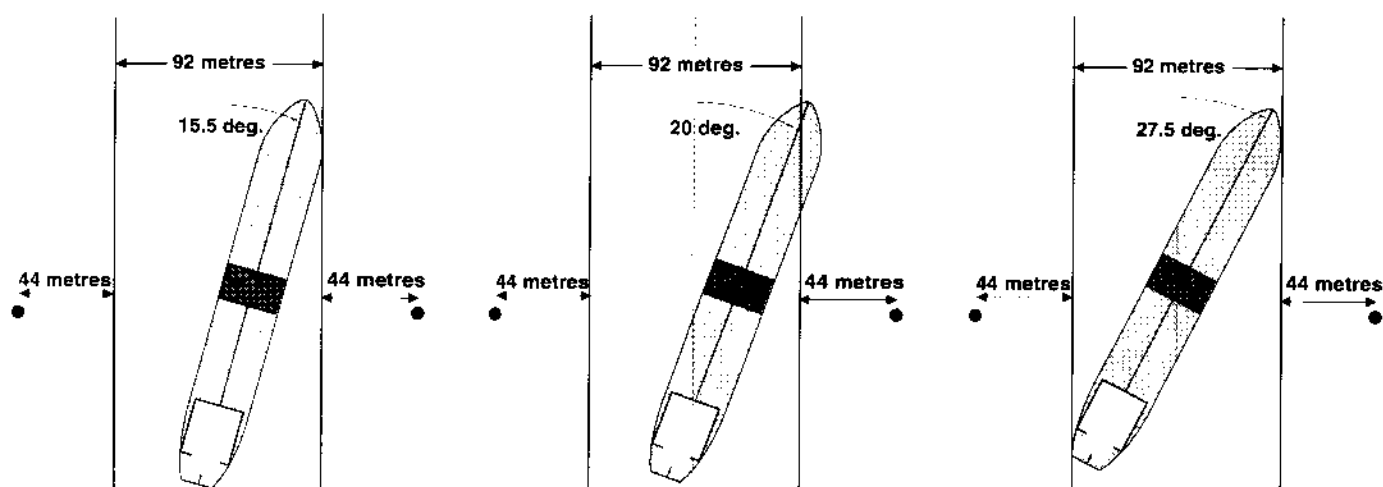
In navigating the narrow entrance channel the vessel was set to the north and west by the east-south-easterly wind, blowing at 16 to 20 knots and the flood tide. The vessel first touched the side of the channel about 500 metres from the harbour entrance, and then came into contact with a channel

marker beacon before coming to a stop just over 1000 m from the entrance.

**'Conus' in Platypus Channel, Townsville**
