RAIL INVESTIGATION REPORT

**Derailment of passenger train 8622,
Sydney – Melbourne daylight XPT service,
Wodonga, Victoria**

25 April 2001

June 2002

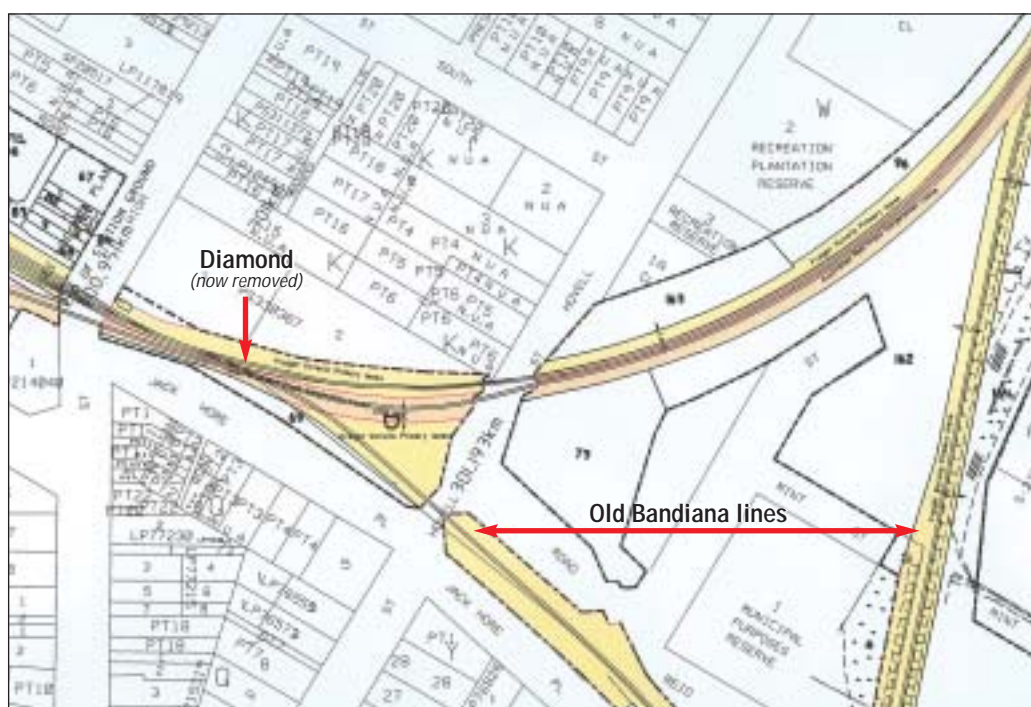
Figure 17 is an excerpt from Victorian Rail Track's plan of the Wodonga Coals Sidings showing the area of the derailment. The plan shows the original diamond and turnout to Bandiana, removed in 1997.

FIGURE 17:
Excerpt from Wodonga coal sidings railway plan showing area of derailment

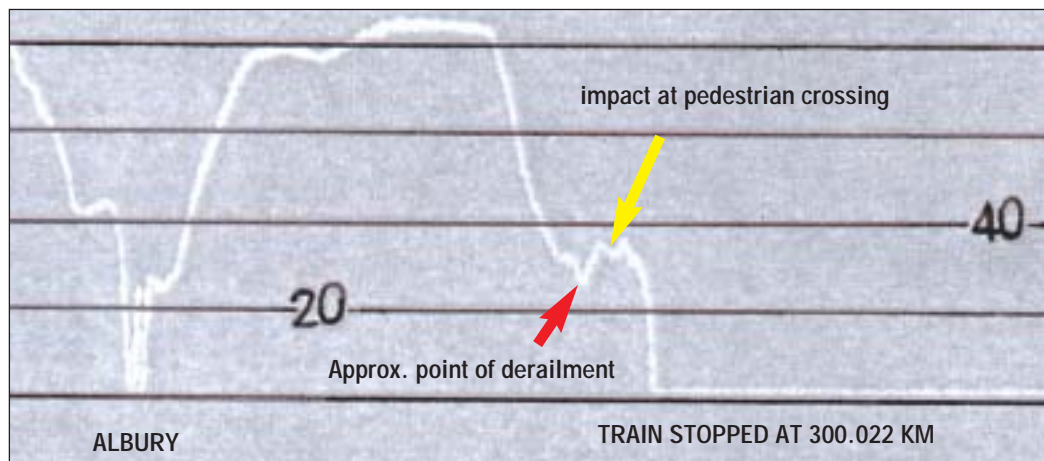
A section of the Hasler speed trace is reproduced in figure 23. It shows, among other things, two points in the speed trace which corroborate the train crew's statements with regard to the 'jerks' they felt around the time of derailment.

FIGURE 23:
Excerpt from Hasler speed trace

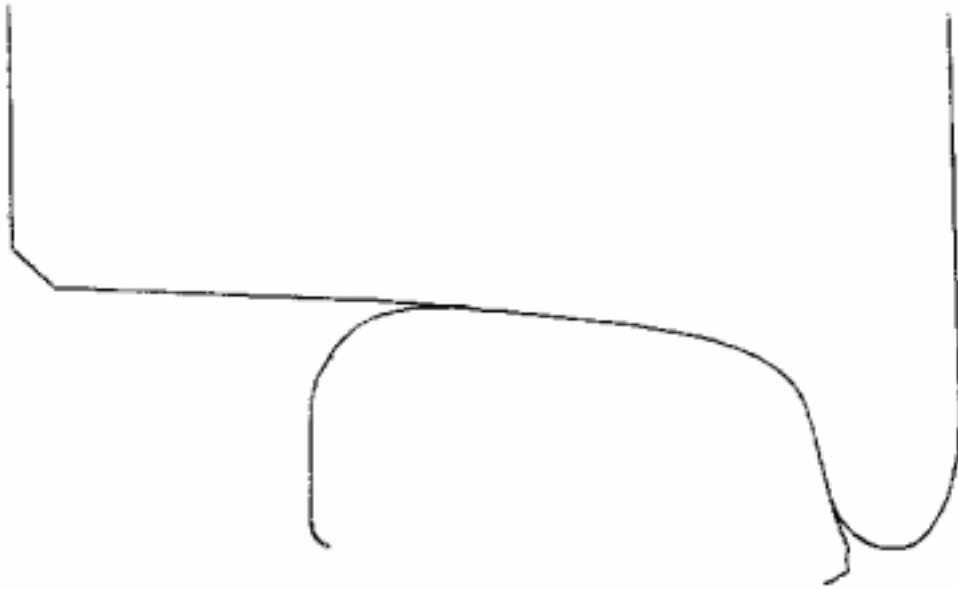
FIGURE 1

Figure 1 shows that the flange of the leading outer wheel (Wheel 1) fits well into the worn side of the outer rail. By taking account of the 1357mm back-back dimension and 49mm dynamic gauge widening the position of the inner wheel on the inner rail may be predicted as shown in Figure 2. This demonstrates the narrow band of contact on the inner rail with the wheel chamfer close to the gauge corner of the rail. No allowance has been made in this illustration for outer rail roll which would reduce the inner rail contact further.

WHEEL-RAIL CONTACT AT LEADING OUTER WHEEL
FROM MEASURED WHEEL & RAIL PROFILES

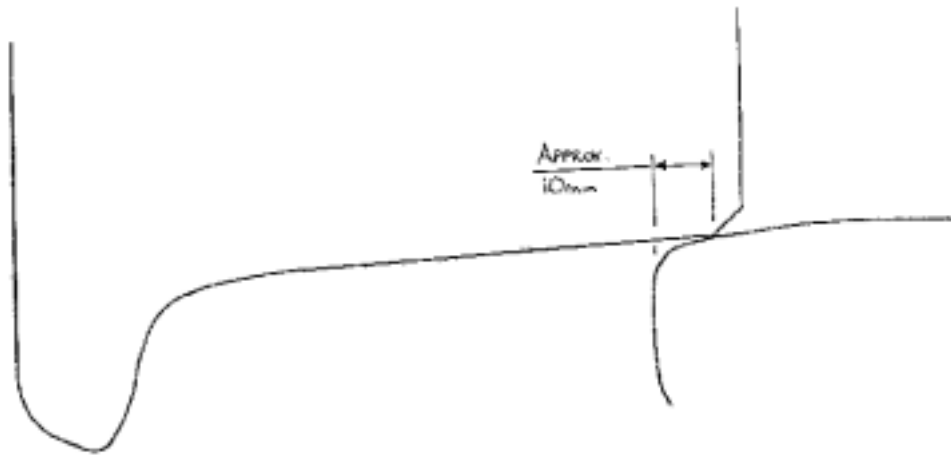
FIGURE 2

WHEEL-RAIL CONTACT AT LEADING INNER WHEEL
FROM MEASURED WHEEL & RAIL PROFILES
& MEASURED DYNAMIC TRACK GAUGE

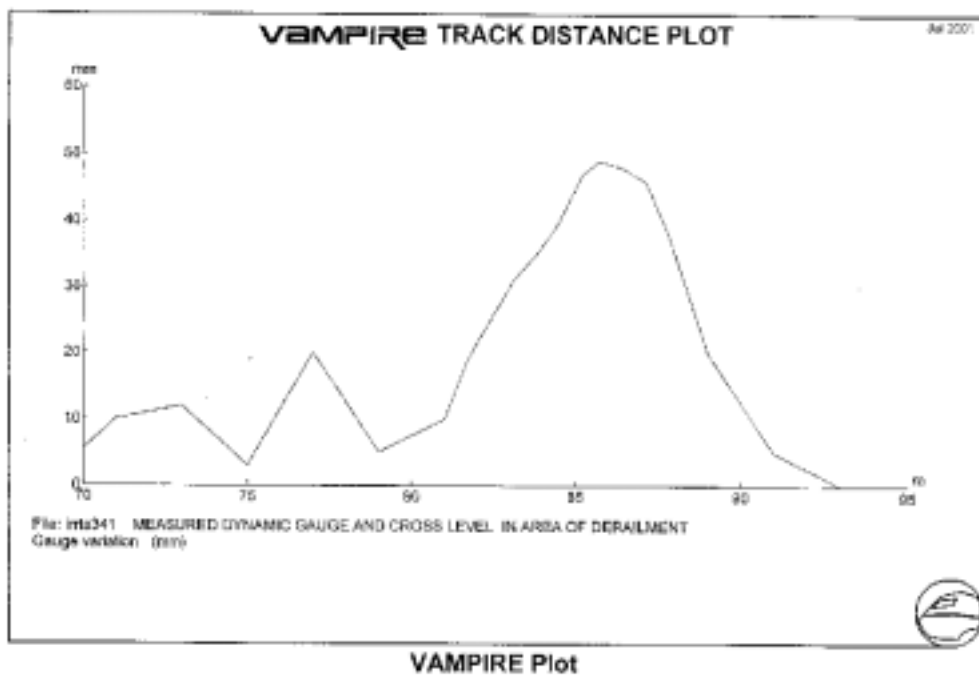
FIGURE 3

This increase is greater than if a random irregularity is superimposed on to the smooth curve, indicating that the shape of the measured input is an important factor to the higher force levels predicted. Figures 3 & 4 illustrate the gauge variation input and leading outer wheel lateral force output, showing the similarity of the shape of the input and output data.

MEASURED DYNAMIC GAUGE IRREGULARITY INPUT TO VEHICLE

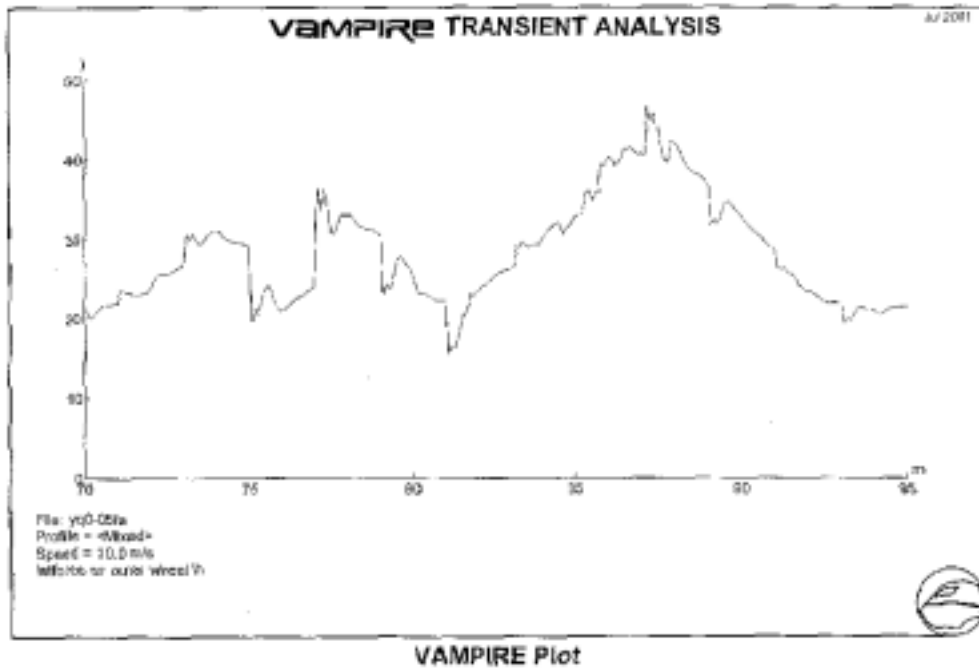
FIGURE 4

PREDICTED LATERAL FORCE OUTPUT AT LEADING OUTER WHEEL
FOR CALCULATION INCLUDING
MEASURED DYNAMIC GAUGE IRREGULARITY INPUT TO VEHICLE

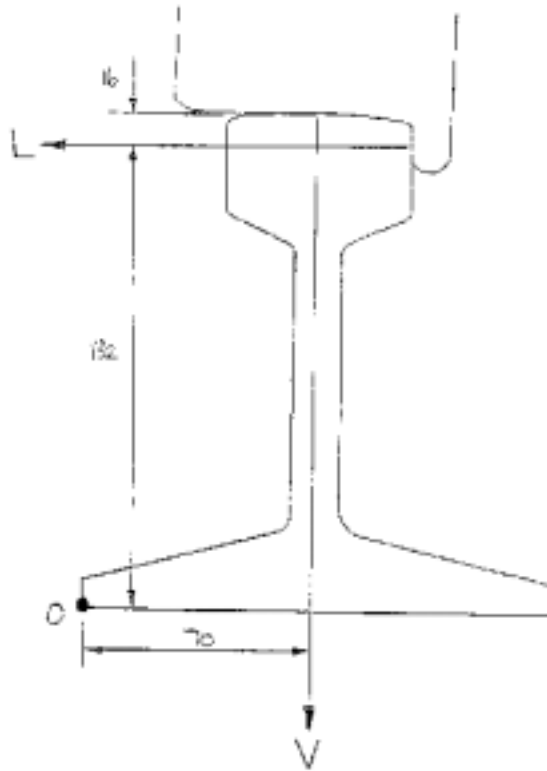
Figure 5 shows the vertical and lateral wheel forces acting on the outer rail. This diagram shows that for an axle load of 10.5 t (51.5 kN wheel load), if there is no restraint from the rail fasteners to react the rail roll, then the rail will have a tendency to roll out for any lateral wheel-rail force that exceeds about 27 kN. The calculations show that the lateral wheel-rail force is predicted to be 30 kN for $X=0.05$ on a smooth curve. Figure 2 (with no rail roll) shows that there is little overlap of the inner wheel over the inner rail. Hence, very little rail roll is required for the inner wheel to drop off the inner rail and into the four foot.

For a heavier axle load vehicle the lateral force at the outer rail is increased, but not by the same proportion as the increase in restraining vertical wheel load. Figure 5 shows that a lateral force in excess of 53 kN is required to roll the rail outwards with a 20 t axle load. The calculations for a 20 t axle load vehicle predicts a force of 50 kN at the outer rail for a smooth curve, but the track irregularities would produce dynamic forces in excess of this. Therefore, although a heavier freight vehicle produces higher lateral forces, the restraining axle load is also higher. As a result, the heavier freight vehicle does not have an increased derailment risk, over a lighter passenger vehicle, as may have been perceived.

FIGURE 5
MOMENTS ACTING ON OUTER RAIL
