AVIATION SAFETY INVESTIGATION REPORT  
200205780

# **In-flight uncontained engine failure and air turn-back, Boeing 767-219ER, ZK-NBC**

8 December 2002

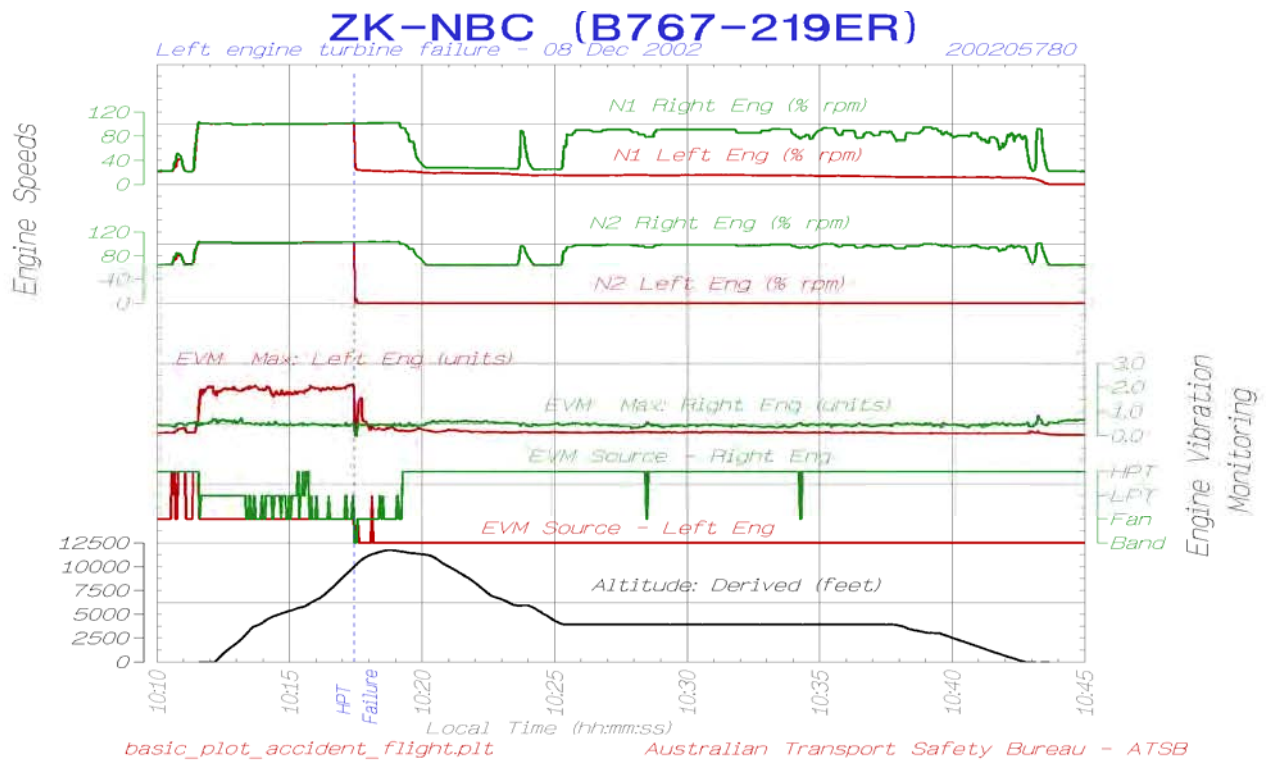
**Fig. 1** basic\_plot\_accident\_flight – entire accident flight showing recorded values of derived altitude, engine speeds N1 and N2 and engine vibration monitoring maximum levels and source.

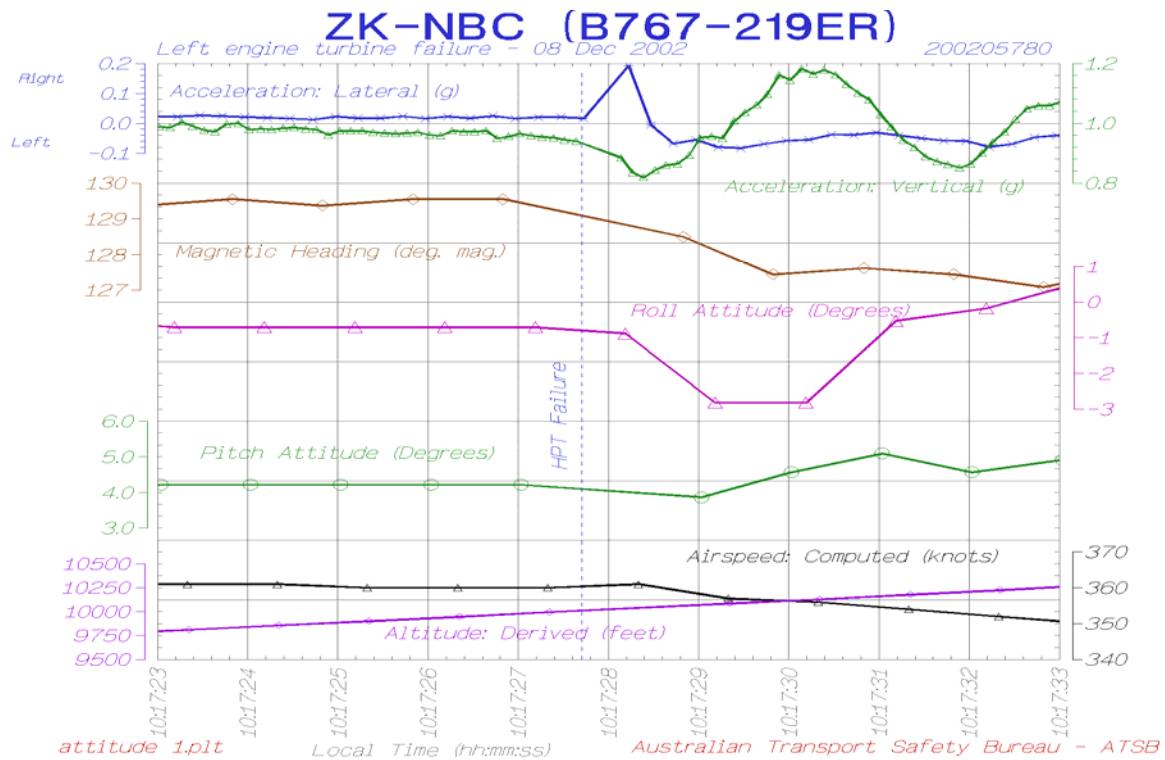
**Fig. 2** attitude1 – ten second period leading up to and after engine failure of the recorded values of derived altitude, computed airspeed, pitch attitude, roll attitude, magnetic heading, vertical acceleration and lateral acceleration.

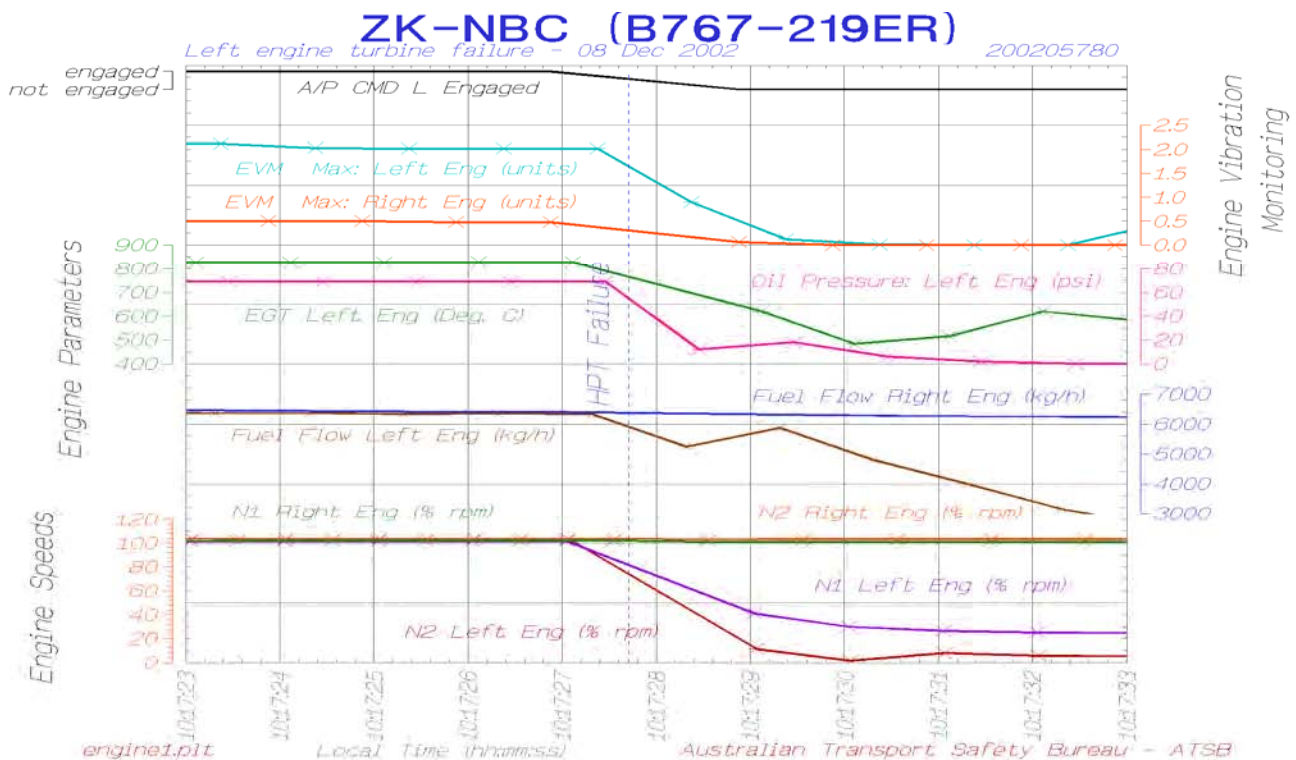
**Fig. 3** engine1 – ten second period leading up to and after engine failure of the recorded values of engine speeds N1 and N2, engine vibration monitoring maximum levels and source, engine fuel flows, left engine EGT, left engine oil pressure and A/P Command – Left discrete.

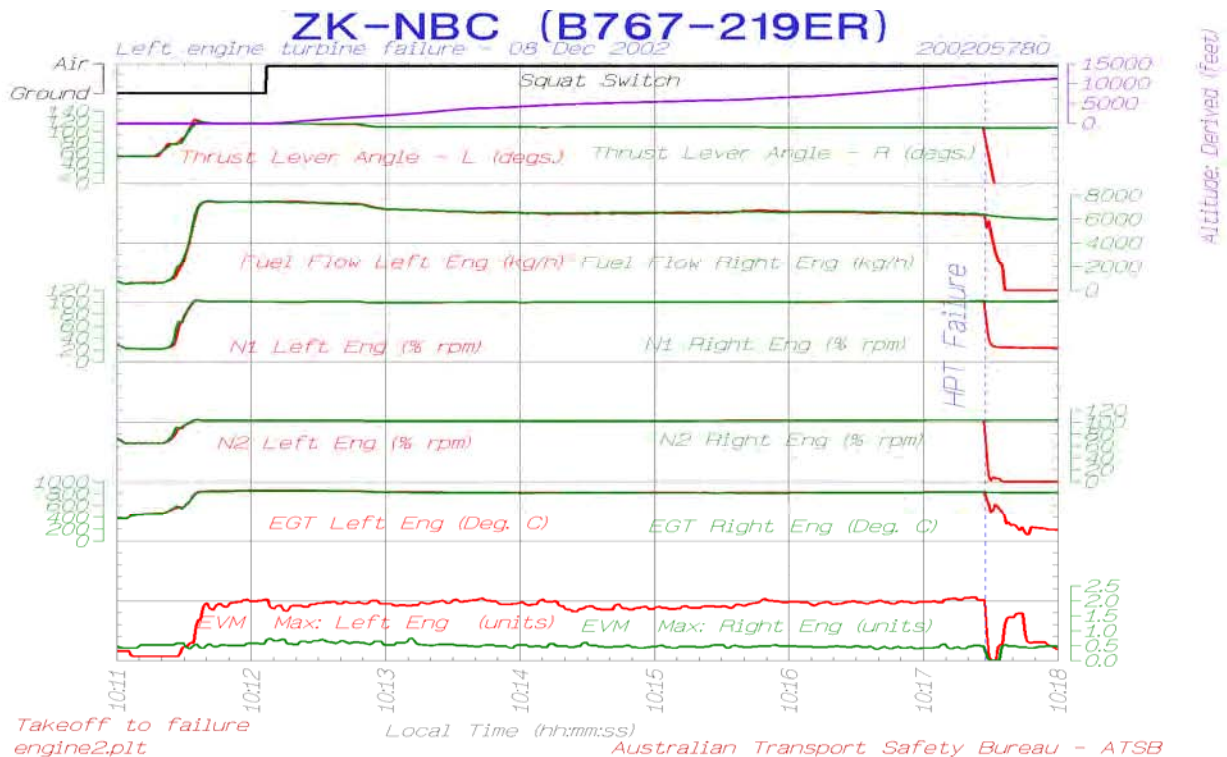
**Fig. 4** engine2 – period from take-off to shortly after engine failure of the recorded values of derived altitude, squat switch, engine speeds N1 and N2, engine vibration monitoring maximum levels, engine fuel flows, EGTs and thrust lever angles

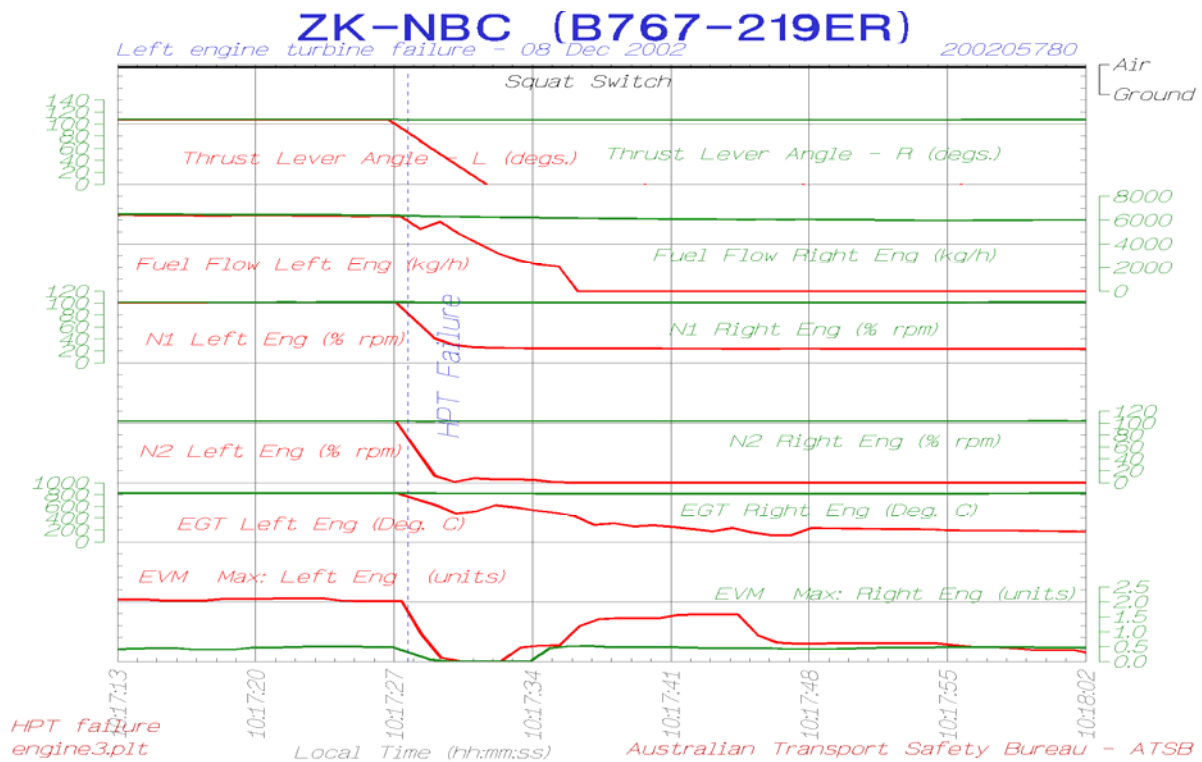
**Fig. 5 engine3** – fifty-second period from shortly before engine failure of the recorded values of squat switch, engine speeds N1 and N2, engine vibration monitoring maximum levels, engine fuel flows, EGTs and thrust lever angles.

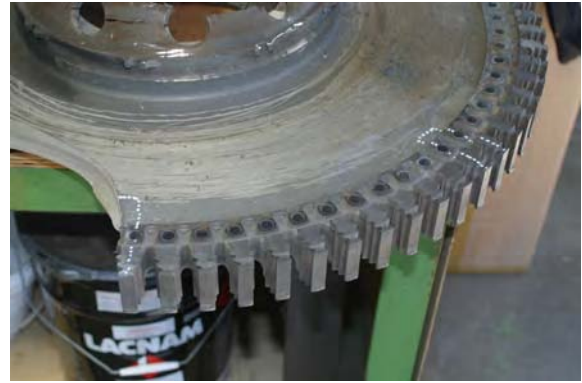
To facilitate the fracture surface analysis, electric discharge machining (EDM, wire-cutting) was used to excise samples containing the primary fracture origin at slot 60 and the secondary cracking visible in fir tree slot 72 (figure 9). The cutting was performed through the centreline of the disk posts to preserve the integrity of the adjacent fir tree slots for later evaluation.

**Fig. 9** Disk slots as marked out for EDM of samples for laboratory examination.

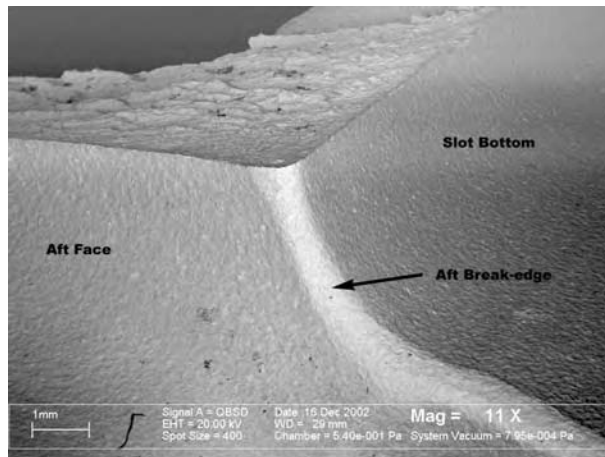
The general slot and rear face surfaces showed a generally uniform, dimpled appearance that was characteristic of the shot-peening process prescribed for initial disk manufacture and post-repair operations (figure 21). The tangency point origin of the slot 60 cracking was associated with a region of flowed material with shallow lap-like features identified as peened surface extrusion folds (PSEF), which extended part-way

**Fig. 21** SEM view of the rear break-edge leading to the crack origin. Dimpled surface typical of shot peening.

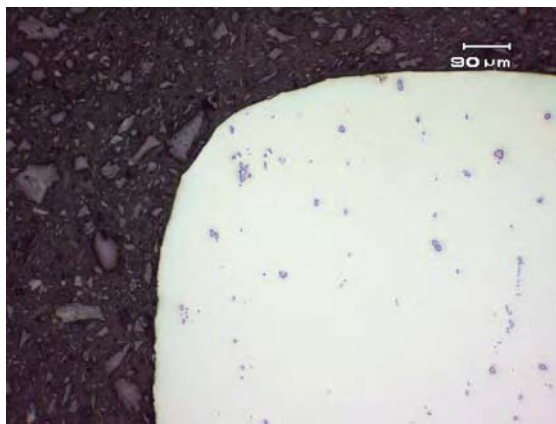
Metallographic characterisation of the fatigue origin area was achieved by controlled polishing into the fracture surface, producing a radial plane through the rear break-edge profile. Examination in the unetched condition (figures 26 and 27) showed a series of shallow (25µm maximum depth) lap-like features around the break-edge and along the rear disk face. The features were characteristic of the various PSEF features observed under the SEM. When etched with ‘Tuckers’ reagent, a 20-25 µm deep surface zone of heavily deformed transformed martensite was evident around the break-edge and rear face surfaces (figures 28 and 29), with a prominent direction of flow around the break-edge toward the slot. The surface material within the slot itself showed little evidence of the deformed grain structure, with the transition to the deformed break-edge material being very abrupt. The general microstructure of the disk alloy was very fine, equiaxed austenite grains with a distribution of coarse carbide particles. Smaller cuboidal nitride particles were also evident. The strengthening precipitate phases of gamma-prime ( $\gamma'$ ) and gamma-double prime ( $\gamma''$ ) were not resolvable at the magnifications used.

**Fig. 26** Unetched metallographic view of the rear break-edge at the fracture origin. Dark particles are coarse carbides.

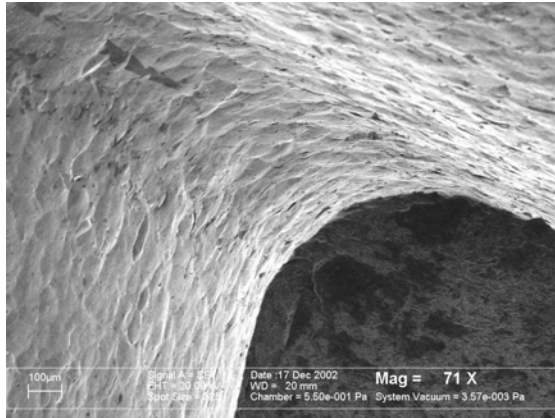
The rear disk face and fir tree surfaces of slot 72 showed a similar appearance to slot 60, with the dimpled effects of shot-peening clearly evident (figure 30). The slot bottom and rear face surfaces showed notable differences in the extent of deformation produced by the peening operation. Figure 31 shows a marked transition from the heavy peened surfaces of the rear face and break-edge to the visibly lighter peened slot bottom

**Fig. 30** SEM view of the rear break-edge of slot 72. Dimpled surface typical of shot peening.
