ATSB TRANSPORT SAFETY REPORT
Aviation Occurrence Investigation AO-2007-065
Final

Midair collision
Latrobe Valley Aerodrome, Victoria
1 December 2007
Cessna 172 VH-EUI & Avid Flyer 28-0929

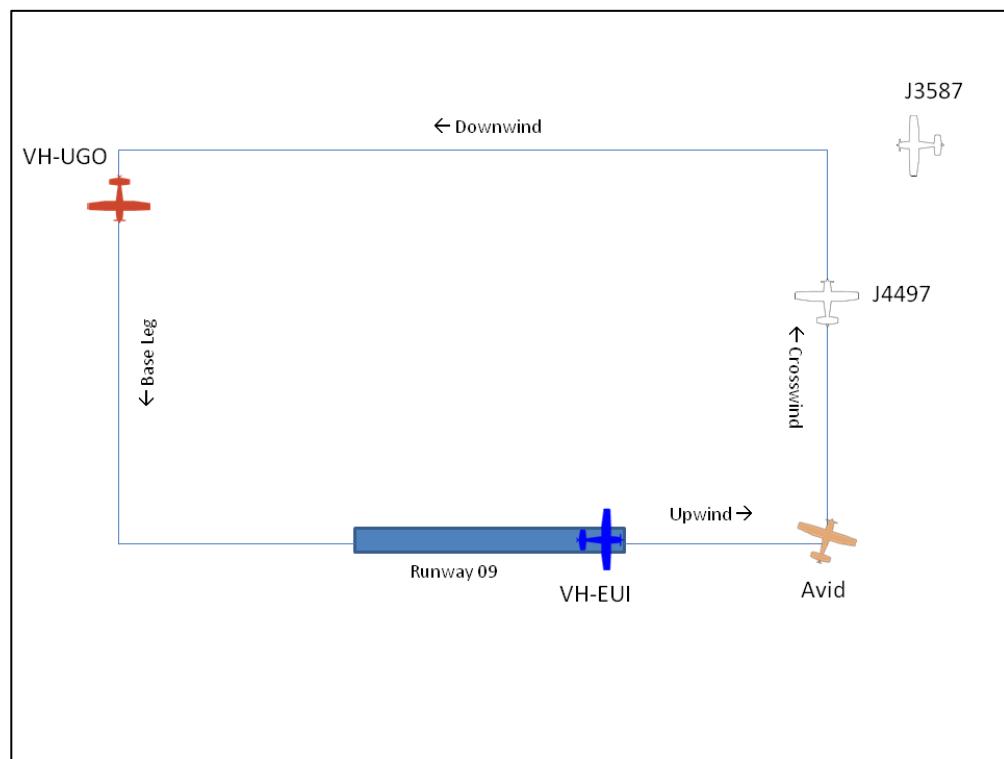
Figure 2: Likely positions of the circuit aircraft when Jabiru 3587 entered the circuit (not to scale)

After the student pilot had flown one circuit and touch-and-go following the Avid, another predominantly white Jabiru aircraft, registered J3587 arrived at Latrobe Valley. The pilot of that aircraft broadcast that he would be entering the circuit on

the downwind leg (Figure 2). It was reported that the pilot of the Avid broadcast that he would adjust his circuit to accommodate the arrival of Jabiru 3587.

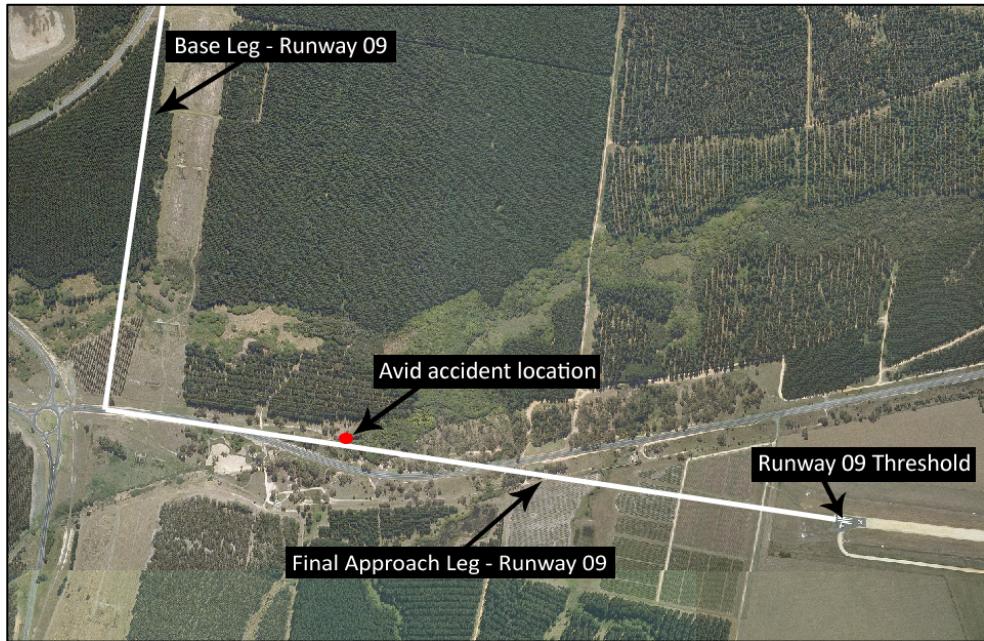
Figure 3: Avid accident location in relation to the base and final legs of the circuit

The instructor in UGO reported continuing the circuit and, while on the downwind leg, noting that there appeared to be two aircraft in close proximity on final approach to runway 09. Shortly after, EUI and the Avid collided on final approach to runway 09 (Figure 3). The Avid aircraft was reported to have spiralled to the ground almost vertically, while the pilot of EUI continued the approach and landed.

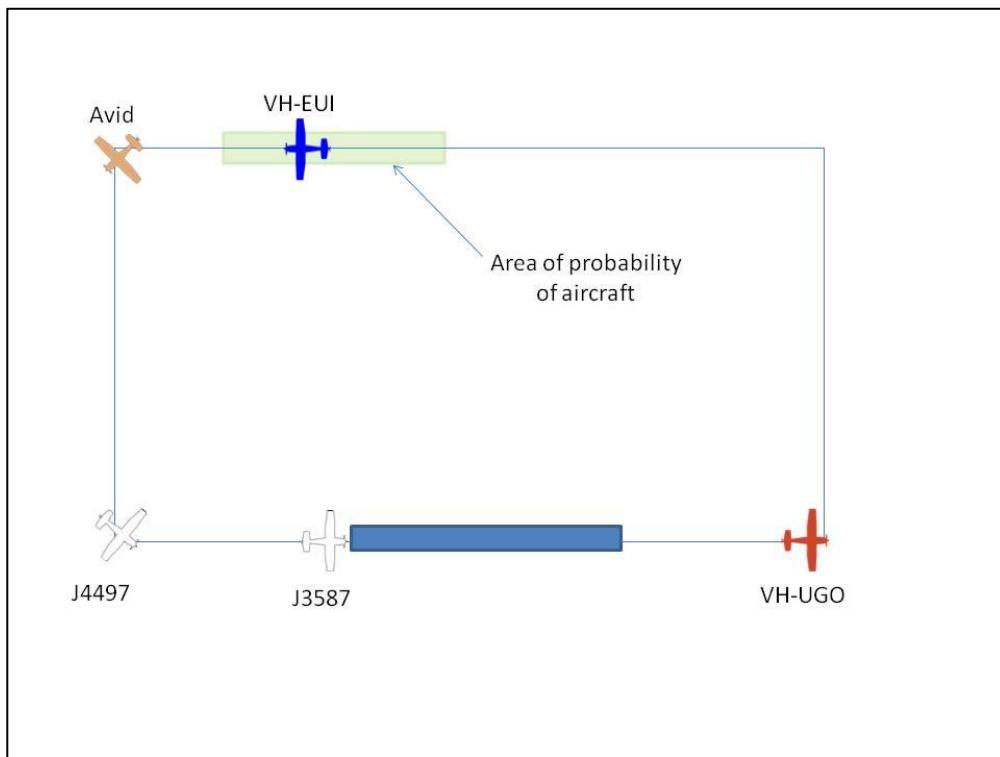
Figure 4: Estimated likely positions of the circuit aircraft at the time of the overtransmission (not to scale)

The CFI flew a circuit with his student and conducted a touch-and-go. The CFI recalled that on the upwind leg of his next circuit, he heard two pilots overtransmit each other, and that he then made a broadcast to alert traffic of that overtransmission (Figure 4). In response to that alert, the pilot of the Avid broadcast that he had the other aircraft sighted. The CFI stated that he then heard the student pilot broadcast a 'base call'³. He could not recall hearing a 'final'⁴ radio broadcast from the student pilot.

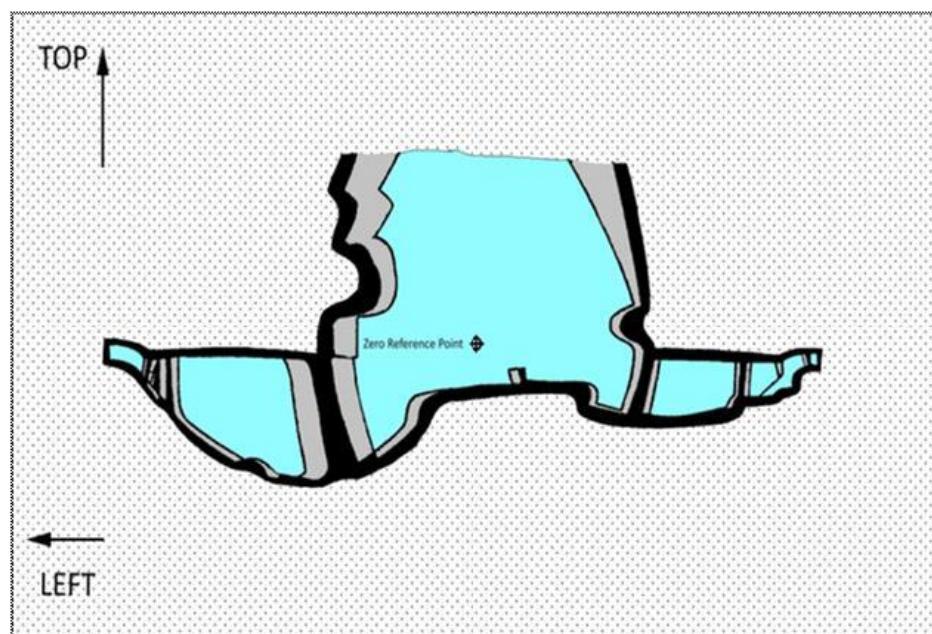
Figure13: Cessna 172 cockpit vision diagram

A standard cockpit vision diagram for the Cessna 172 is at Figure 13.⁴⁶ The picture is taken from the perspective of a pilot seated in the front left seat and depicts the zero reference point.⁴⁷ The areas indicated in light blue are those that provide unobstructed binocular vision to the pilot. The light grey shaded areas indicate those areas of monocular vision, and the black and dotted areas indicate the complete obstruction of the pilot's external vision.

A pilot's seating position can affect the vision from the cockpit. Following the accident, the student pilot was asked to take his normal seating position in the aircraft and photographs were taken of that position. An examination of those photographs revealed that the student pilot's seating position placed his eyes lower than the zero reference point (Figure 13). That would have decreased the area of vision that was available to the student pilot, particularly ahead of the aircraft.

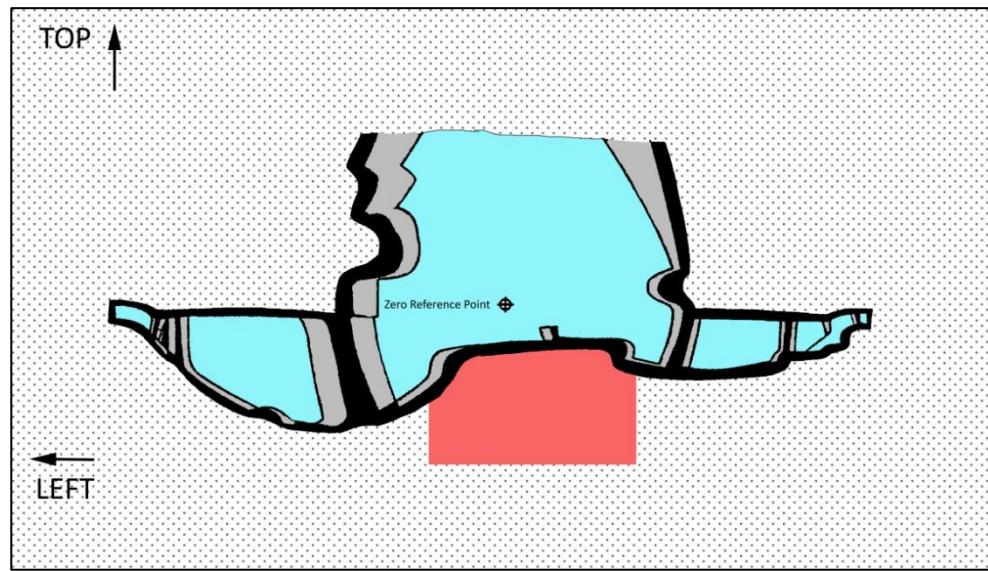
Figure 14: Area obscured by the Cessna 172 instrument panel (shaded in red)

cockpit forward vision. The left and right edges of the instrument panel represented a restriction of about 35° to the left and 60° to the right of the zero reference point. Therefore, a total of about 95° of vision was obstructed or cut off by the instrument panel. Vision below the zero reference point was unaffected for about 16° before being totally obscured by the instrument panel (Figure 14).

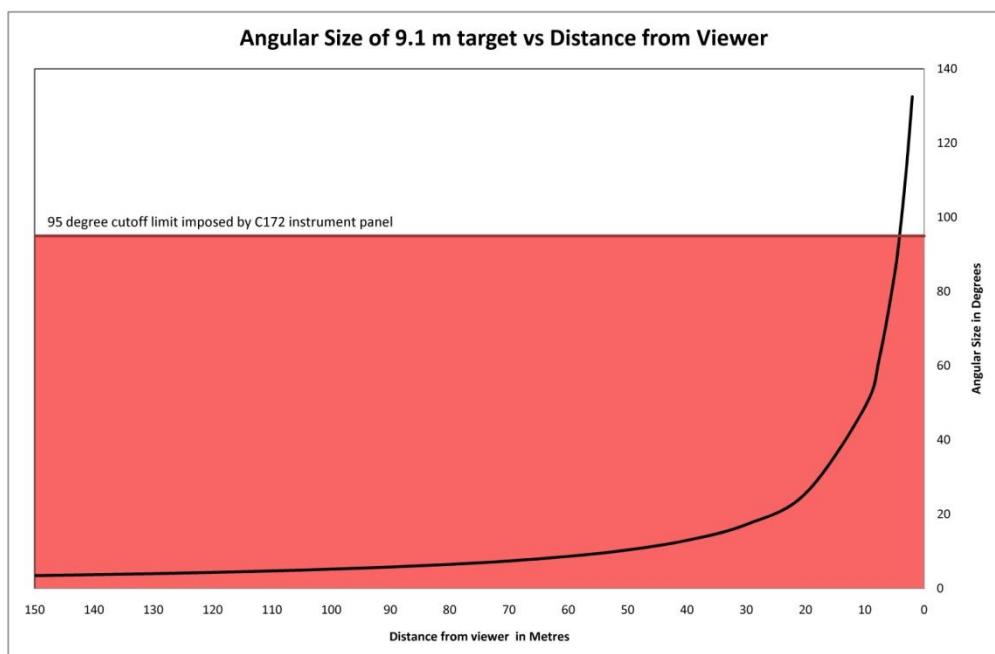
Figure 15: Angular size of a 9.1 m object when viewed at various distances

The wingspan of the Avid was about 9.1 m. When an object of that size is viewed at a distance of 150 m, it has an angular size of 3.47° . As the object moves closer to the viewpoint, the angular size increases. The angular sizes of a 9.1 m object at varying distances from a specified viewpoint were calculated and are presented at Figure 15 (the area that is obscured by the instrument panel cut-off angle of 95° is marked in red).

As indicated on the chart by reading left to right on the horizontal distance scale, the angular size of the Avid's 9.1 m wingspan remains relatively small as the distance to the viewpoint decreases. The angular size of the Avid does not become visible outside of the Cessna 172's instrument panel until the Avid is about 5 m from the Cessna.

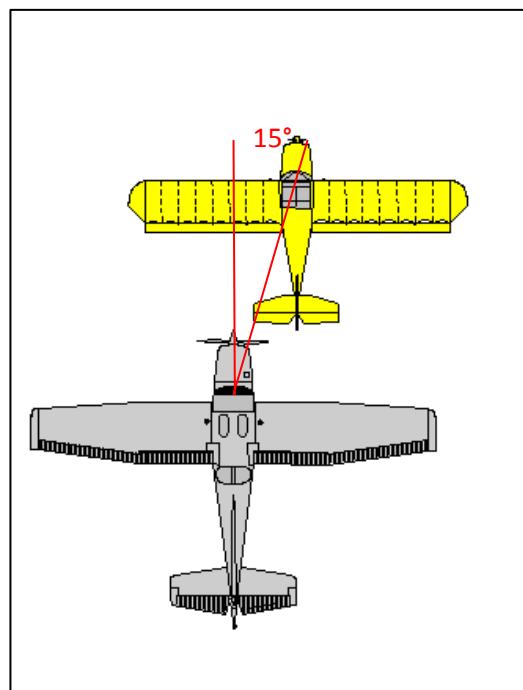
Figure 16: Aircraft positions immediately prior to the collision

A plan view of the estimated relative locations of the Avid and EUI immediately prior to the collision, as reported by witnesses and confirmed by the on-site physical evidence is at Figure 16. The Avid is located to the right of EUI at an angle of about 15° from the zero reference point. EUI is above the Avid and the vertical and horizontal distances between the two aircraft is decreasing.

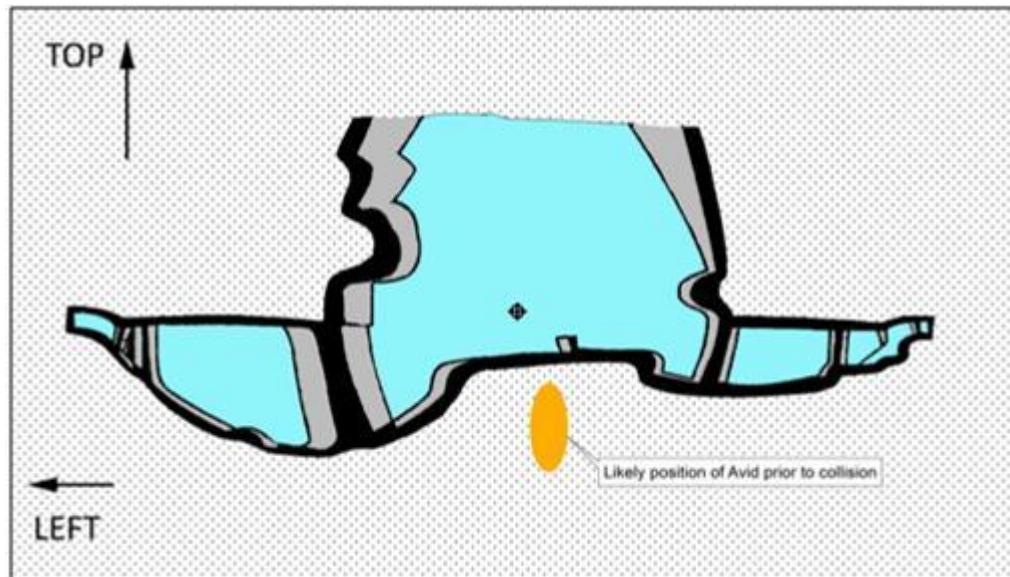
Figure 17: Representation of the relative position of the Avid on the Cessna 172 cockpit vision diagram

The transfer of the Avid's position to the Cessna 172 cockpit vision diagram (Figure 17) shows the Avid in a position that is lower and to the right of EUI's zero reference point, in an area that is obscured by the instrument panel, engine and

aircraft structure in front of the student pilot. An aircraft in that area would not have been visible to the student pilot from the front left seat.

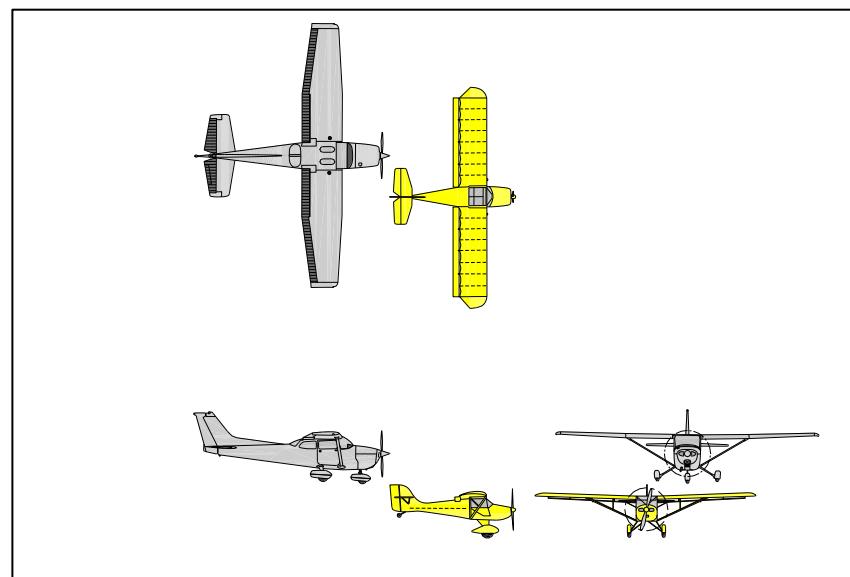
Figure 18: Collision sequence 1

The collision sequence commenced with EUI approaching from above and behind the Avid (Figure 18), and with EUI's rate of descent and speed over the ground greater than that of the Avid. Due to the relative differences in the aircraft's speeds and rates of descent, the propeller of EUI missed the tail surfaces of the Avid.

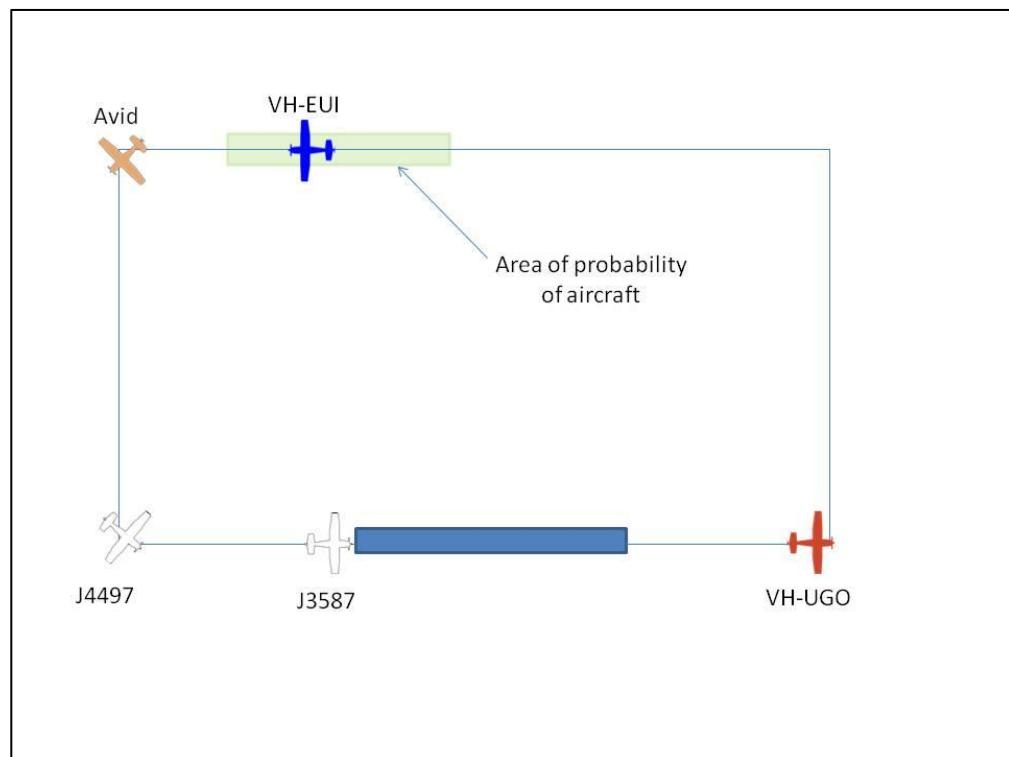
Figure 24: Likely positions of the aircraft at the time of the overtransmission (not to scale)

The CFI's broadcast that there were two aircraft on the final approach leg of the circuit was an attempt to ensure that if that was the case, the affected pilots were aware of each other in spite of the overtransmission. However, that overtransmission was most likely not between the two aircraft that were on the final approach leg, it was between Jabiru J4497 and the Avid. J4497 was turning from base to final and the Avid was turning from downwind to base (Figure 24).

An additional effect of the CFI's broadcast was that pilots would naturally look to the final leg of the circuit to identify the two aircraft; Jabiru J3587, who had joined the circuit on downwind, and Jabiru J4497 who was ahead of the Avid. Seeing the two Jabiru aircraft on final would have confirmed the student pilot's expectation in response to the alert from the CFI. In consequence, the subsequent broadcast from the pilot of the Avid that he had the other aircraft sighted could have been interpreted by the student pilot that it came from the second aircraft on finals, Jabiru 4497. That could have served to further confirm the student pilot's (incorrect) understanding that there was no aircraft on the base leg, and that he could commence a normal base turn.
