ATSB TRANSPORT SAFETY REPORT Aviation Occurrence Investigation AO-2009-068 Final

Operational event 132 km west of Horn Island Aerodrome Queensland 9 November 2009 VH-EMZ Bell Helicopter 412

Operational event 132 km west of Horn Island Aerodrome, Queensland 9 November 2009 VH-EMZ Bell Helicopter Company 412

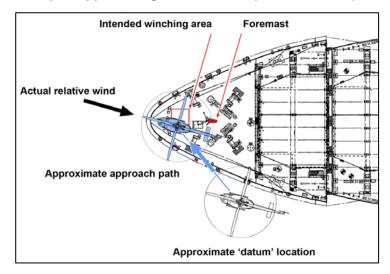
Figure 5: Helicopter approaching the forecastle (shown to scale)

At about 1550, the pilot approached the ship and terminated to the hover alongside at a position known as the 'datum' (Figure 5), from which the crew had a clear view of the winching area. While established at the datum with the helicopter facing into the relative wind, the pilot and ACO assessed the obstacles in the proximity of the winching area and confirmed that the helicopter had sufficient power margin¹⁰ to conduct the winch. The pilot reported that although the helicopter airspeed indicator showed about 30 kts while hovering at the datum, there was no associated turbulence.

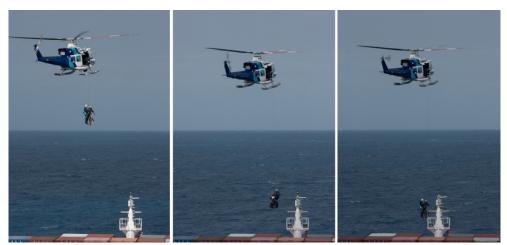
Figure 6: Approaching the winching area¹²

The ACO obtained permission from the pilot to commence the winch and began lowering the crew while the pilot began moving the helicopter towards the forecastle with the helicopter facing into the relative wind (Figures 5 and 6). A short time later, the pilot called 'losing sight'¹¹ and the ACO commenced providing verbal guidance to allow the pilot to manoeuvre the helicopter towards the designated winch area. The pilot recalled that this guidance included instructions to descend as the helicopter approached the forecastle. The ACO reported that the crew had agreed to maintain about 20 ft vertical clearance from the foremast.

The pilot reported that as the helicopter approached overhead the target area with the ship's structure as a hover reference, he glanced inside the cockpit to check the cockpit instruments. On looking back outside he could no longer see the ship. In response, the pilot changed hover reference to the view of the horizon directly to the front of the helicopter and announced to the ACO that he had 'lost reference'. The pilot reported that although he had not considered the possibility of losing sight of the ship, he believed that any unintended movement of the helicopter due to the inferior hover reference would be compensated for by guidance from the ACO.

The ACO recalled that at the time the pilot called 'lost reference', the RCO and paramedic were about 6 m above the forecastle deck and nearing the centre of the winch area. He stated that on hearing the term 'lost reference', he understood that the pilot could no longer see the ship. A short time later, the ACO observed the helicopter begin to drift rearwards towards the ship's foremast. The ACO immediately announced the drift to the pilot and requested that he move the helicopter forward. In response, the pilot applied a forward correction that he assessed would be sufficient to arrest the movement. However, the helicopter continued to drift towards the foremast.

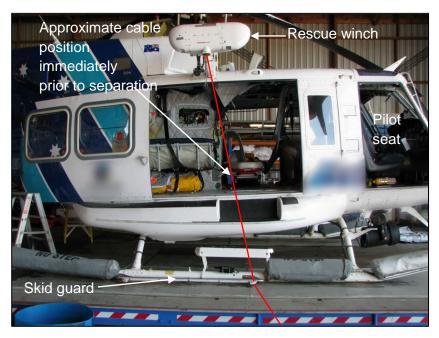
Figure 7: VH-EMZ

The helicopter continued to drift backwards over the ship and to the left of the foremast. The ACO observed that the winch cable was caught on the helicopter's skid guard and running at an angle down towards the foremast (Figure 7), and that despite continuing to pay out on the cable, it remained under tension.

The Bell 412 is a single main and tail rotor-equipped helicopter that is powered by two gas turbine engines, and equipped with skid-type landing gear (Figure 6). The occurrence aircraft was equipped with an electrically-powered rescue winch that was fitted on the right of the helicopter, adjacent to the rear cabin (Figure 7).

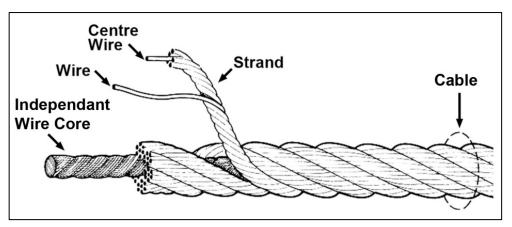
Figure 15: Winch cable construction

The 3/16th inch diameter winch cable comprised an independent wire core that was surrounded by a layer of central strands. The 19 strands each consisted of seven smaller diameter individual wires (Figure 15).

Wire cable can experience a significant reduction in strength when passed over a curved surface due to the inability of the individual strands and wires to reposition (Figure 15). This results in an increase in bending stresses, particularly within the larger diameter wires.

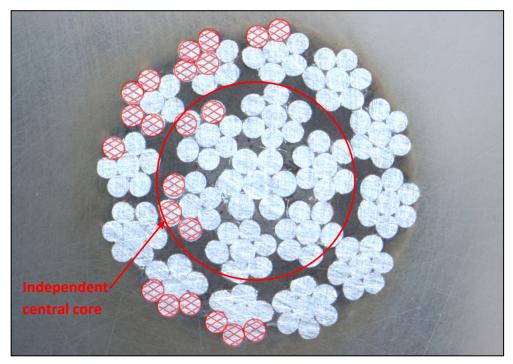
Examination of the winch cable via visual and scanning electron microscopy techniques identified that about 17% of the cable had been severed through abrasive contact with the foremast structure (Figure 16). The separation of the remainder of the cable was consistent with the effects of a combination of shear and tensile overstress. There was no evidence of fatigue failure within any of the cable strands.

An inspection of the entire cable length revealed that, aside from the damage close to the separation point, there were no other forms of degradation such as corrosion, broken wires or kinks.
