ATSB TRANSPORT SAFETY BULLETIN

Aviation Level 5 Investigations

AB-2010-103

# Level 5 Factual Investigations: 1 October 2010 to 31 December 2010

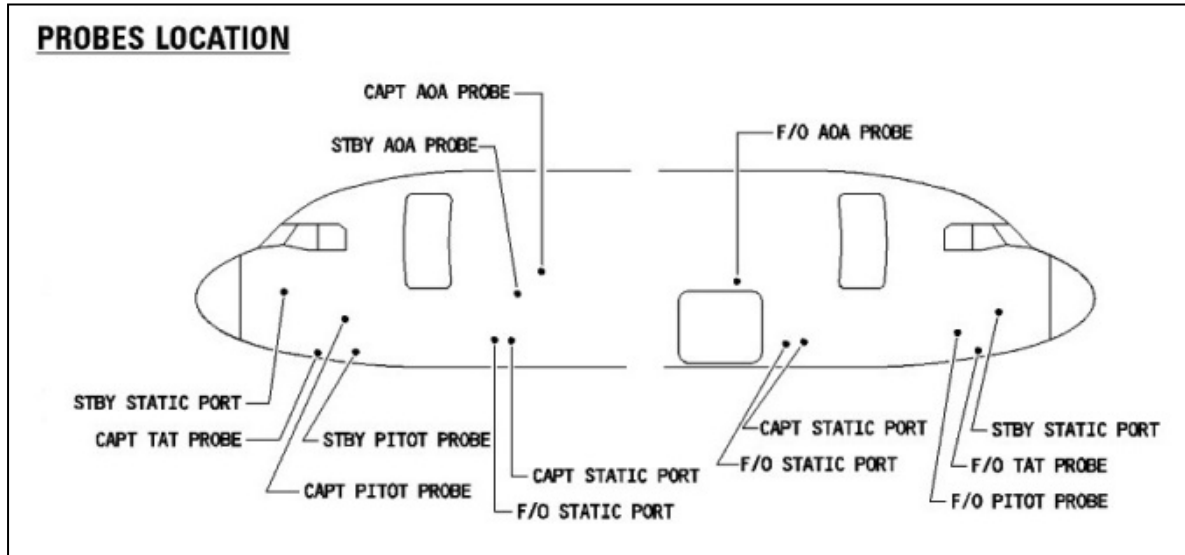
Figure 1: Airframe probe (sensor) locations.

Further technical procedures were also completed. These included the flushing of the crew and standby pitot total pressure lines, the static systems and cleaning of the pitot probe drain holes and testing the principal static and total air data systems. There were no defects found during these activities.

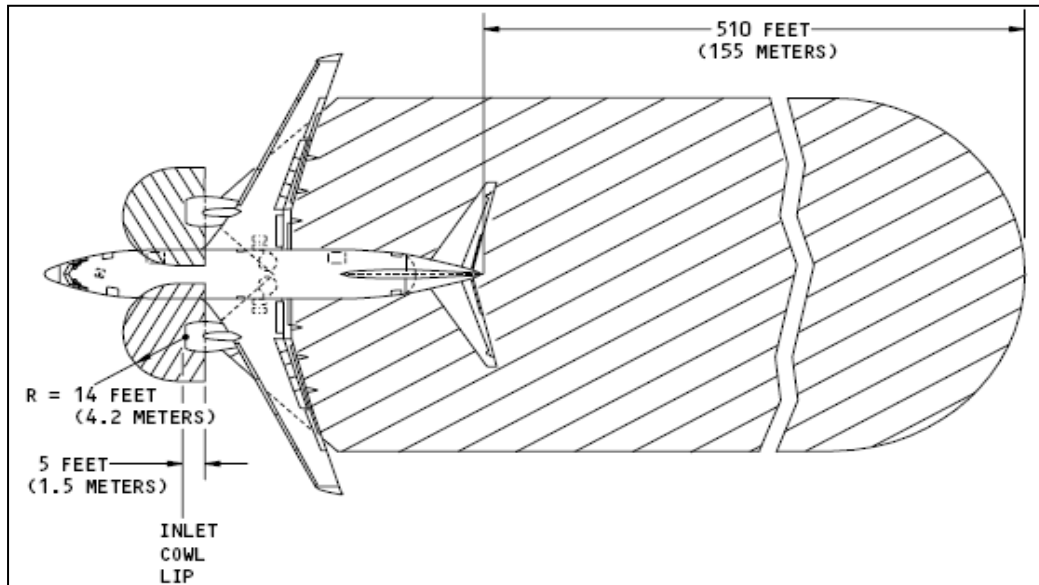
Figure 2: B737 inlet and exhaust hazard areas at breakaway power

When the engine is at ground idle, as may be experienced during the pushback operation, the low pressure hazard area extends to a distance of 3.1 m from the mouth of the inlet. When breakaway power is applied to move the aircraft, this hazard area increases to 4.2 m. A hazard area also exists when hot air exits the engine exhaust at a very high temperature and speed. When the engines are operating at forward breakaway power, the exhaust hazard area extends 155 m to the rear of the aircraft tail (Figure 2).
