Australian Transport Safety Bureau

ATSB TRANSPORT SAFETY REPORT Aviation Short Investigations AB-2011-040 Final

Aviation Short Investigation Bulletin: First Quarter 2011

Issue 5

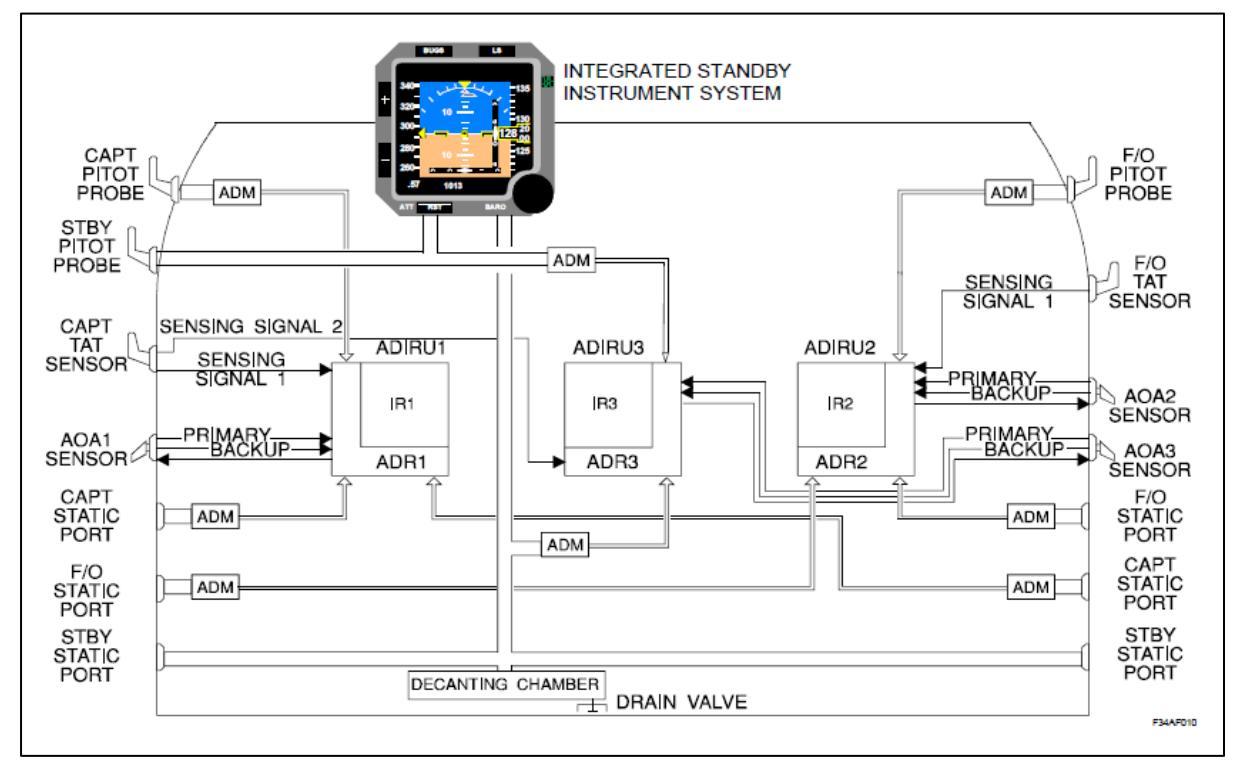
Figure 2: A330 Air Data System

The FDR did not record total air temperature⁶ (TAT) data, but did register three separate static air temperature (SAT) parameters⁷ which were calculated from the TAT probes. The FDR indicated that the SAT data from one TAT probe failed at 1604. One minute later, the SAT data from the other probe failed and resulted in the loss of both autopilot and autothrottle capabilities. The failure of all the recorded SAT parameters suggested that both the captain's TAT probe and the first officer's TAT probe failed within one minute of each other.

Post flight testing confirmed that both the captain's and the first officer's TAT probes were unserviceable and were subsequently replaced.

The operator contacted the aircraft manufacturer and, based on a description of the event, the manufacturer suspected that the TAT probe failure was due to icing caused by severe environmental conditions. The manufacturer concluded that the probes failed when the sensing elements within the probes were affected by high mechanical stress due to ice expansion.

The aircraft had two TAT probes (P/N 102LA2AG) which were electrically heated. Each probe fed temperature data into independent air data inertial reference units (ADIRU). That data was used to calculate SAT and true airspeed (Figure 2). The loss of this information from the ADIRU resulted in a loss of autoflight capabilities.

similar multiple TAT probe failures have been reported. Due to the previous failures, a new TAT probe was certified and issued through an optional service bulletin in 2008. There have been no reported events of multiple failures involving the new TAT probe.

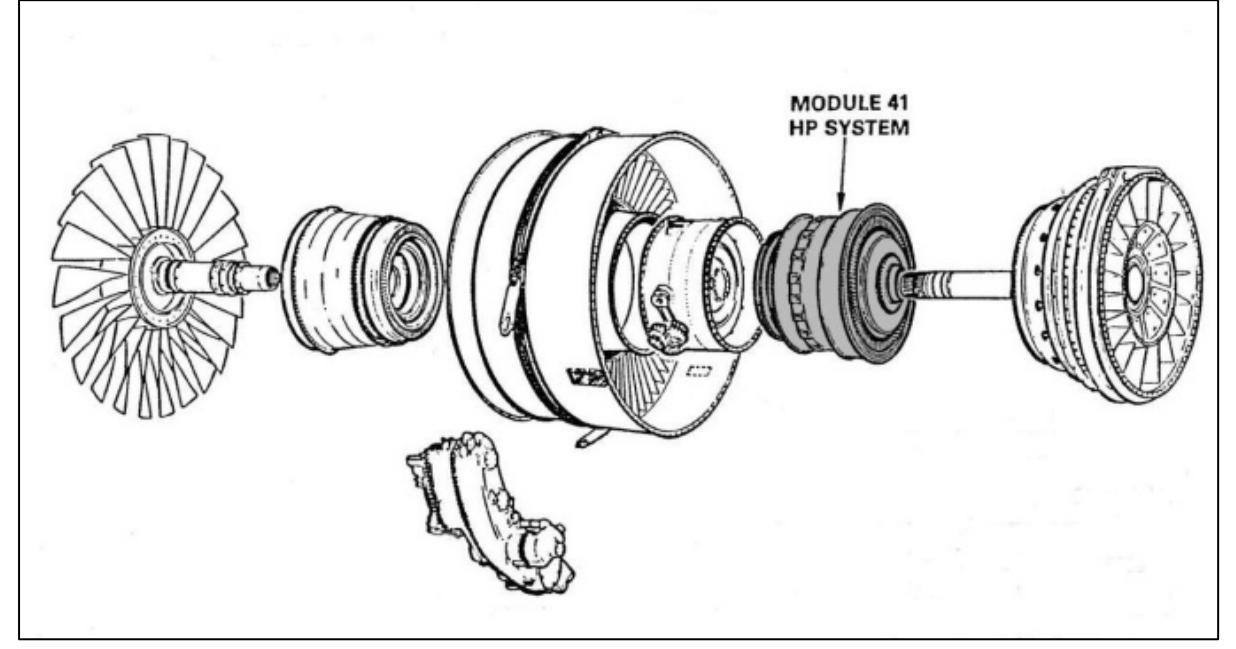
that the engine had sustained serious damage to all six stages of the high pressure compressor (HPC) however the damage was contained within the engine. The engine was then removed for shipping to the operator's repair facility and was replaced with a serviceable engine. After a satisfactory engine ground run, the aircraft was returned to service.

A borescope inspection confirmed that a HPC stage 1 blade had liberated at the blade root. The liberated blade resulted in severe damage to all stages of the HPC. There were no titanium fire symptoms evident and no obvious defects found in other areas of the engine. The HPC stage 1 blade root failure, and secondary HPC damage of the engine, was consistent with previous HPC stage 1 blade root failures. The engine was inducted into the operator's engine overhaul facility where the HPC 41 module (Figure 1) was removed for overhaul.

The operator is continuing to embody SB RB211-72-G036, issued in 2009, at engine shop visits where the HPC module is removed. However, should the rate of failures increase significantly, a review of current modification policy will be undertaken.
