ATSB TRANSPORT SAFETY REPORT

External Investigation – AE-2010-024

Flight Data Recovery

CT-4 Airtrainer, NZ1990

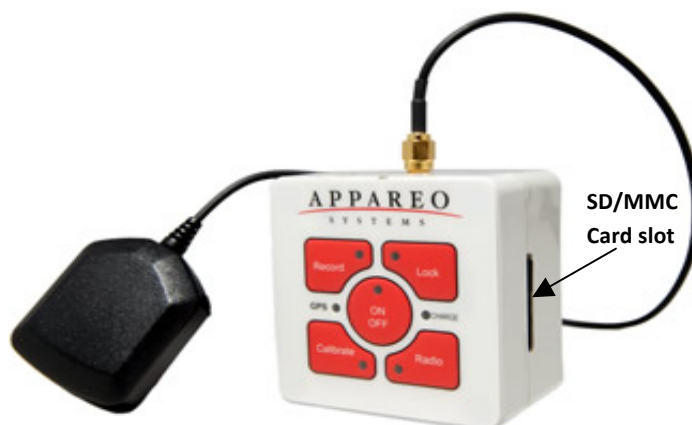
Figure 1: Example Appareo Systems GAU1000 recorder

The Appareo Systems GAU1000 data recorder (Figure 1) was a non-crash protected flight data recorder mounted to the aircraft with hook-and-loop fasteners (Figure 2). The recorder contained gyroscopes, accelerometers, barometric pressure sensors, and a solid state compass. It also recorded Global Positioning System (GPS) data¹. Data was recorded to a Secure Digital (SD) card or Multimedia Card (MMC) fitted in the side of the recorder (arrowed in Figure 1) as well as to on-board NAND flash memory.

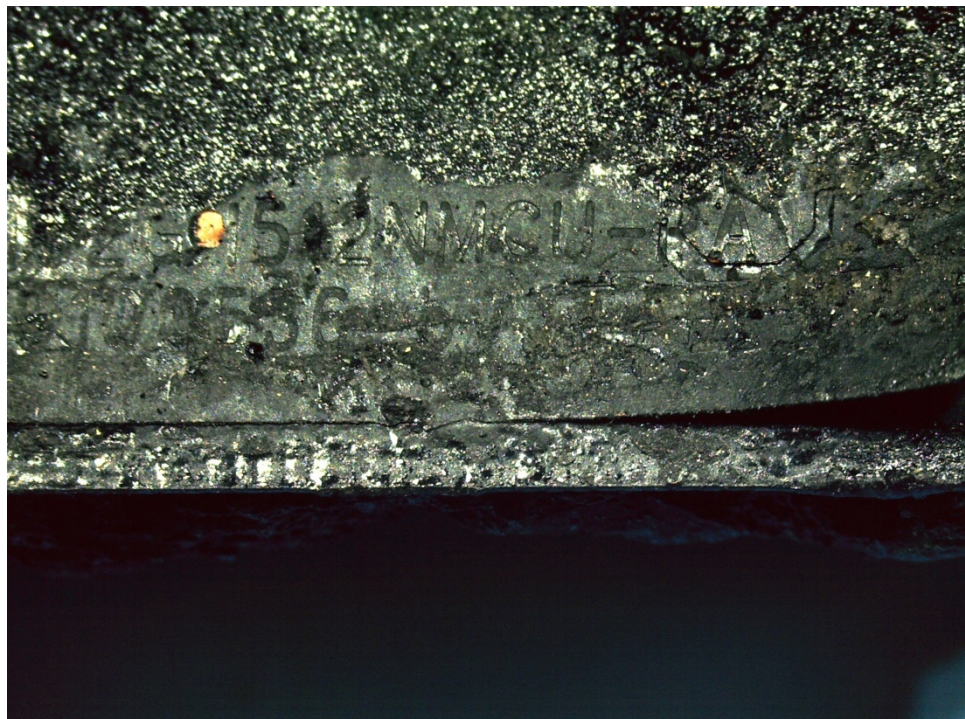
The SD/MMC was identified (by the part number visible at the base of the front side of the card, Figure 7) as an *Imation* 512 megabyte (MB) multimedia card (MMC) (Figure 8).

Figure 7: Part number of SD/MMC card visible at base of card

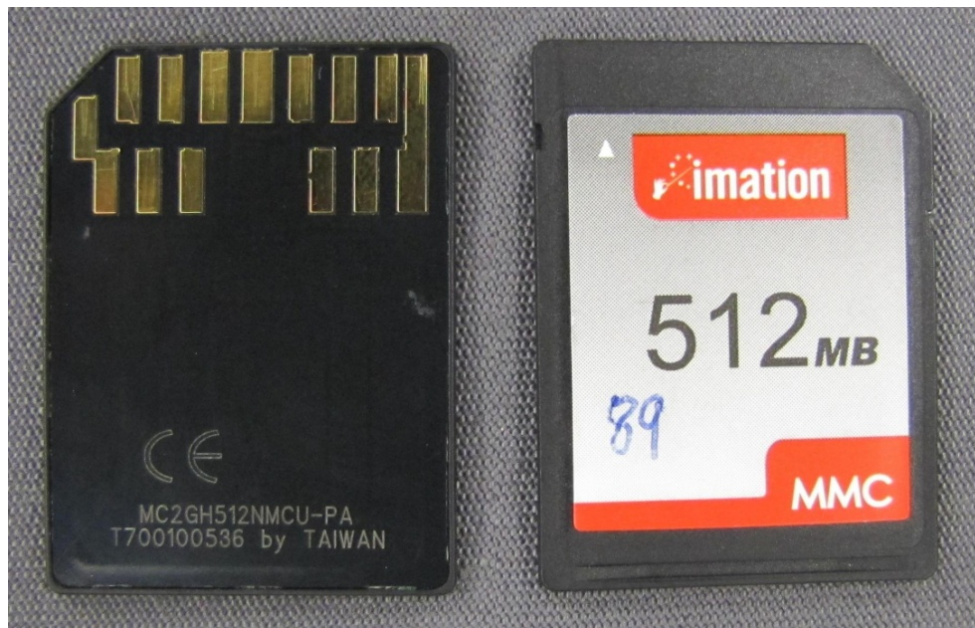
Figure 8: Example MMC card provided by RNZAF flight safety

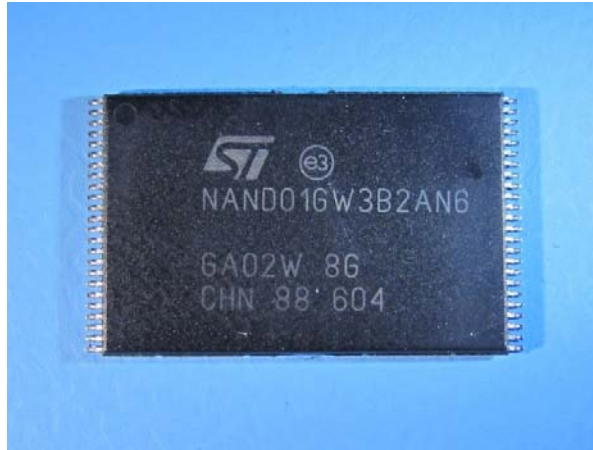
Figure 11: NAND01GW3B2AN6 flash memory device

Manufacturer: *ST Electronics*

Part number: NAND01GW3B2AN6

Package type: TSOP-48

Dimensions: 12mm x 20mm

Density: 1 Gigabit (equivalent to 128 megabytes (MB))

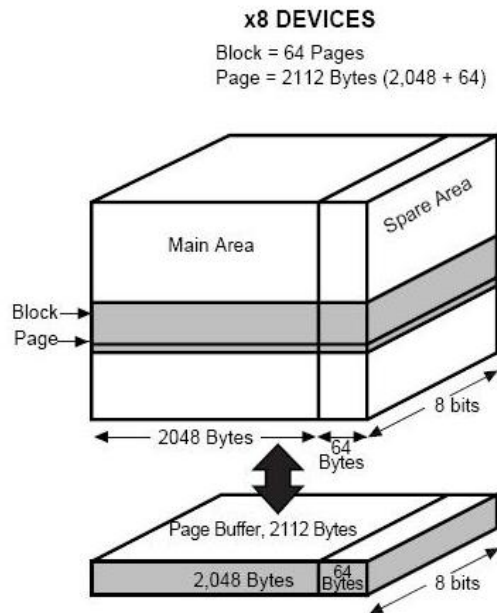
Figure 12: Architecture of flash memory device family NAND01G-B

The accident NAND flash memory was structured as 1024 blocks; each block contained 64 pages of 2048 bytes and 64 spare bytes⁶:

As such, a successful, complete, download of the flash memory device should yield a binary data file of 132MB in size. Figure 12 is a graphical representation of the structure of the NAND flash memory⁷.
