ATSB TRANSPORT SAFETY REPORT
Aviation Occurrence Investigation – AO-2008-003
Final

Electrical system event
25 km NNW of Bangkok International
Airport, Thailand
7 January 2008
VH-OJM
Boeing 747-438

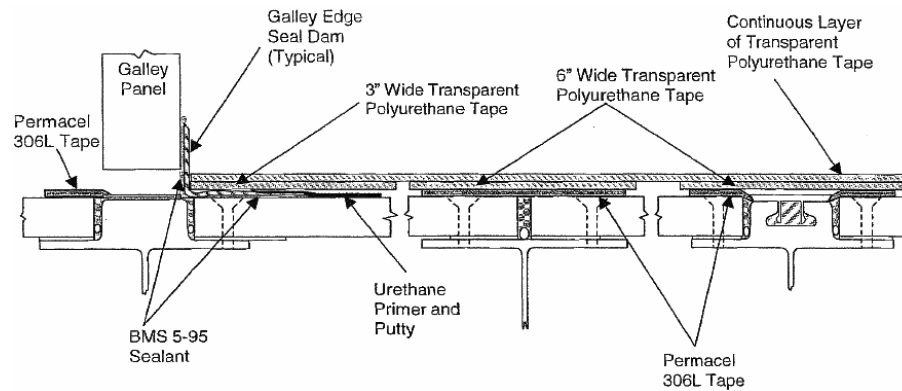
Figure 10: 747-438 wet area floor sealing specification

The specification for sealing wet area floors around seat tracks is shown in Figure 10. Galley edge seal dams were required around the inside of galley perimeter walls, whereas none were in place around the forward galley bulkhead in OJM.

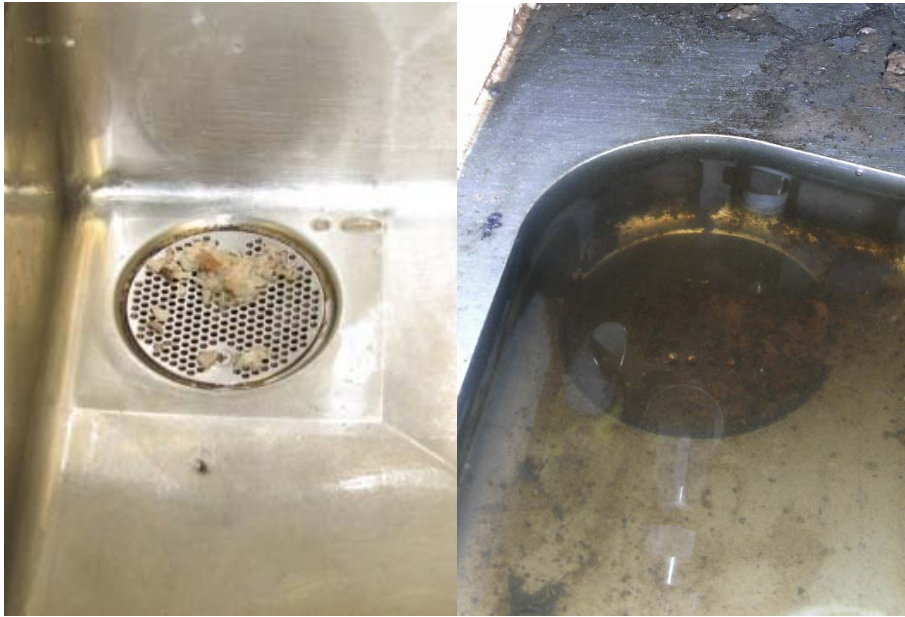
Figure 24: Galley sinks and solid waste

Inspection of the galley drains showed remnants of solid waste in the forward and mid galley sinks. The mid galley sink drain was completely blocked (Figure 24).

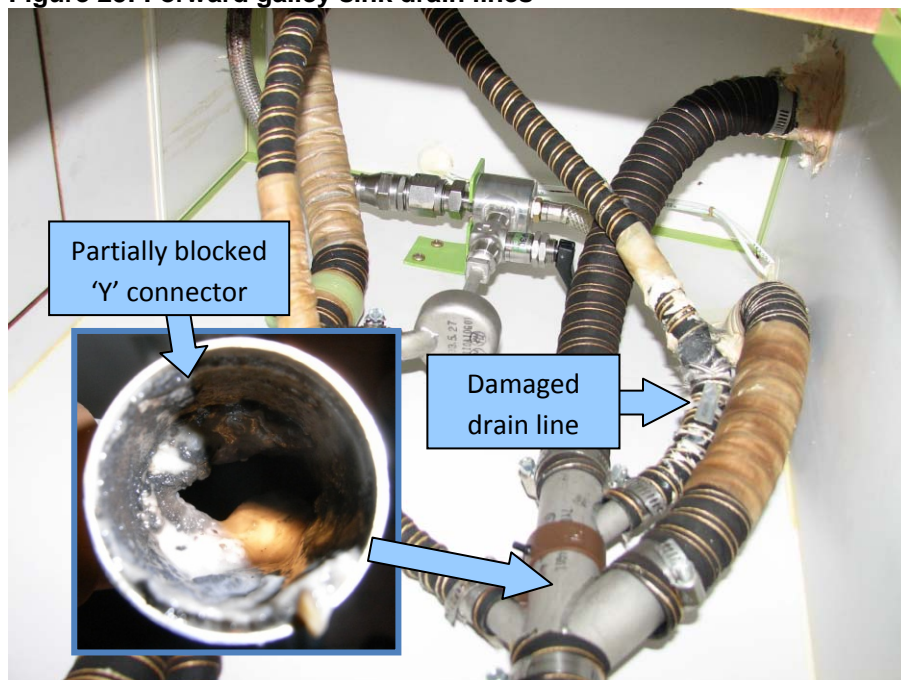
Figure 25: Forward galley sink drain lines

A damaged drain line beneath the forward galley sink did not leak when tested in place (Figure 25). A metal drain line 'Y' connector in the forward galley was removed and found to be partially blocked by solid waste (Figure 25).

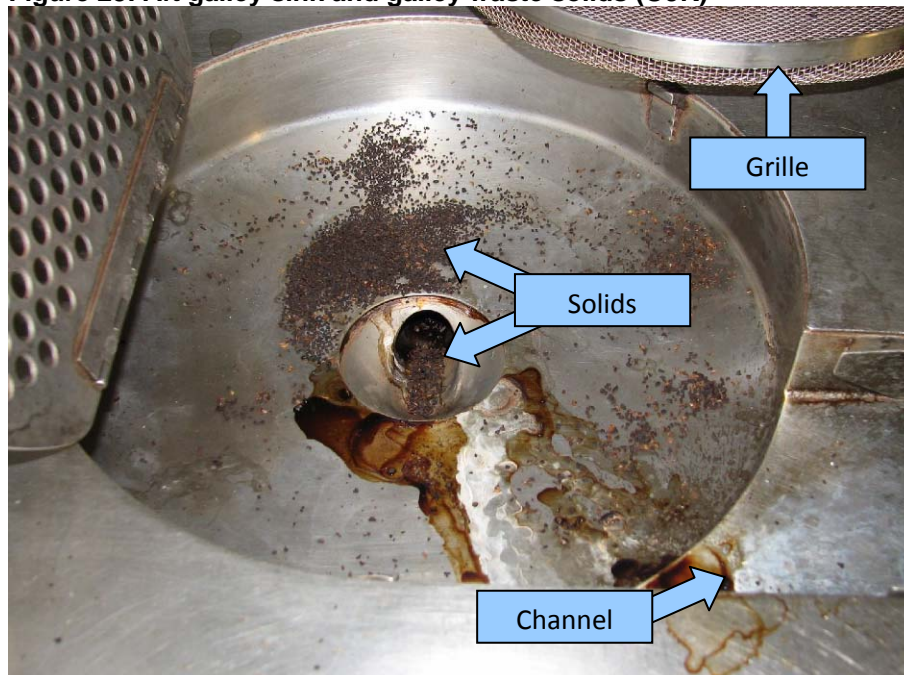
Figure 28: Aft galley sink and galley waste solids (OJK)

Inspections of the galley sinks revealed solid waste, which appeared to be coffee grounds, in one of the sinks in the aft galley (Figure 28).

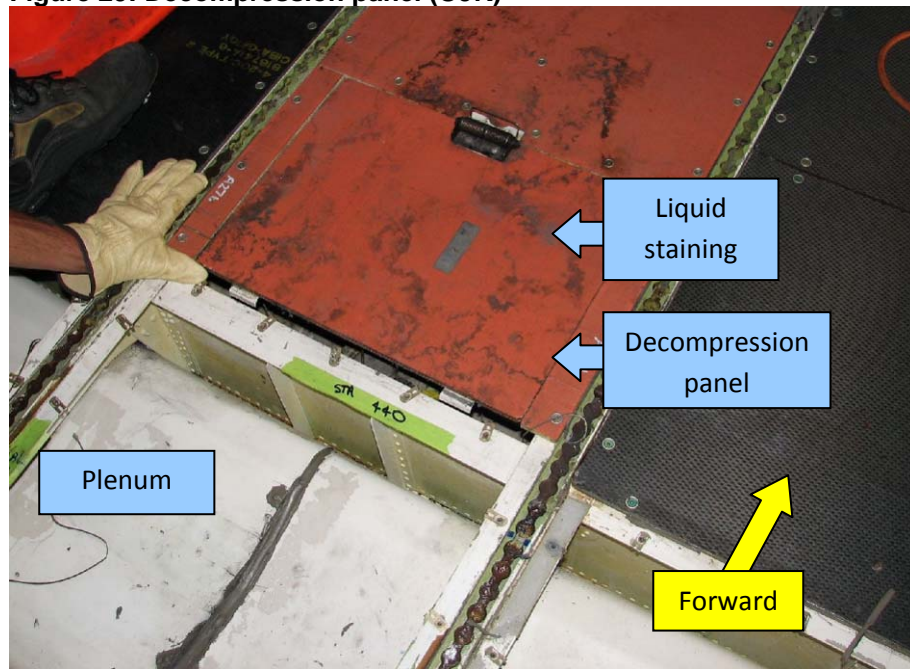
Figure 29: Decompression panel (OJK)

Examination of the galley floor revealed liquid staining on the floor panels, including the decompression panel (Figure 29).

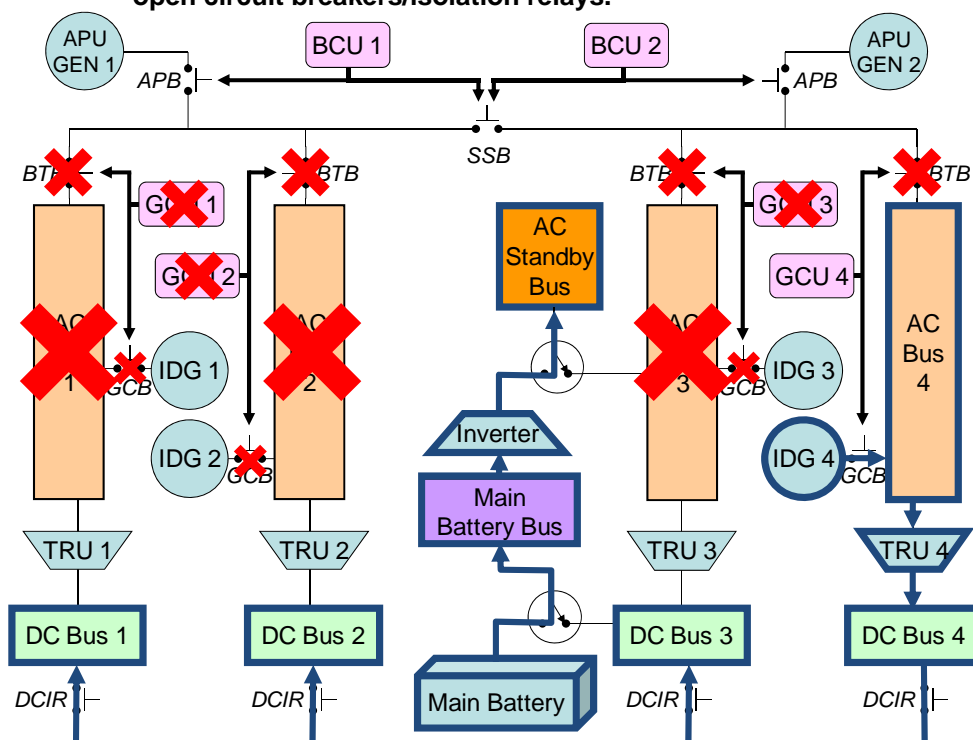
Figure 33: Simplified overview of the aircraft's electrical system configuration at landing. Blue border: active systems; red: inactive systems and open circuit breakers/isolation relays.

Of the aircraft's four primary AC buses and four primary DC buses, only AC bus 4 and the four DC buses remained powered during the aircraft's final approach and landing (Figure 33). In addition, the aircraft's batteries provided power to the two battery buses and to the AC standby bus via the aircraft's static inverter.

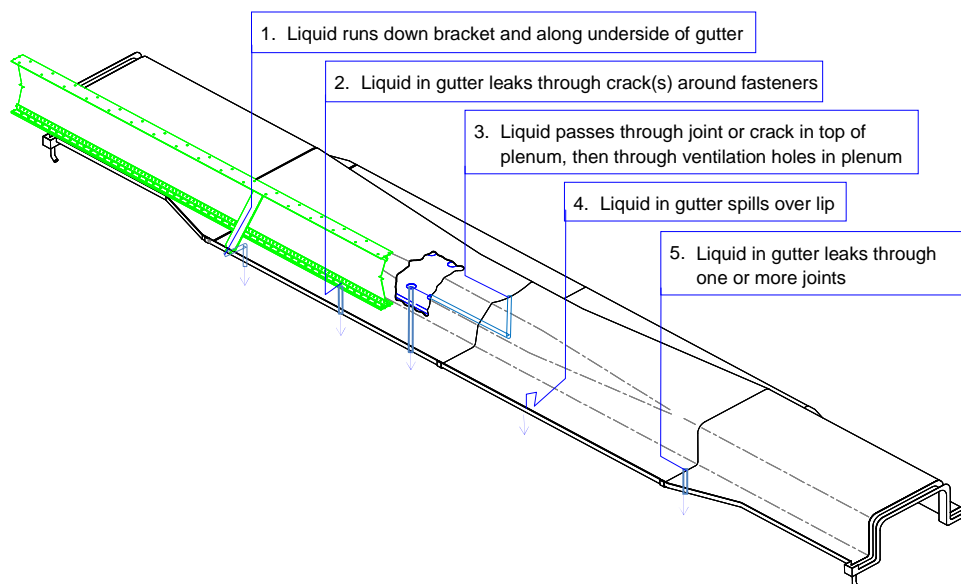
Figure 35: Potential water ingress paths

During inspections of two 747-400 aircraft, including the incident aircraft, the investigation identified five potential paths by which liquid from above could reach the equipment in the E1 and E2 racks. The investigation concluded that although the drip gutter joints were the most likely path for water to have bypassed the dripshield, all five potential liquid paths posed a substantial risk to the electrical equipment in the E1 and E2 racks (Figure 35).

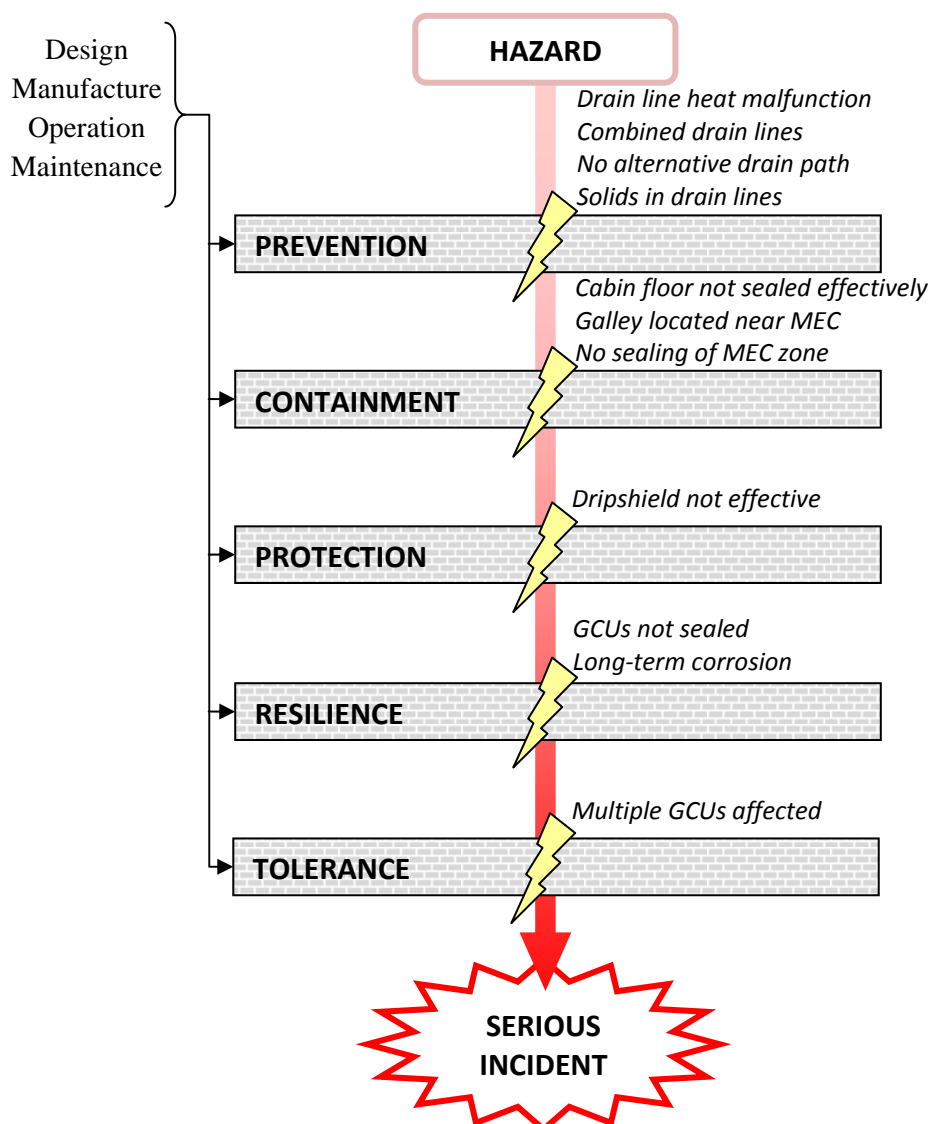
Figure 37: Breaches of defence

In this incident, each of those defences was breached by a different failure or design characteristic (Figure 37).

A breach in any single defence could be considered low-risk in view of the other defences that were in place, but the circumstances that allowed that breach to occur could also affect the other defences. As a result, the overall integrity of the system is compromised. Such circumstances could involve a weakness in the principles and policies that drive the design, operation, and/or maintenance of the defences, or a weakness in the implementation of those principles and policies.
