ATSB TRANSPORT SAFETY REPORT Aviation Short Investigations AB-2011-077 Final

## Aviation Short Investigation Bulletin: Second Quarter 2011

Issue 6

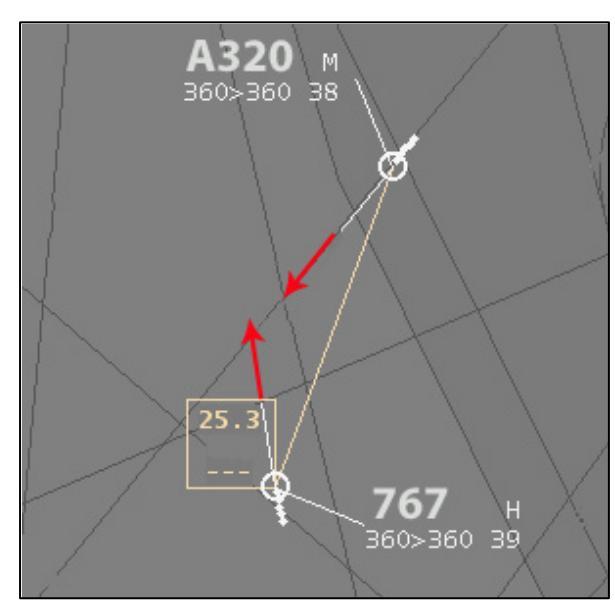
Figure 1: Position of aircraft at 1001

At 1000, the incident controller accepted control of the A320 and identified the confliction between it and the 767, which were both maintaining FL360 and 26.2 NM (48.5 km) apart. About 1 minute later, the controller instructed the flight crew of the 767 to climb to FL370. The radar data indicated that there was 25.3 NM (46.86 km) between the aircraft at that time (Figure 1). The pilot of the 767 responded with a request for a different level, which delayed the climb.

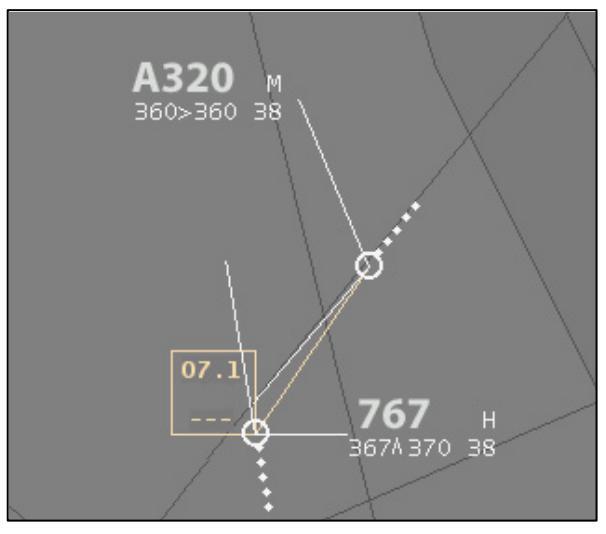
ahead of the A320 (Figure 2).

The applicable separation standards were either 1,000 ft vertical separation, or 5 NM lateral separation between the aircraft, on radar.

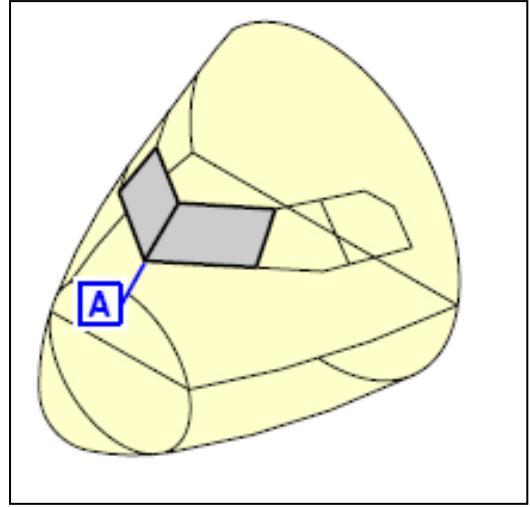
Due to similar windshield events, the aircraft manufacturer, Airbus, issued SB A330-56-3009 on 04 May 2010, with revision 1 dated 27 January 2011. The SB recommended a visual inspection of the left and right windshields (Figures 1 and 2) to In April 2011, Airbus, via the BEA4, informed the determine if their part number and serial numbers were part of the batch identified in the SB. The identified windshields were required to be replaced within 900 flight hours of the SB being issued.

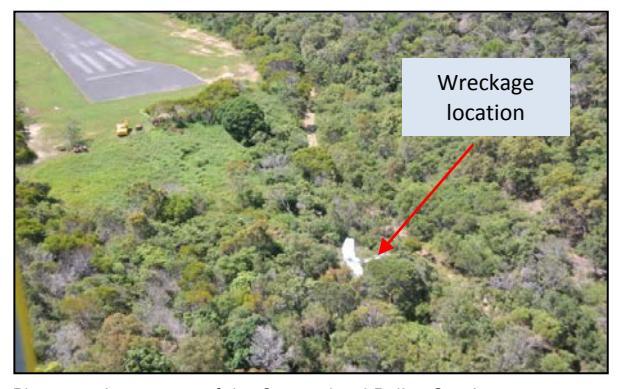
#### Figure 2: Wreckage location

The pilot and passengers exited the aircraft and commenced walking back to the airstrip. The pilot and two passengers sustained minor injuries, while the third passenger was not injured. The aircraft sustained serious damage (Figure 3).

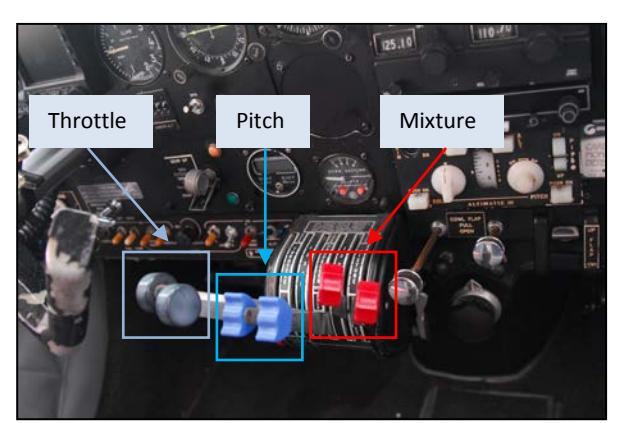
#### Figure 1: Engine controls

After takeoff, the student completed his aftertakeoff checks. The instructor contacted air traffic control and requested approval to conduct asymmetric operations; the request was approved. Shortly after, at about 400 ft above ground level (AGL), the instructor directed the student, 'practice engine failure'. The instructor, covering the engine mixture controls (Figure 1) with his hand, moved the mixture control on the right engine close to, or at the idle cut-off position. The instructor continued to position his hand on the mixture control.

Note: Figure 1 represents the position of the engine controls after the accident occurred and the aircraft was shutdown.

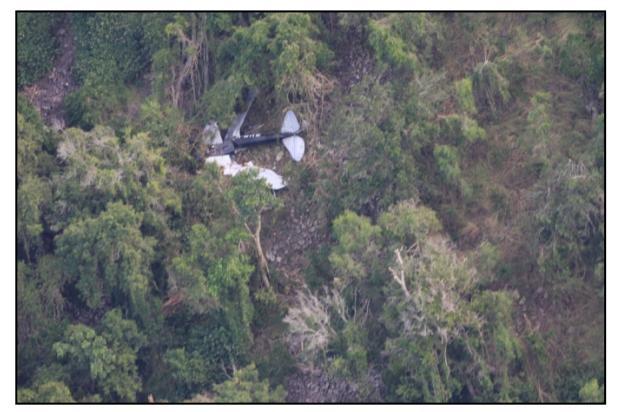
#### Figure 1: VH-WHW accident site

The aircraft came to rest upside down on the side of Mount Davidson in bushland (Figure 1). Both occupants sustained serious injuries.

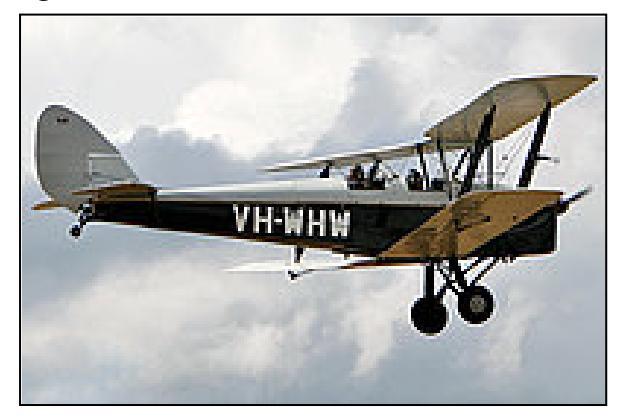
#### Figure 2: VH-WHW

The aircraft (Figure 2) was manufactured in 1941 and was used for pilot training by the British Royal Air Force until 1946. WHW then was used to tow

About 7 years prior to the accident, the aircraft had been incorrectly lifted during a repair to the undercarriage. As a result of damage sustained, WHW had required three new wings, a new engine and a new propeller prior to being returned to service.

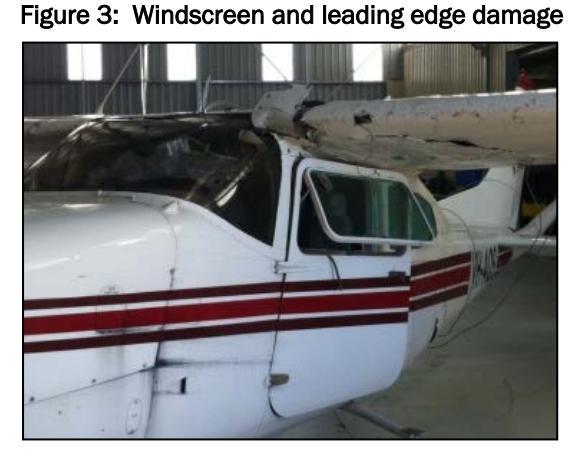
The pilot reported that the aircraft handled normally and was unaware of the damage to the aileron and flaps during the flight.

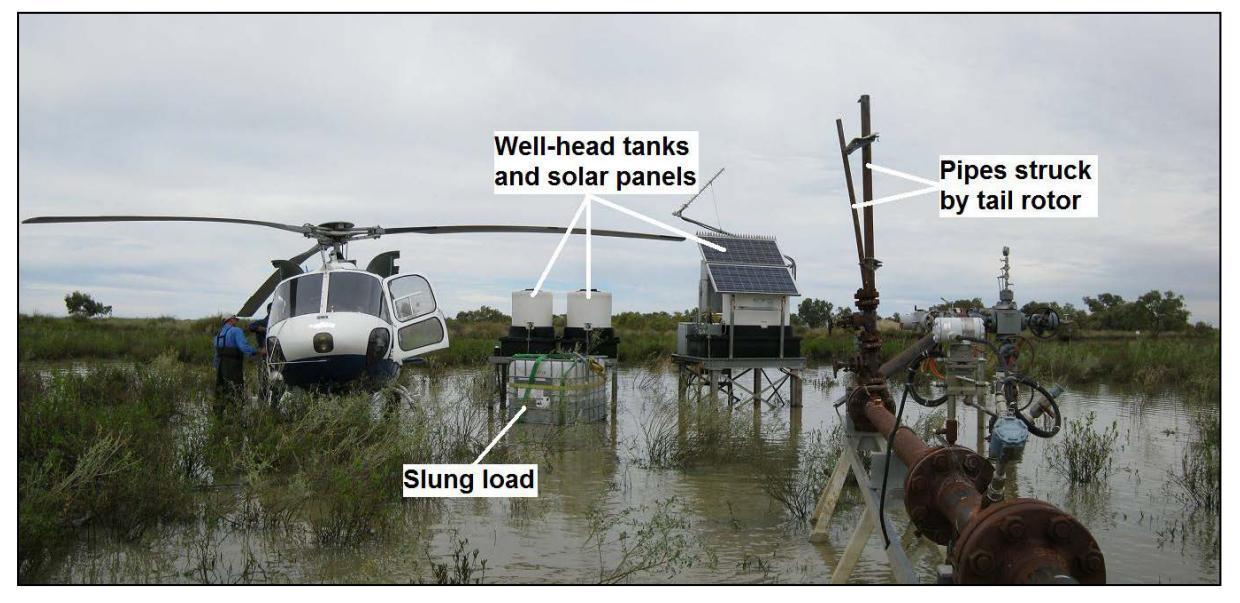
The well-head tank replenishment task included many sub-tasks that were repetitive. Repetitive tasks can increase an individual's susceptibility to attention failure and/or memory lapse and lead to skill based errors. The use of standard checklists and crew vigilance are two means of militating against skill based errors.

Figure 2: The occurrence site, looking south, showing well-head components and position of obstacles relative to position of helicopter
