Loss of tailrotor control, VH-UHD

Nangar National Park, New South Wales

23 December 2009

Abstract

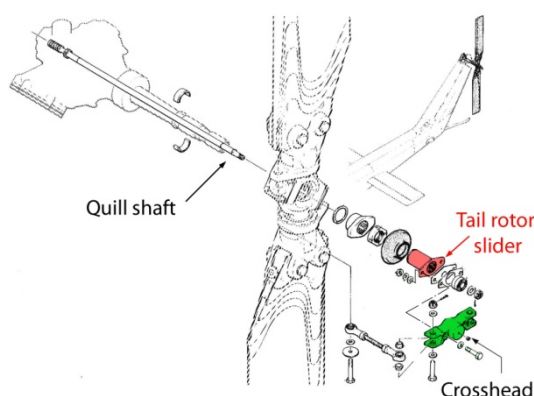
Figure 2: Tailrotor slider and crosshead

The tailrotor pitch control mechanism included a 'crosshead' and 'slider' assembly (Figure 2), which translated linear movement of the quill shaft into a tailrotor blade pitch change. The crosshead was secured to the slider by two National Aerospace Standards (NAS) 1304⁶ attachment bolts and castellated nuts that were torqued to a specified value and locked by split pins.
