ATSB TRANSPORT SAFETY REPORT
Aviation Occurrence Investigation
AO-2010-006
Final

Total power loss
11 km NE of Derby Airport, WA
29 January 2010
VH-NWO, Pilatus PC-12/45

**Total power loss
11 km NE of Derby Airport, Western
Australia
29 Jan 2010
VH-NWO, Pilatus PC-12/45**

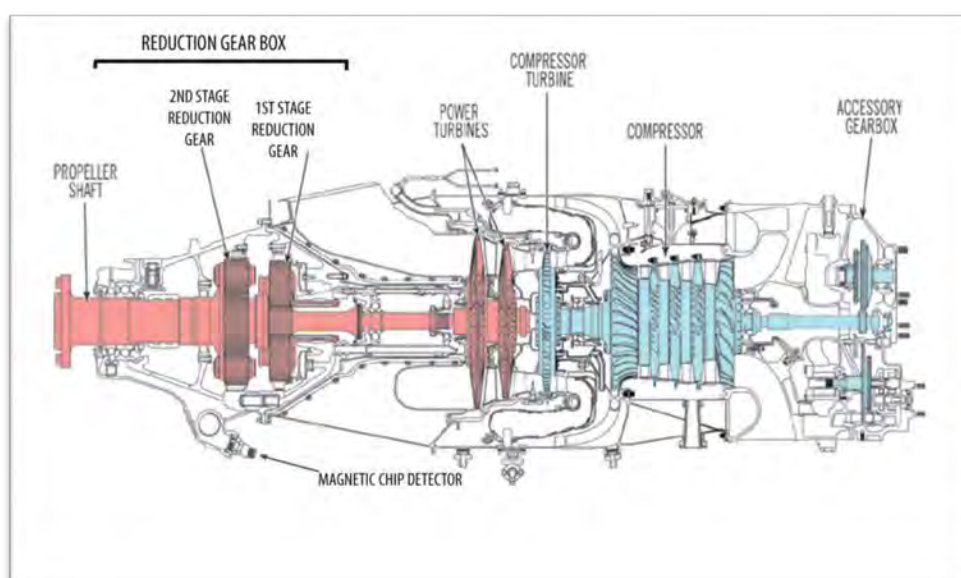
Figure 1: Schematic of the PT6A-67B engine

The aircraft was fitted with a Pratt and Whitney PT6A-67B engine (Figure 1), serial number PCE-PR0092. The engine was manufactured in Canada in June 1998 and had a total time in service of 5,619 hours. The engine's power section, which included the propeller reduction gearbox, had accumulated 1,120 hours since its last overhaul, which was carried out on 23 May 2007.

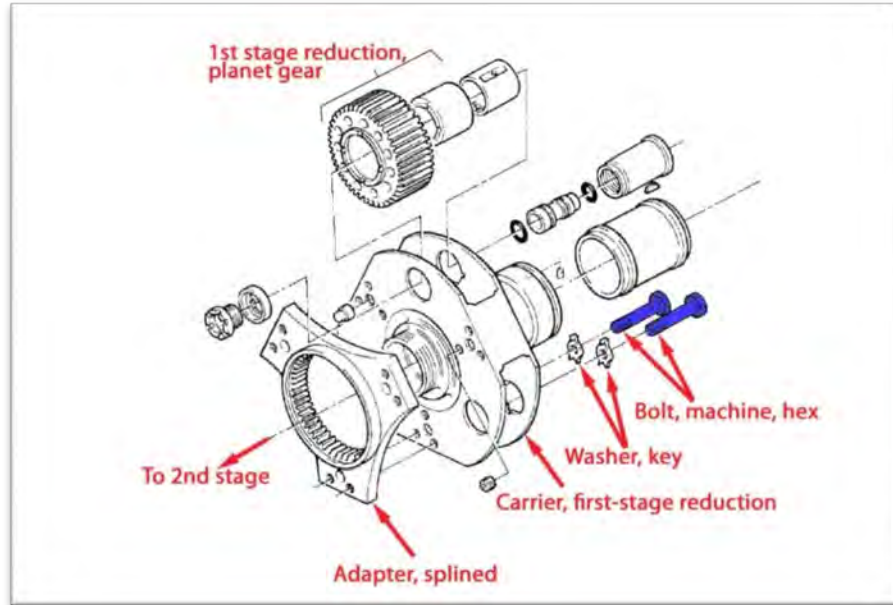
Figure A1: Schematic of the first stage reduction assembly

Seizure of the reduction gearbox was attributed to the fracture of the carrier bolts. These bolts provided a clamping force between the carrier plate and the splined adapter (Figure A1).

The assembly contained six bolts (Figure A2); four of the bolts had failed underneath the bolt head, one of the bolts had failed in the threaded region at a location between the carrier plate and splined adapter (Figure A3) while the final bolt remained intact.

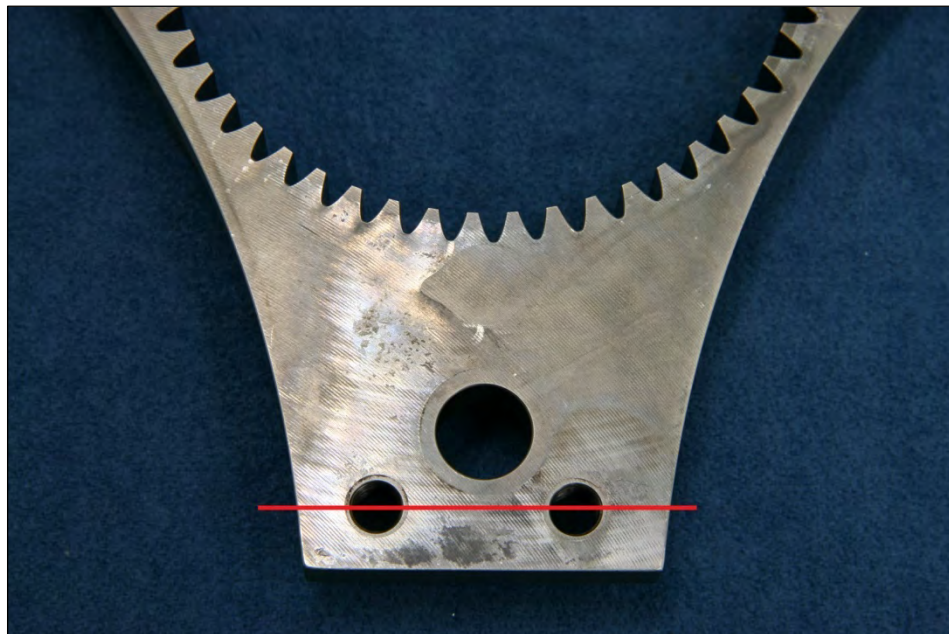
Figure A18: Corner of splined adapter with the location of the section removed shown in red

The splined adapter was sectioned through the internally threaded sections for characterisation of the thread form and condition (Figure A15). A section was removed through bolt holes S and T (both fractured under the bolt head), and another through bolt holes R (intact) and N (failure through threads). The thread form exhibited a squared-crest profile and a flattened root contour; consistent with an internal UNJF thread-form (Figure A16).

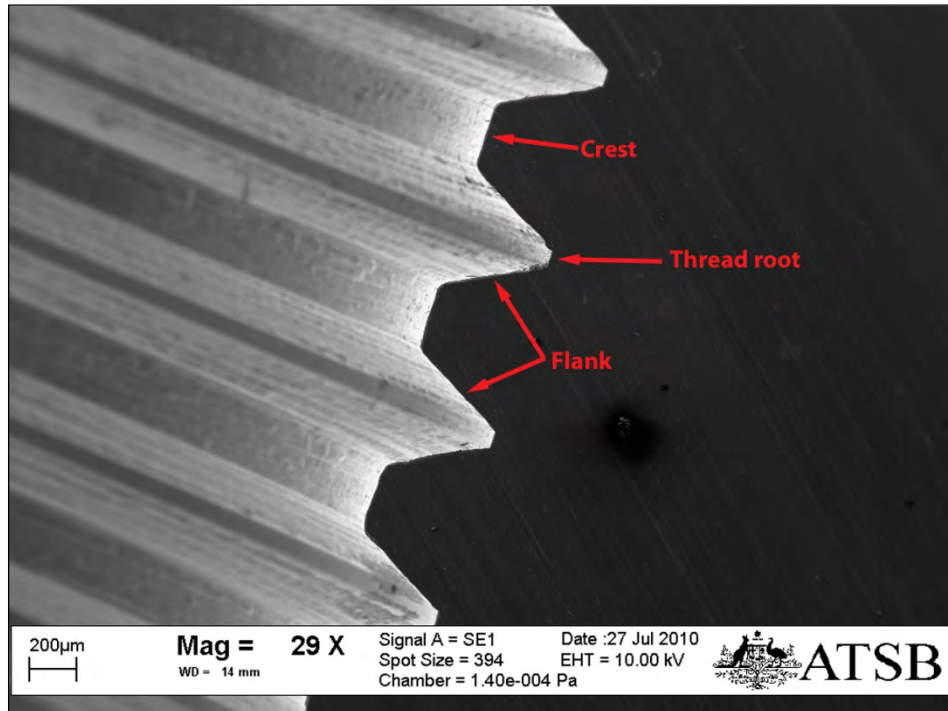
Figure A19: Scanning electron microscope image, showing the squared-crest profile of the internal threads of the splined adapter

An examination of the thread crests and flanks revealed evidence of minor plastic deformation of the surface (Figure A17 and A18); likely to be consistent with the general surface features associated with the thread forming process. Some evidence of galling/adhesive wear was observed on the thread flanks towards the surface in contact with the bolt head.

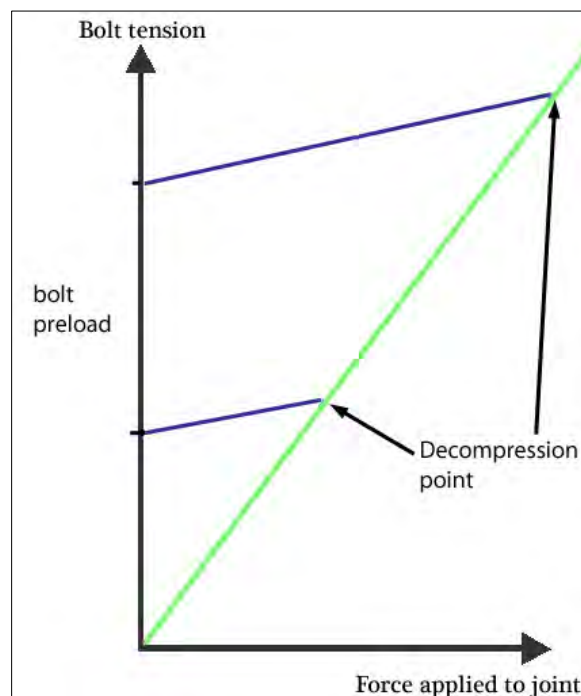
Figure A19: Graphical representation of affect of pre-load on strength of bolted joint

Bolts are usually tightened by applying rotational torque to the head or nut, with the spiral thread form causing the bolt to stretch. This stretching results in bolt tension or preload, which is the clamping force that holds a joint together. High preload tension helps keep bolts tight, increases joint strength, creates friction between parts to resist shear and improves the fatigue resistance of bolted connections (Figure A19). Further, the joint will not be vulnerable to fatigue cracking until the cyclic operational stresses increase above the original applied preload, i.e., above the decompression point in Figure A19. That is, the higher the bolt preload, the more force can be applied to the joint before the decompression point is reached.

Joints with insufficient bolt torque (and thus tension) can result in a loss of compression during service. This may result in loosening of fasteners under conditions of cyclic loading and reduction of fastener fatigue life. A common location for bolt failure in this situation is directly under the bolt head.
