Aviation Short Investigation Bulletin: Third Quarter 2011

Issue 7

Aviation Short Investigations AB-2011-128 Final

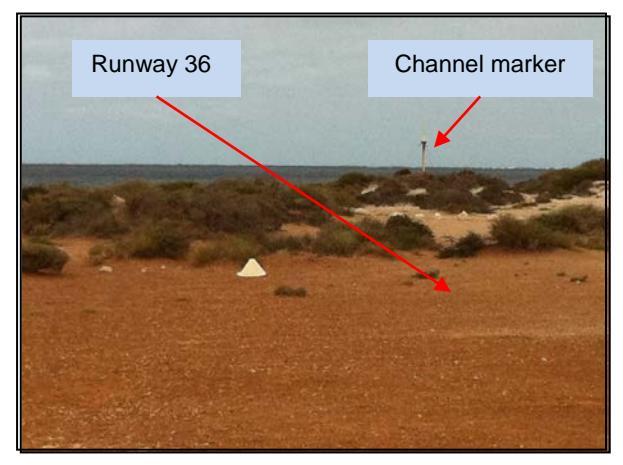
#### Figure 2: Channel marker

The channel marker provided navigational guidance for vessels operating into the anchorage and jetty area located on the eastern side of the Island. The marker, which was about 2.8 m in height, was located to the south-west of the runway<sup>3</sup> (Figure 2). The pilot stated that, while the marker was positioned to the left of the runway centreline, it was reasonably visible when on final approach.

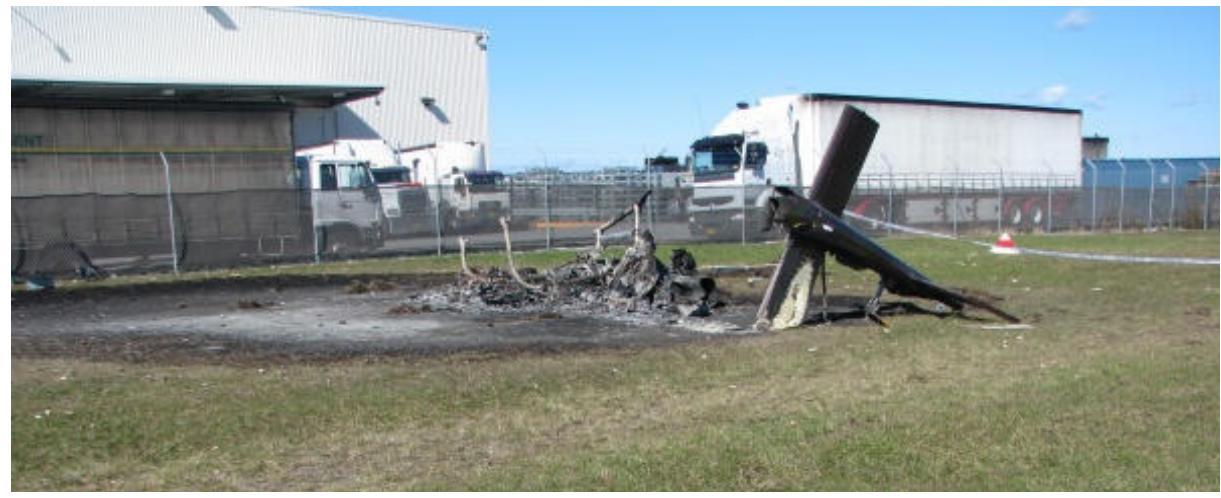
The ATSB did not attend the accident site, or examine the wreckage to assess the likelihood of a mechanical malfunction. The ATSB did, however, review maintenance documentation for the helicopter which confirmed there were no known problems with the flight controls or systems that may have affected yaw axis directional control. Based on the prevailing winds at the time and that the helicopter was in a stationary hover, the ATSB considered that XXW was in conditions conducive to loss of tail rotor effectiveness.
