ATSB TRANSPORT SAFETY REPORT
Aviation Occurrence Investigation
AO-2008-084
Final

**In-flight breakup
PZL M18A Dromader, VH-IGT
58 km SW of Nyngan, NSW
29 December 2008**

The investigation found that the outboard 1.8 m of the right wing separated from the aircraft resulting in a loss of control and subsequent impact with the terrain. The separation of the right wing section could not be conclusively attributed to any particular factor.

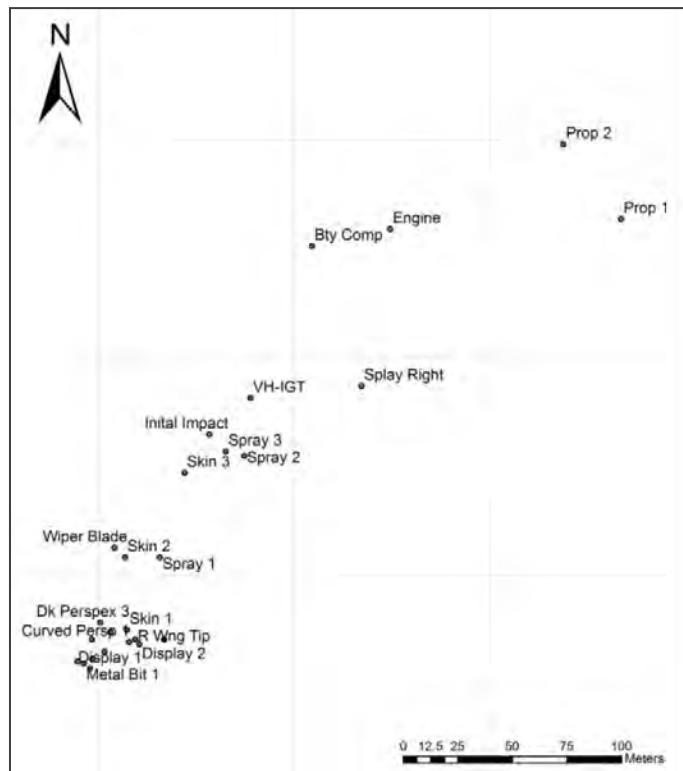
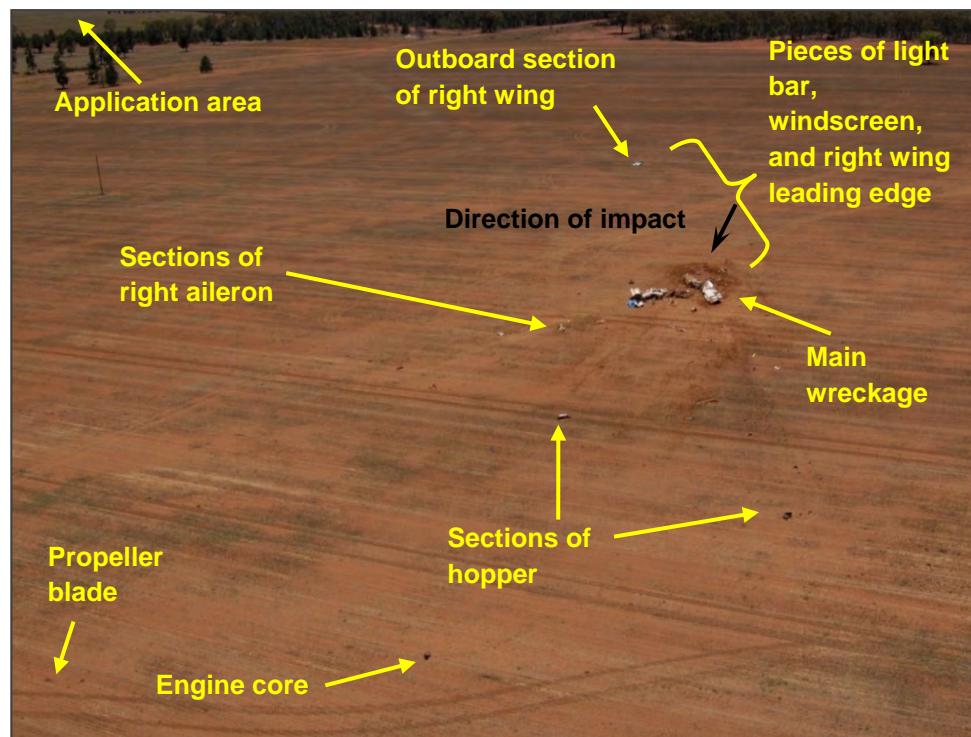
The wreckage trail extended for about 330 m in a north-easterly direction; starting with a group of items that included perspex from the cockpit, the lightbar and the outboard section of the right wing. The last item beyond the main wreckage was a propeller blade (Figure 17 and 18).

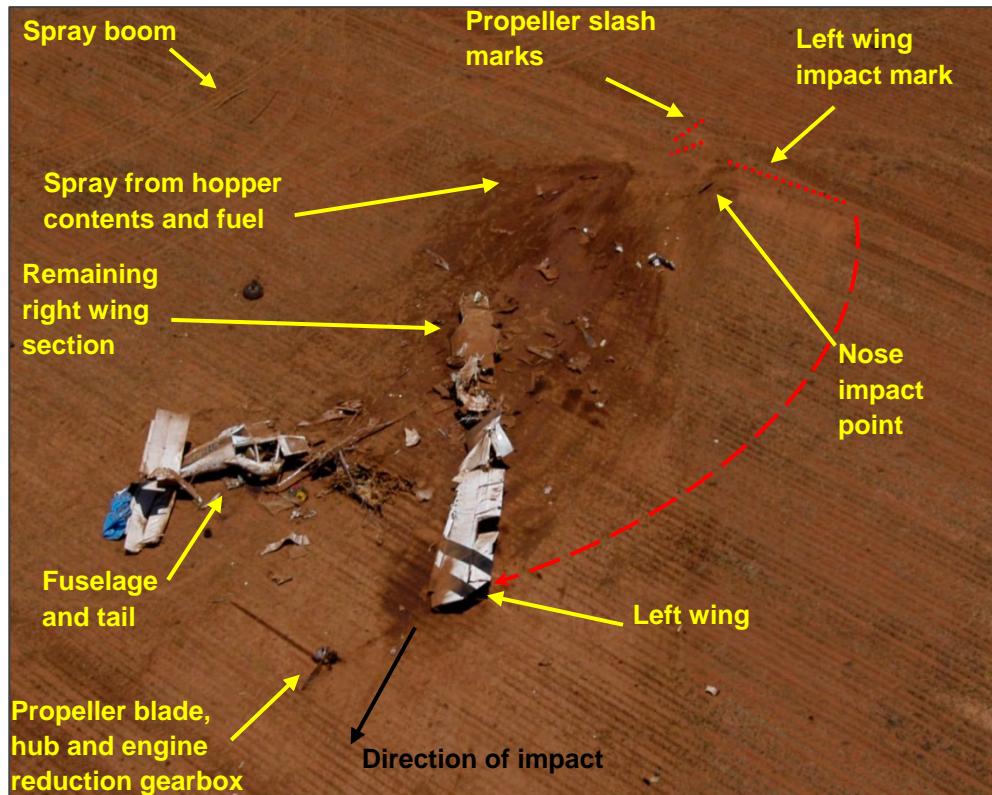
Figure 19: Main wreckage

The main wreckage was located about 100 m from the outboard section of the right wing. The immediate area around the main wreckage contained most of the

remaining aircraft parts (Figure 19), with the exception of sections of the hopper, the engine core and two propeller blades.

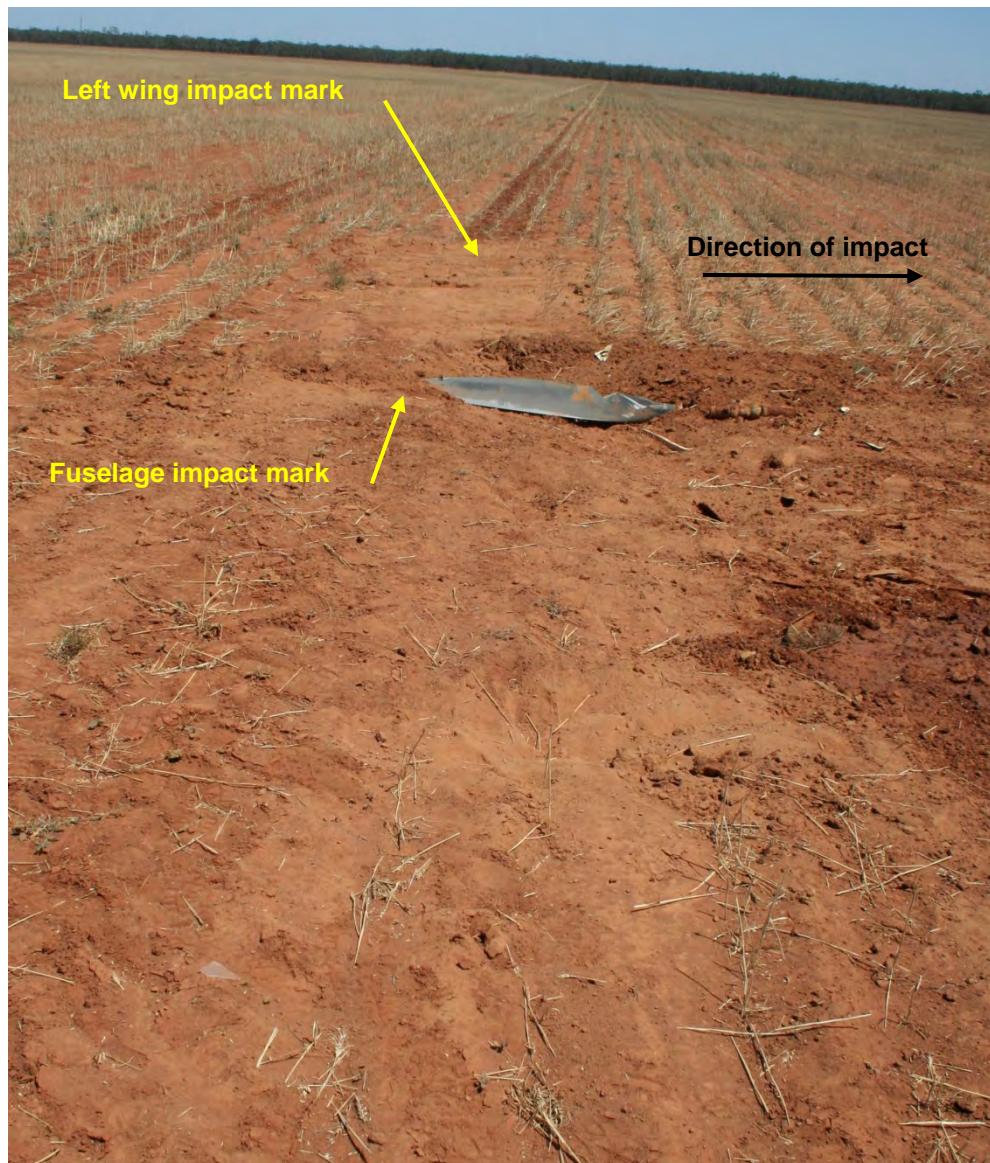
Figure 20: Impact point

Ground impact marks and damage to the wreckage indicated that the aircraft was rotating about its longitudinal (rolling) and vertical axis (yawing) just prior to ground impact (Figure 20), which was consistent with the witness reports. When the aircraft impacted the ground, the left wing, remaining section of right wing, engine, propeller, hopper, right aileron and flap separated from the aircraft due to impact forces. The fuselage and tail rotated over the top of the wings and came to rest facing in a westerly direction.

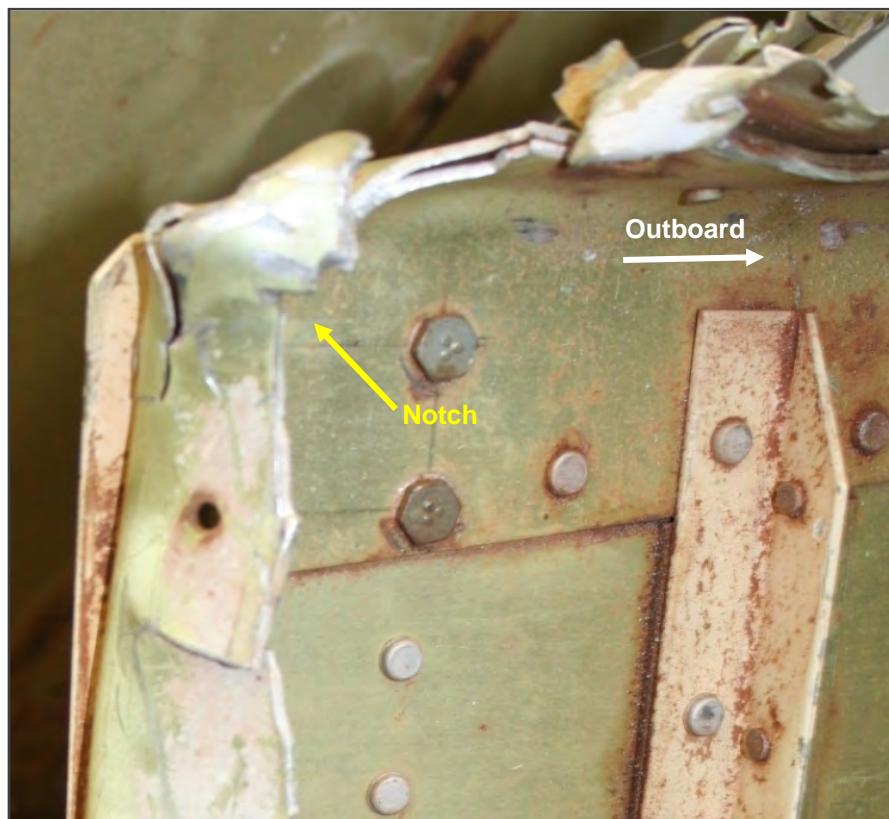
Figure 27: Upper spar cap of right wing outboard section

There was no evidence of any pre-existing cracking, mechanical or corrosion damage that could have compromised the overall strength of the wing. Wrinkles were identified at several locations along the upper spar cap that were consistent with a compression loading 'buckling' the cap material. The web material was folded rearwards, such that it was almost bent back on itself, and there was a square notch out of the material in the upper cap that was consistent in size and shape with the outboard end of the heavy angle on the upper cap (Figure 27).

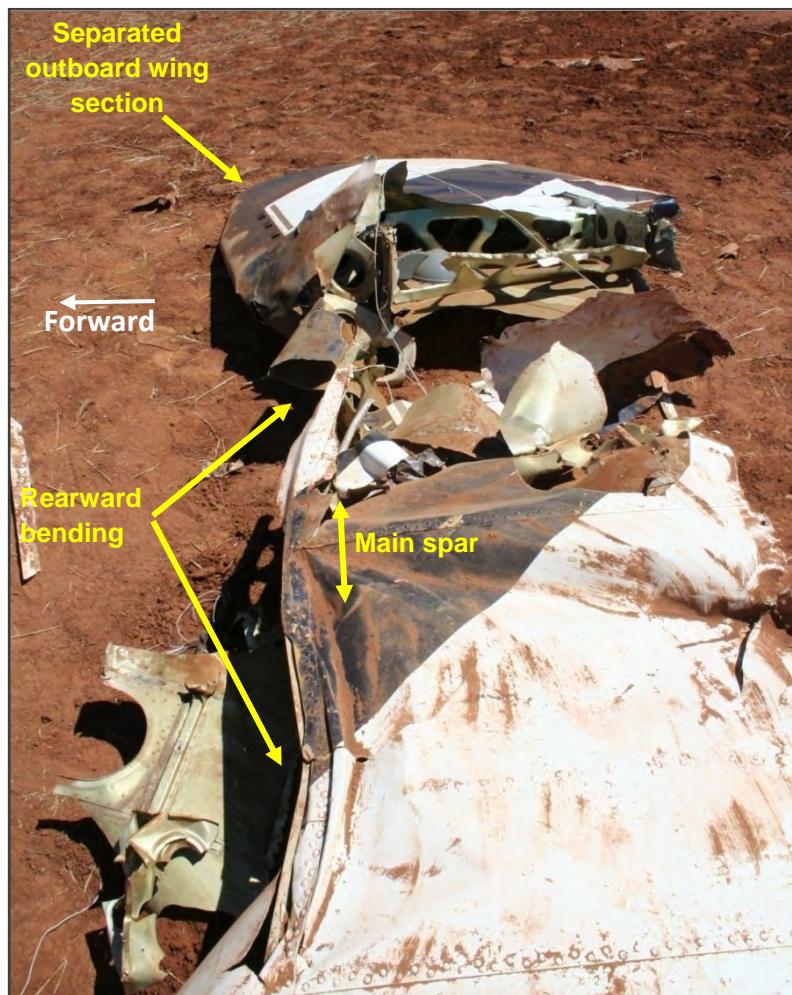
Figure 28: Right wing main spar (top view) with separated section shown placed in close proximity

The inboard section of main spar was exposed where the leading edge had separated. The upper spar cap was permanently deformed such that the exposed length had an 'S' shape (Figure 28). This shape was formed by the upper cap bending rearwards at two points. The lower spar cap did not have the same rearwards bending at the inboard point, instead presenting a slight upward bending deformation (Figure 29).

The rearward bending about 1 m inboard of the tip of the remaining inboard spar was present in the upper spar cap only (Figure 29). This was more consistent with the upper spar cap buckling under upward bending, rather than from striking an object that only contacted the upper spar cap.

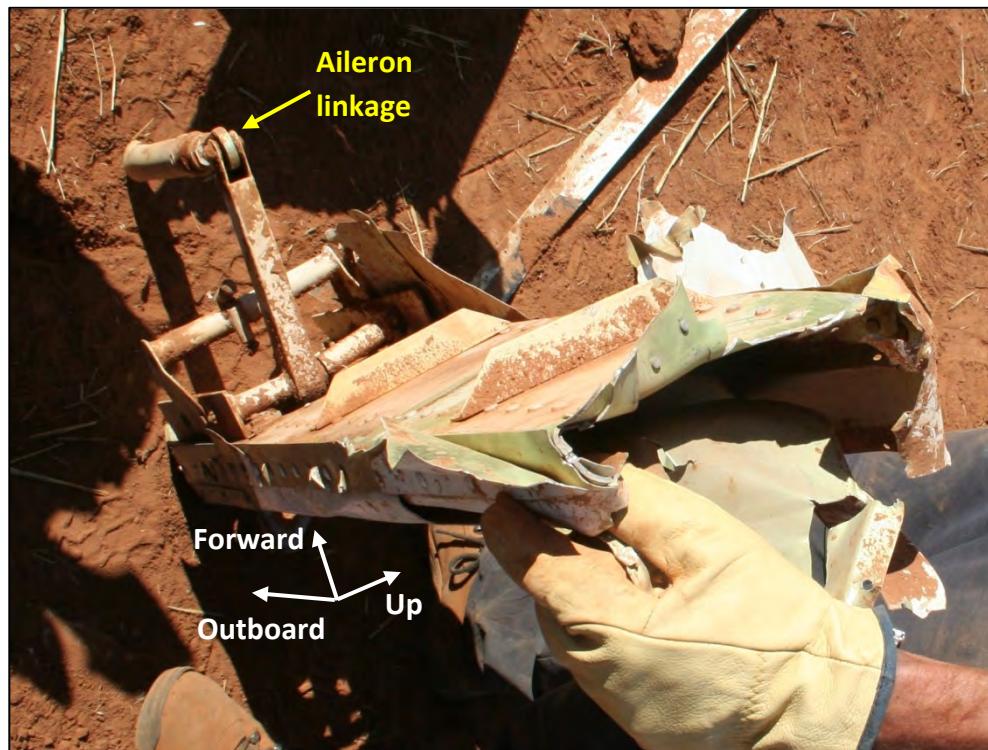
Figure 32: Rear spar section looking along its length from the inboard fracture

The section of rear spar attached to the aileron was examined on site. The rear spar fractured in two locations, directly behind the main spar fracture and near the inboard aileron attachment point. The section was straight and did not contain any damage that would indicate a point load (Figure 32). The spar section also contained a portion of the aileron control system. The outboard fracture surface was consistent with an upward bending overstress and was approximately in line with

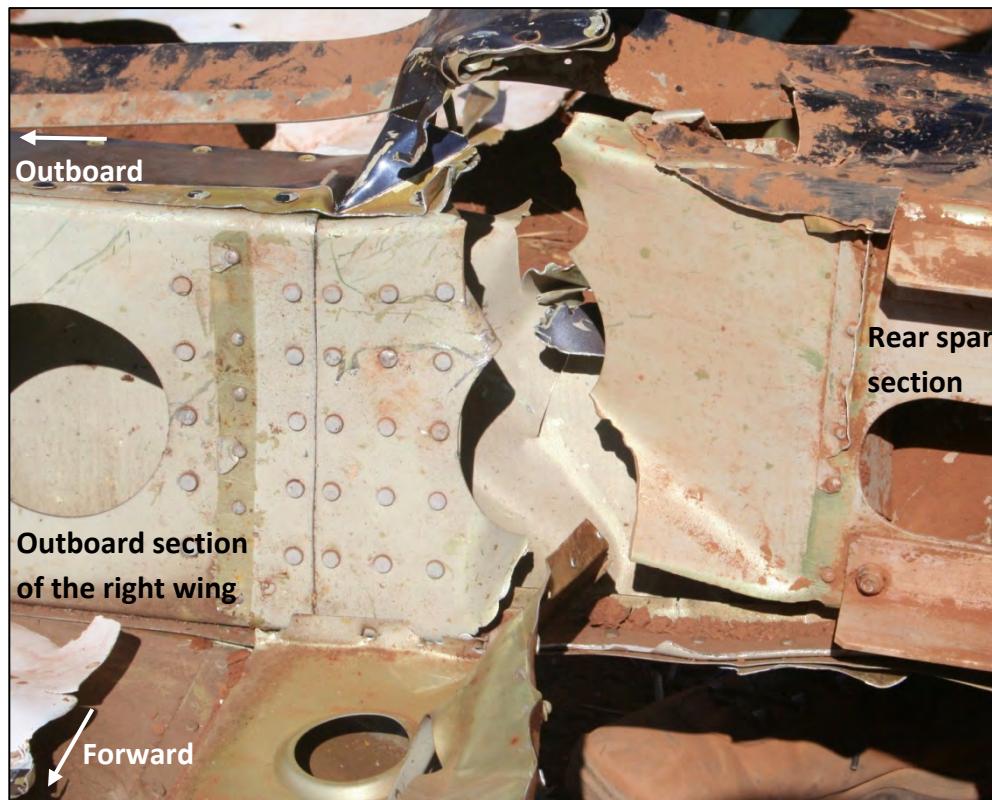
Figure 33: Rear spar looking rearward at the outboard fracture point

the main spar fracture (Figure 33). The inboard fracture contained damage that was of a mixed mode, but showed predominantly upward bending (Figure 34).

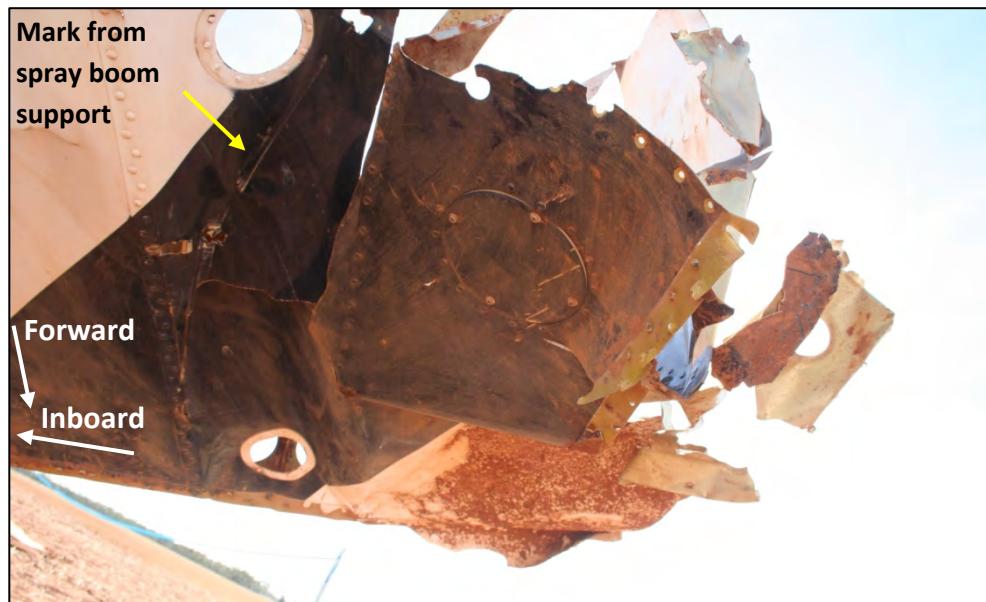
Figure 35: Underside of the inboard wing section at the primary fracture

The underside of the right wing was examined on site. All of the skin was present and the outboard skin fracture corresponded to the skin fracture on the detached wingtip section. The damage to the lower wing skin that was just inboard of the primary wing fracture was consistent with the outboard spray boom support structure being forced upward and outboard during the ground impact (Figure 35).

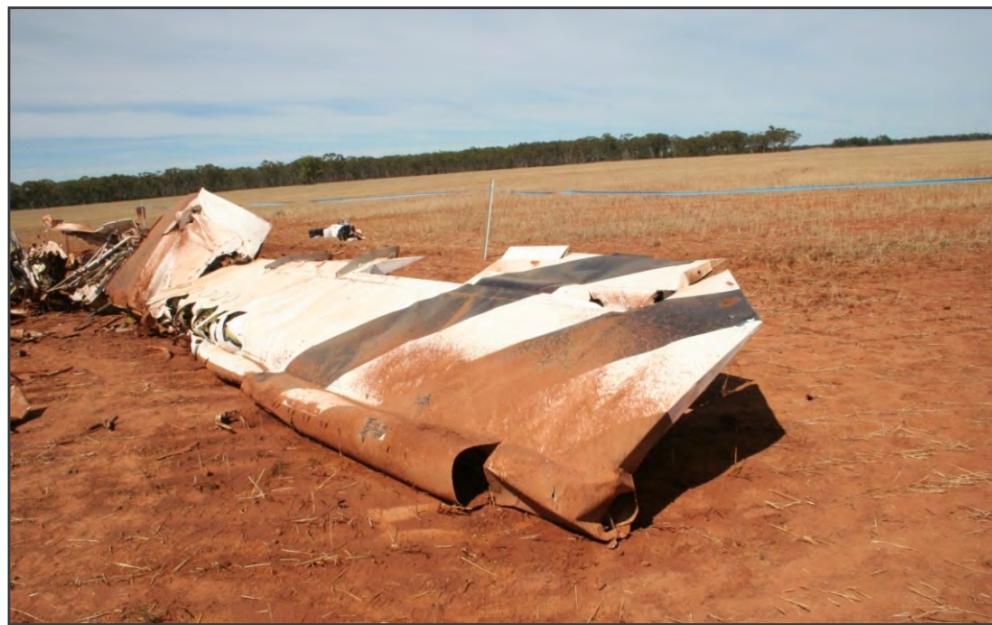
Figure 37: Left wing

The left wing leading edge crush damage indicated that it impacted the ground at greater than 40° nose-down (Figure 37). Red glass fragments from the left wingtip navigation light were located at the initial impact point. The wing was intact and all of the damage sustained by the wing was consistent with the impact with the ground.

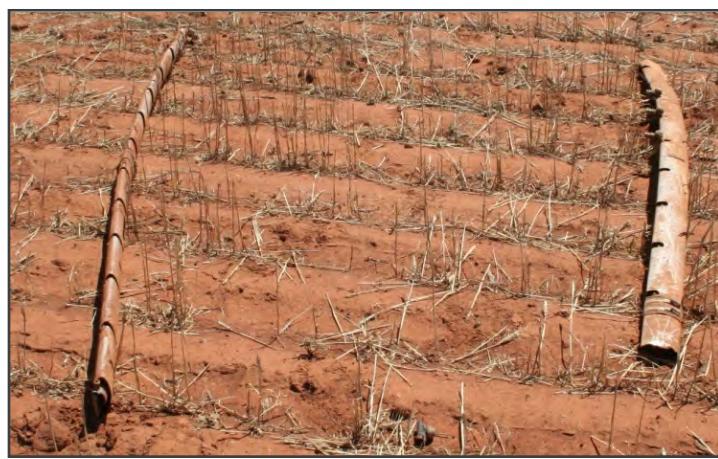
Figure 38: Spray boom

The spray boom was broken into three sections. One was located at the main wreckage site, between the left wing and fuselage, and was a complete side from the inboard junction to the tip. The other two sections were located close to the right of the impact point, and comprised two sections of another complete side. The spray boom had a general bending in a vertical plane (Figure 38). All of the damage to the boom was consistent with the ground impact with no evidence of a concentrated (point) contact.

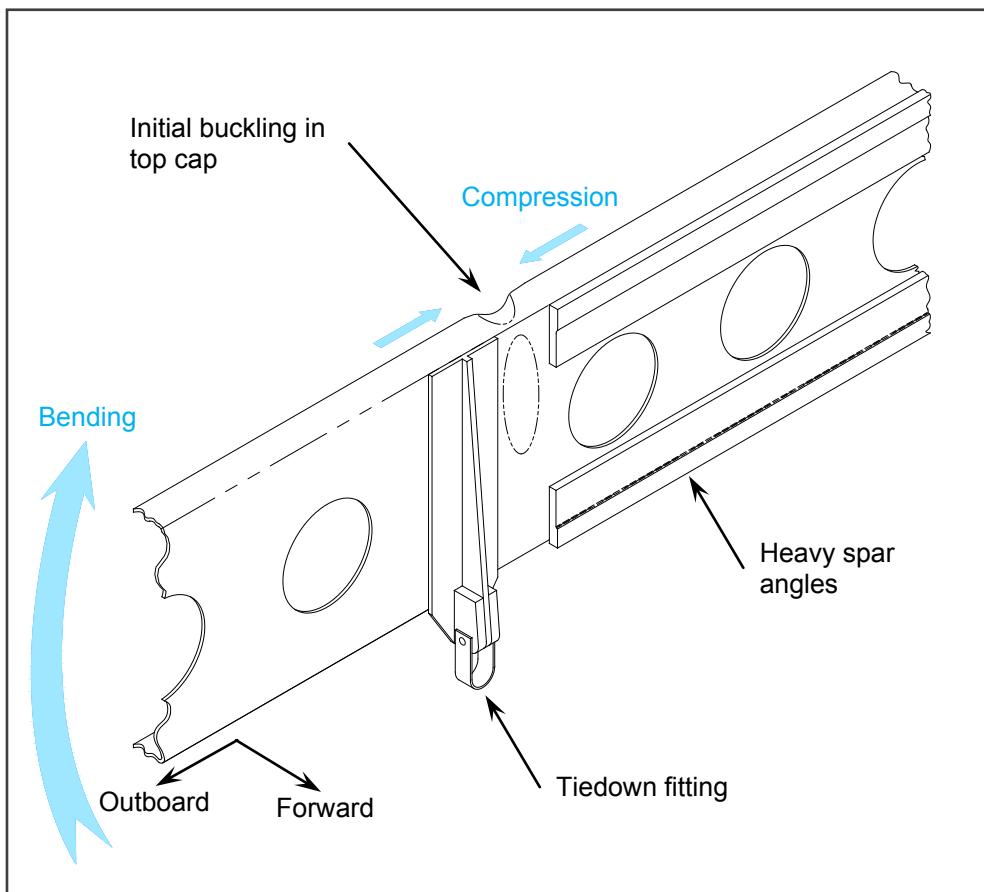
Figure 40: Initial failure of main spar

The failure of the right main wing spar commenced with a localised buckling of the folded sheet C-section between the end of the upper heavy spar angle and the tiedown fitting (Figure 40). A buckling failure is an unstable failure, which means that the strength of the wing was suddenly and significantly reduced, and while the upward load was present the wingtip was able to rotate upward, effectively unhindered. There was no pre-existing damage identified that would have reduced the strength of the spar prior to the buckling. Thus, the buckle was likely a result of a compression load, and hence upward bending load that exceeded the strength of the spar.

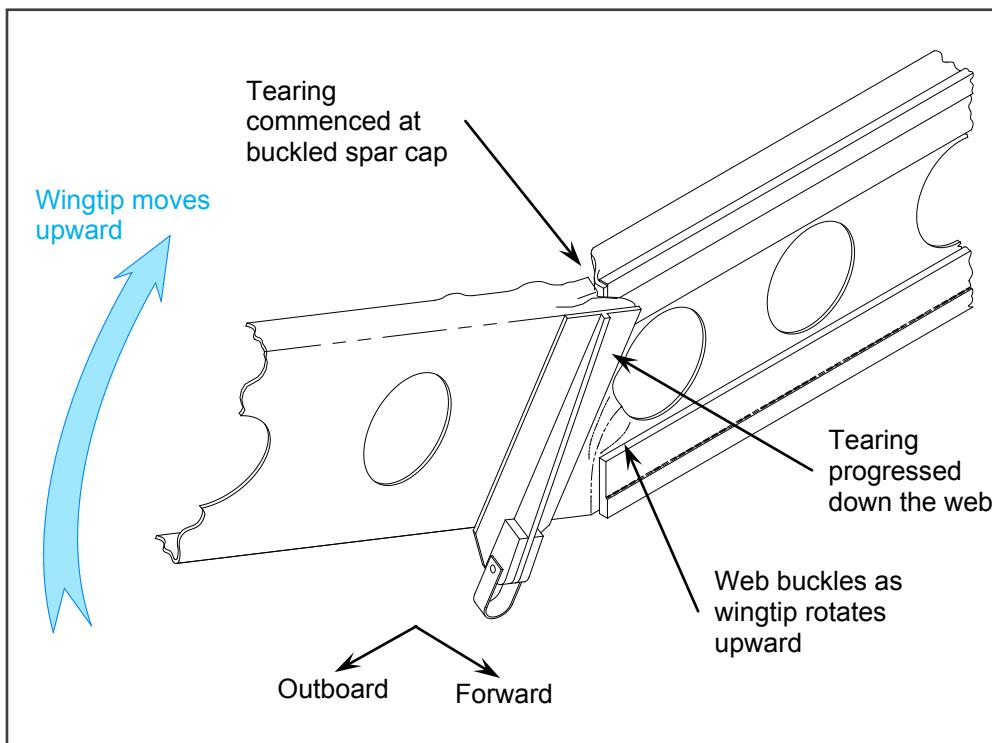
As the upward displacement of the wingtip increased, and deformation at the buckle increased, the material began to tear. The tearing progressed down the web until it reached the lower cap (Figure 41 and 42), at which point the wingtip separated from the wing. The outboard section of main spar slipped forward of the inboard section and rotated about the lower spar cap. Sections of skin that were still attached to the outboard section scraped down the inboard section leaving the scoring identified in Figure 31.

Figure 41: Progressive tearing of the main spar

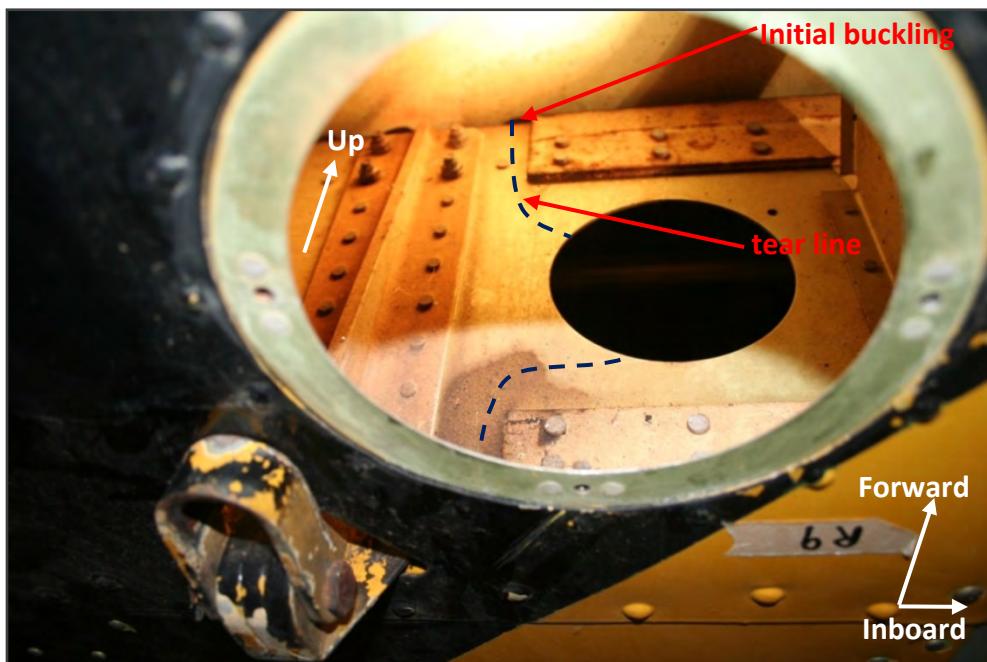
Figure 42: Main spar web tear line

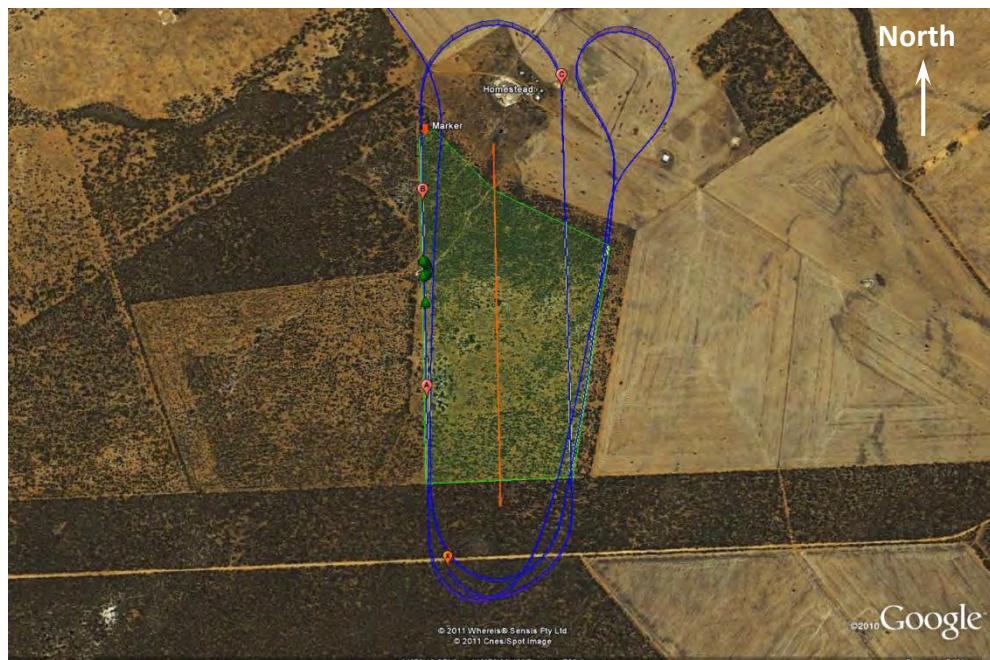
The next expected swath in the racetrack pattern would have been swath #21, which would have been located approximately down the centreline of the field (Figure 43).

Figure 43 : Approximate location of next swath (#21, indicated by the orange line)

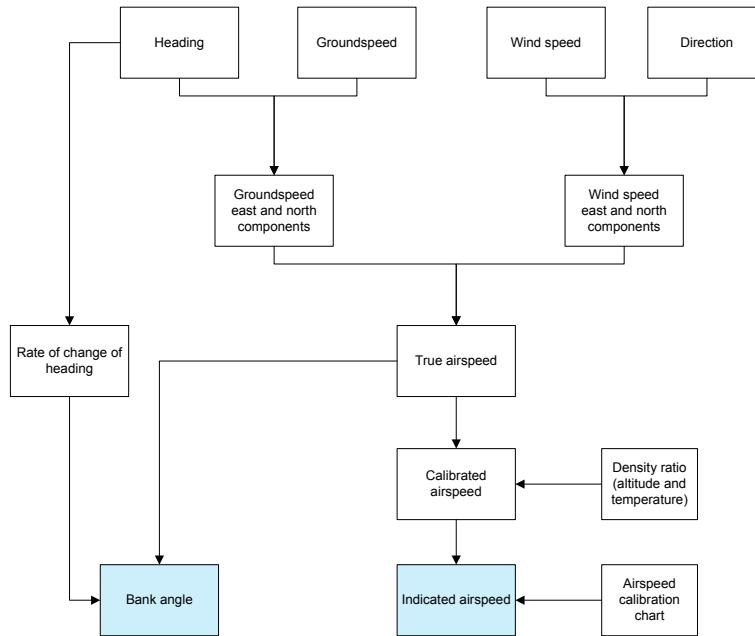
The SATLOC GPS data was used to estimate the indicated airspeed and bank angles during the flight to enable a comparison of the aircraft's operating regime and the operating limitations. The methodology used to convert the data is shown in Figure A1.

Figure A1: Conversion of SATLOC data to indicated airspeed and bank angle

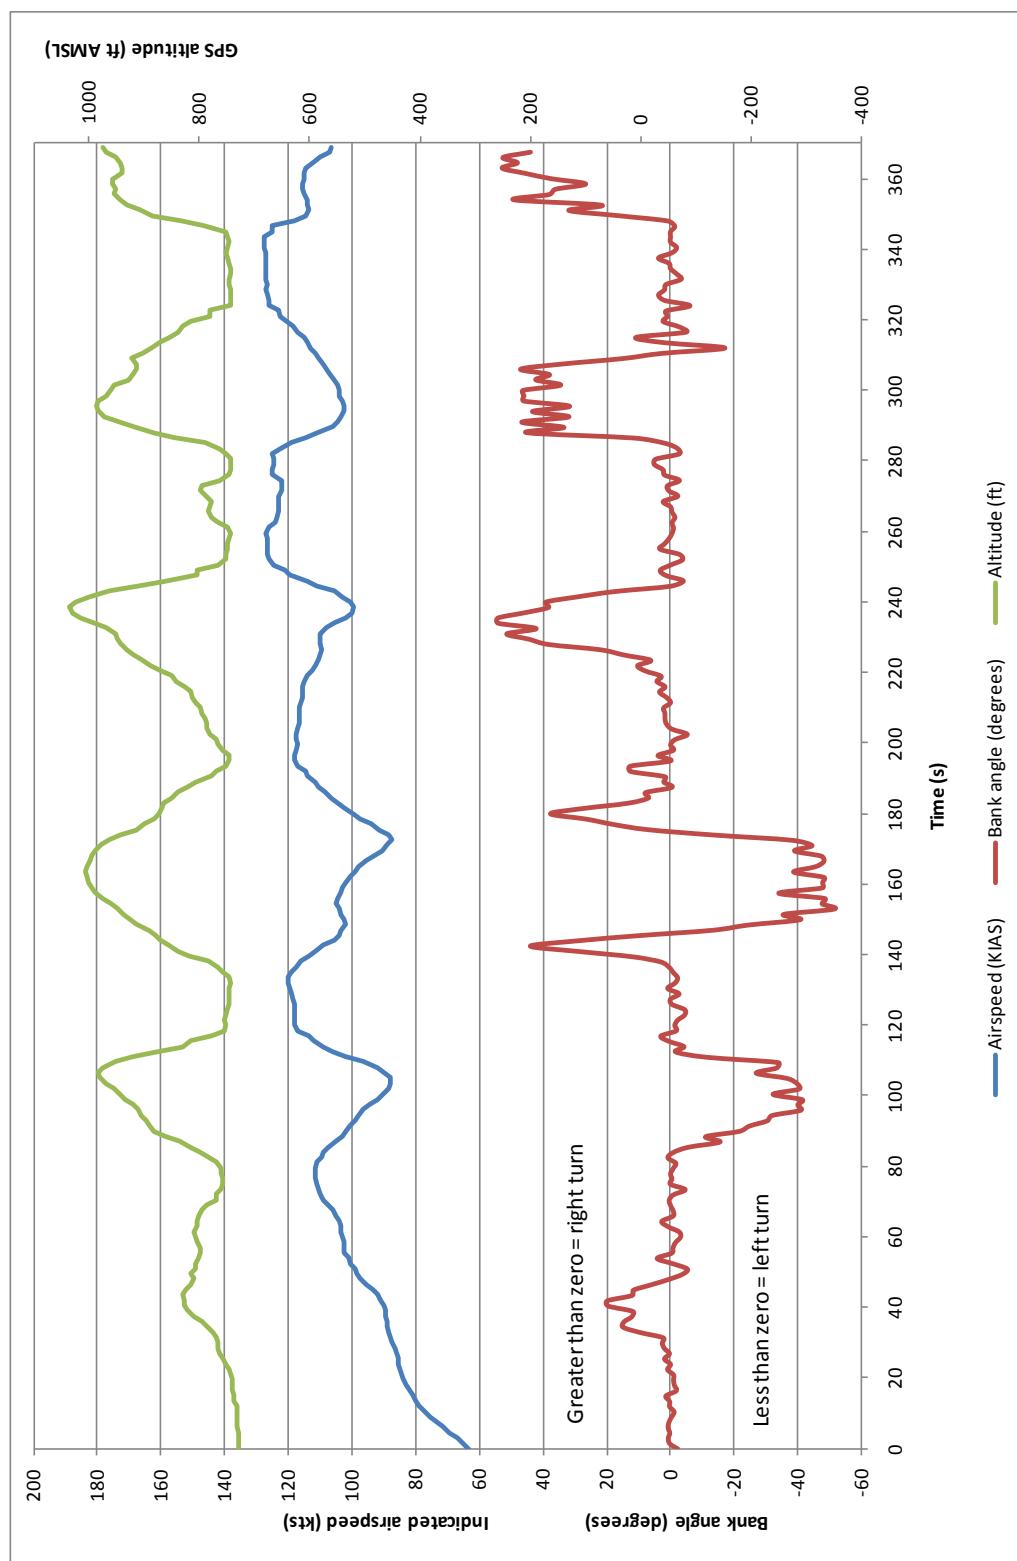
The derived bank angles for the flight are presented in Figure A2, together with the altitude data that was taken directly from the SATLOC track data.

Figure A2: Recorded data from the accident flight

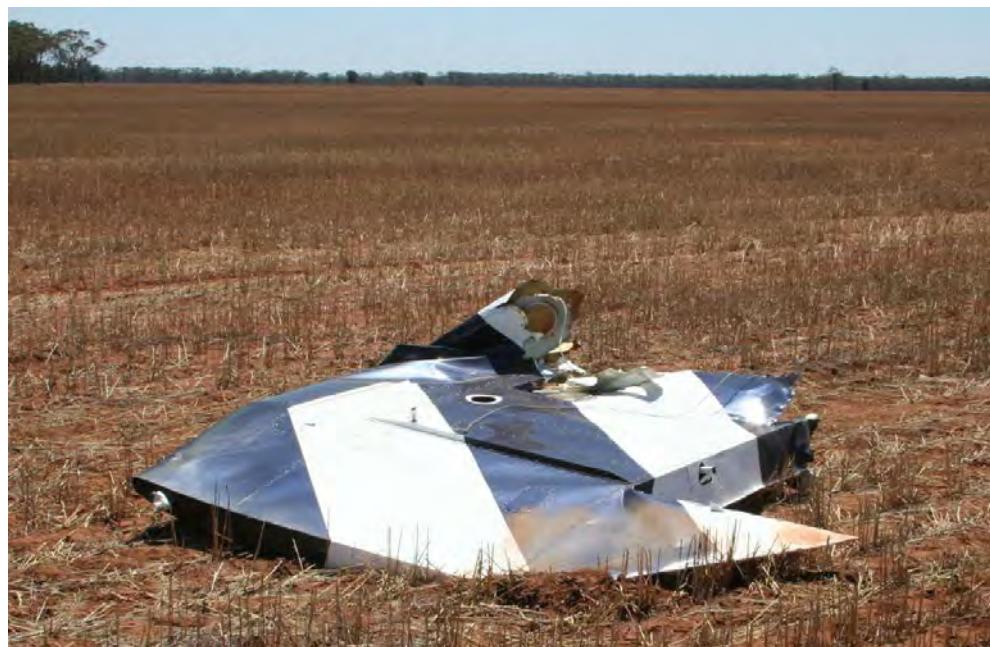
The outboard section of the right wing was located approximately 100 m before the fuselage impact point, and was the first item along the debris trail (Figure B1). Sections from the aircraft's hopper, the light bar and the pilot's canopy were also found before the main impact. The right aileron was found near the main wreckage, having broken into two sections along the same line as the wing failure.

Figure B1: Outboard right wing section - as found at the accident site

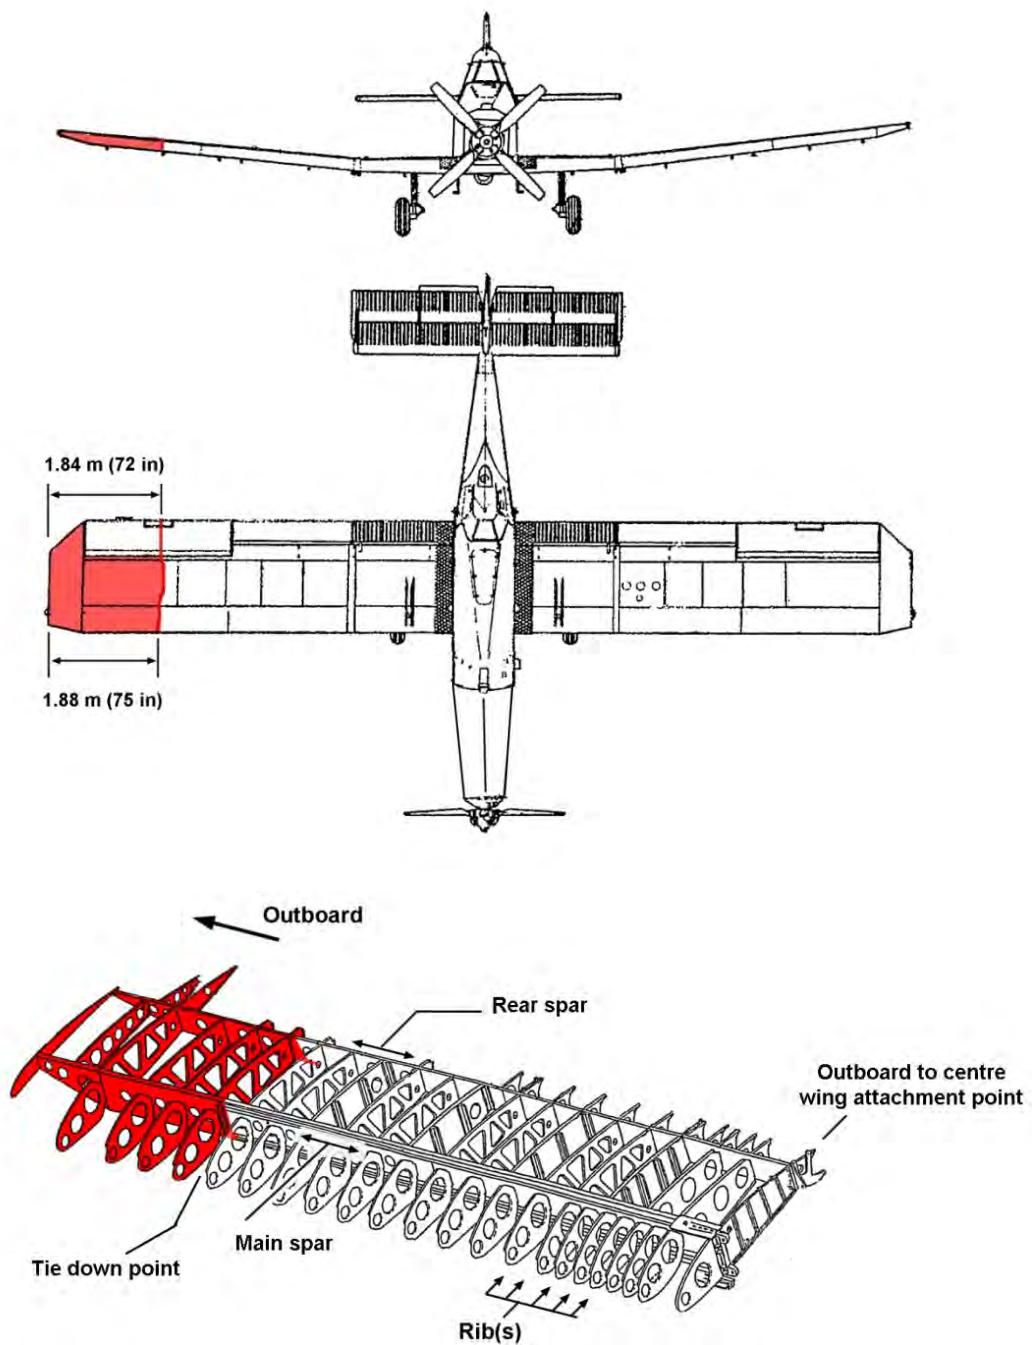
Figure B2: Illustration of the PZL M18A Dromader aircraft and wing structure depicting the approximate location of the in-flight wing separation

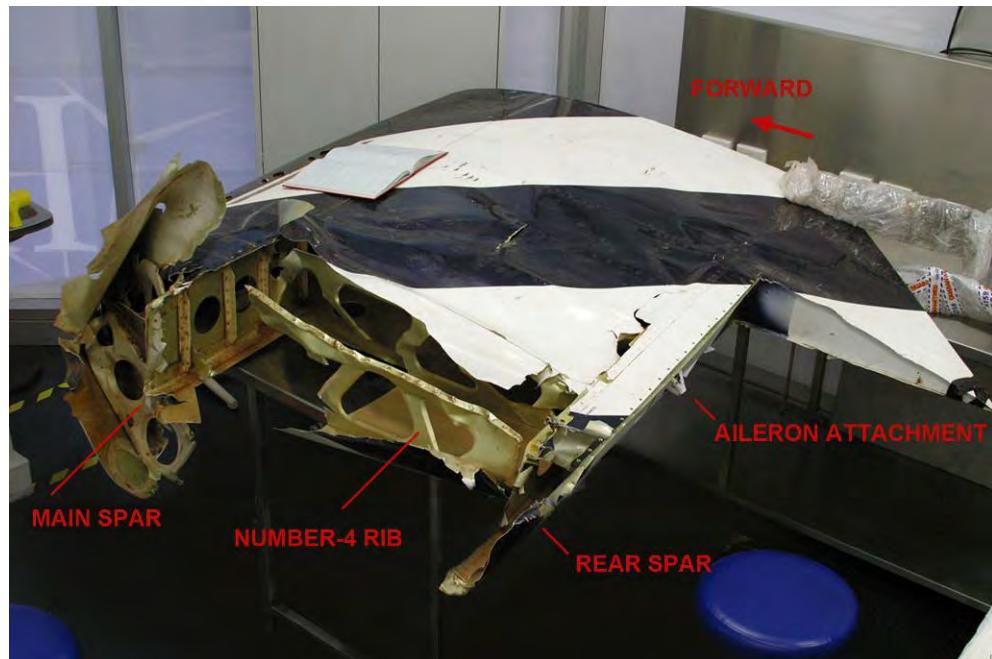
Figure B3: View of the separated right wing as received

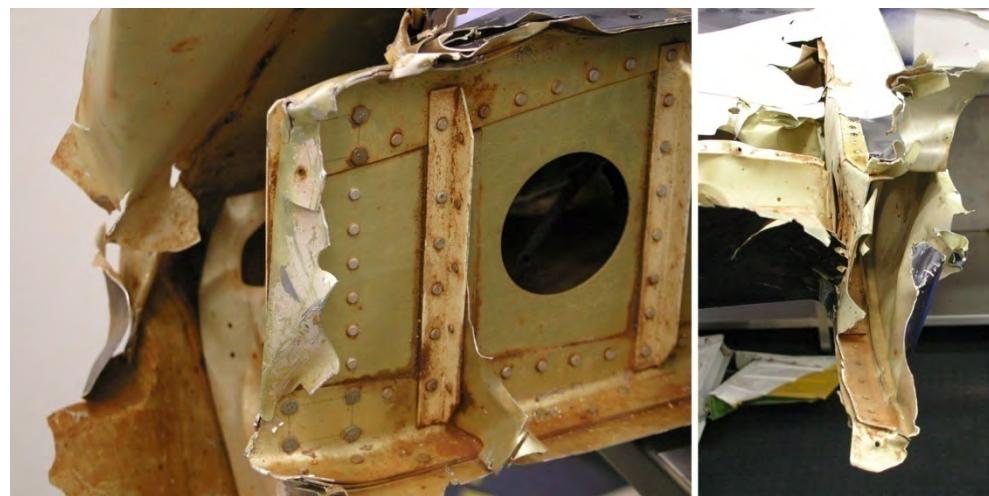
Figure B4: Composite image showing alternate views of the main spar (left) and rear spar (right) as received

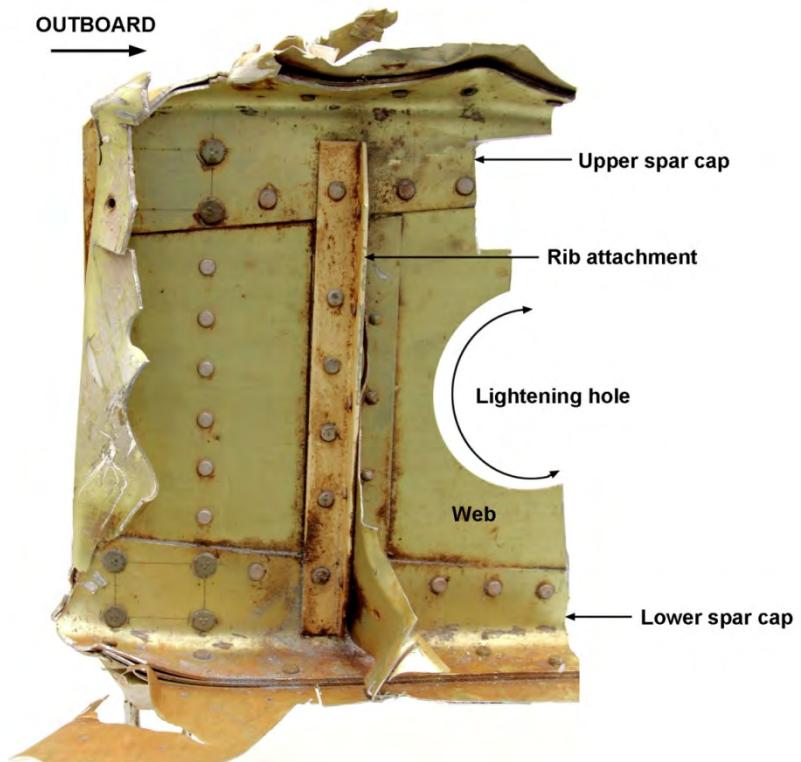
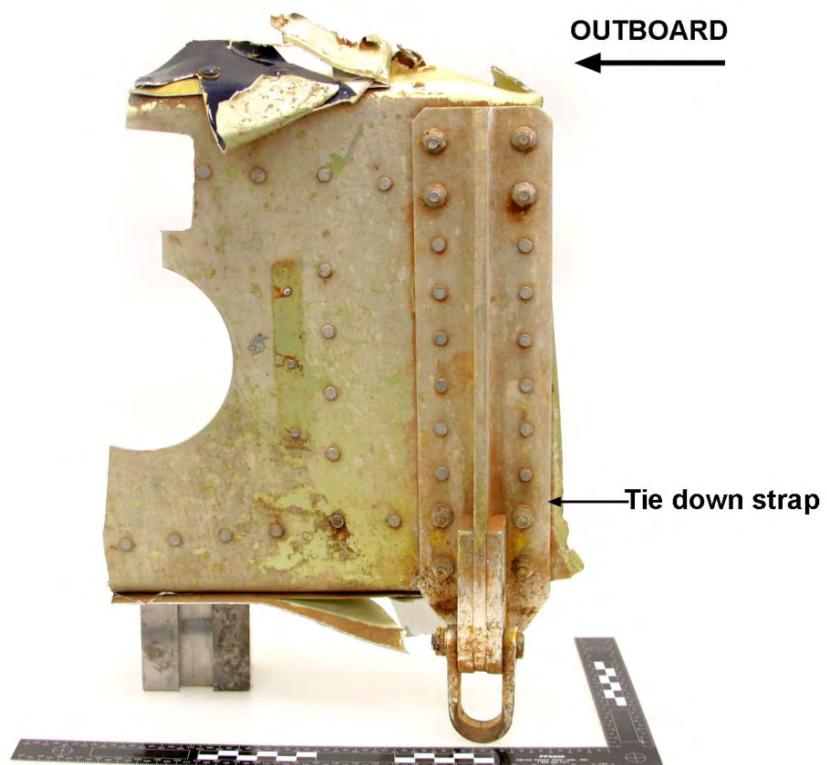
The main and rear spars formed the primary load bearing structure for the Dromader's wing. Visual examination of that structure showed that the point of fracture through the main spar was located slightly inboard of the front tie down strap (Figures B5 and B6). Measurements showed that the rear spar had fractured through the spar caps and web, approximately 200 mm inboard from the number-4 rib (Figures B7 and B8).

Figure B5: Segment of outboard main wing spar – view looking forward

Figure B6: Segment of outboard main wing spar – view looking rearward

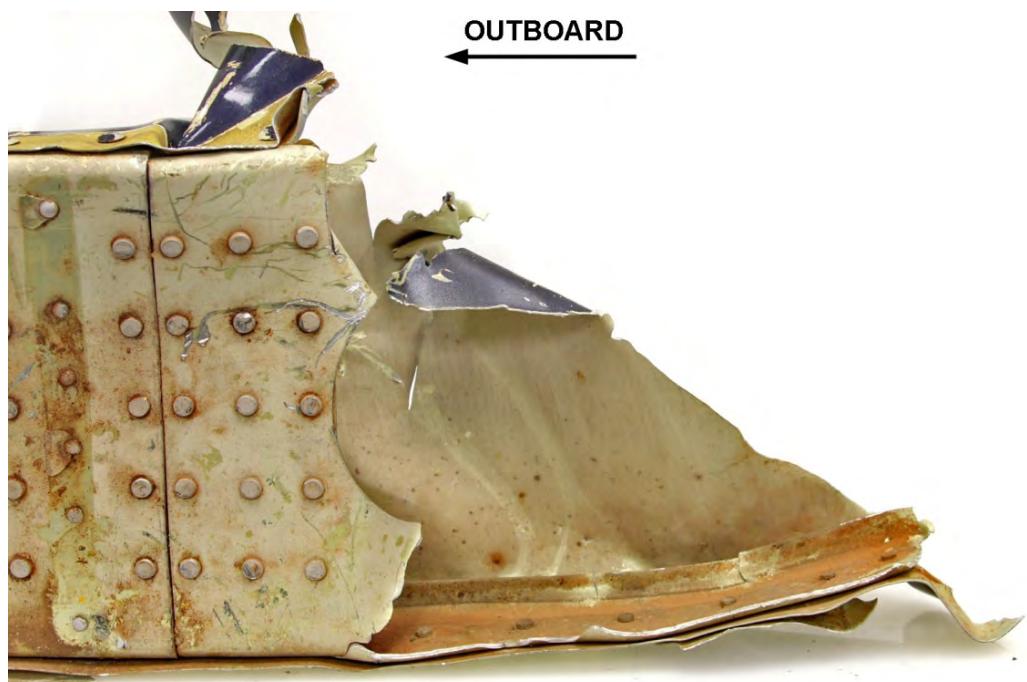
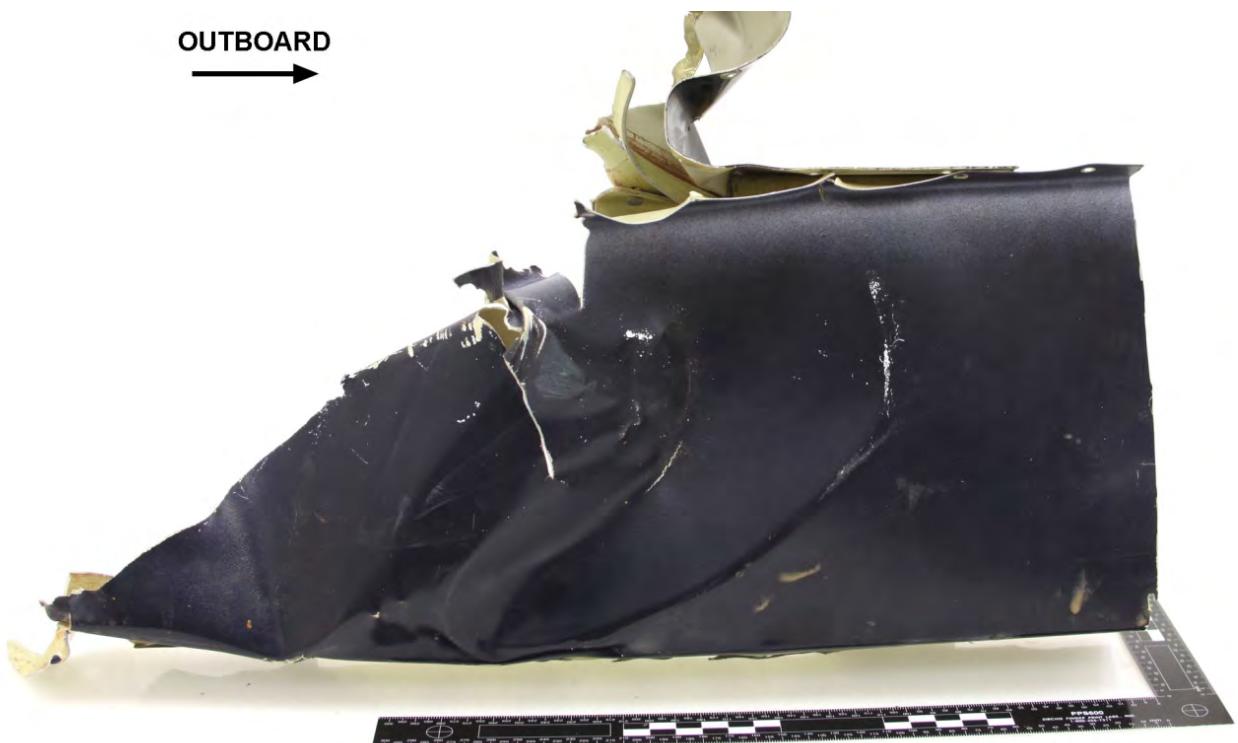
Figure B7: Segment of rear outboard wing spar – view looking rearward

Figure B8: Segment of rear outboard wing spar – view looking forward

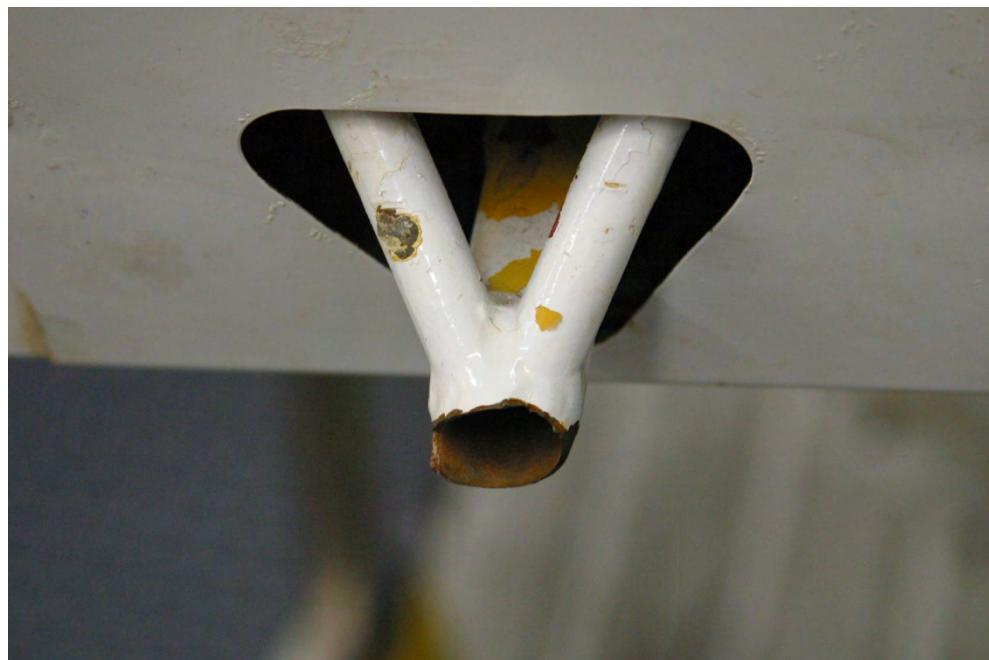
Figure B13: Right wing outboard aileron attachment point

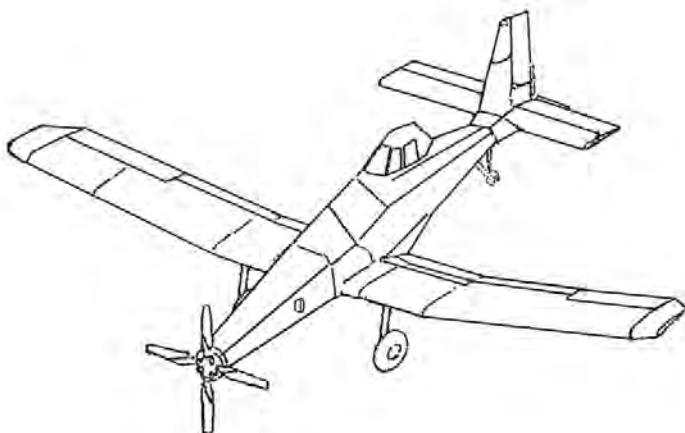
Figure B14: Illustration of the PZL M18A Dromader aircraft showing the primary failure sequence
