ATSB TRANSPORT SAFETY REPORT Rail Occurrence Investigation RO-2007-006 Final

# **Derailment of Freight Train 6413**

near Stewart, Western Australia

17 August 2007

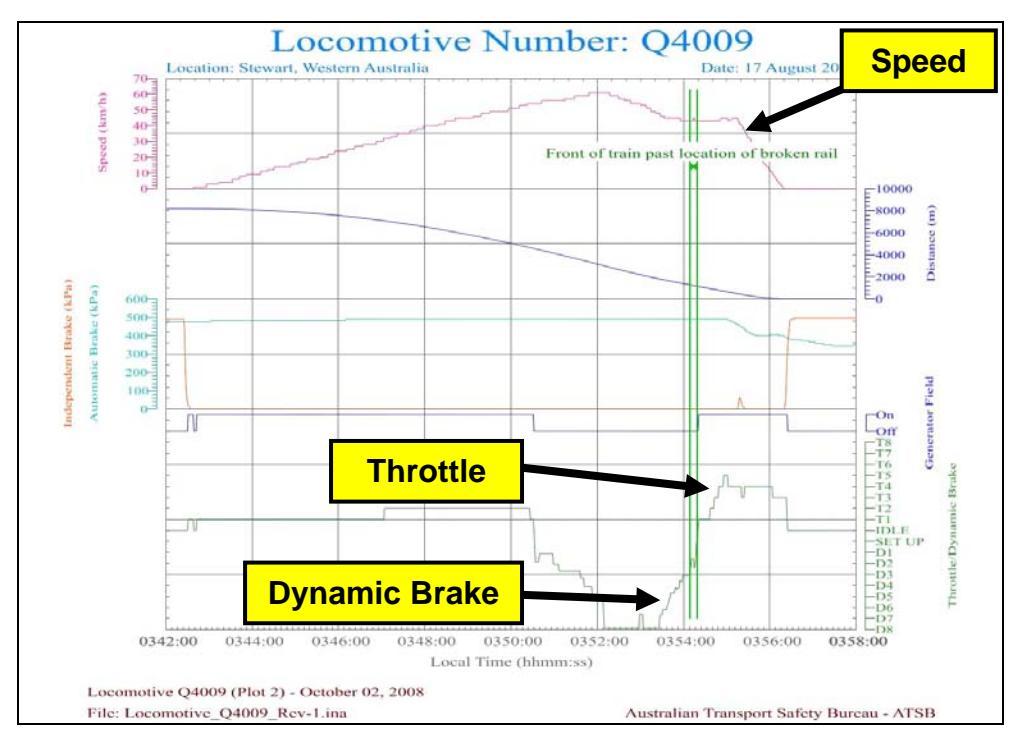
#### Figure 7: Extract from Q4009 locomotive data log, Stewart to 'Point of Derailment'

The locomotive data log for Q4009 (Figure 7) shows that after receiving the Proceed Order, the train steadily accelerated using throttle setting notch 1, followed by notch 2. The train accelerated to 50 km/h on a falling grade. At that time, dynamic braking was applied. The train continued to accelerate to a maximum speed of 60 km/h until the effects of the dynamic brakes combined with a change in track gradient slowed the train to 45 km/h. The dynamic braking was reduced to maintain this speed through the curve commencing at 497.45 km. As the lead locomotive exited the curve and the green indication of signal D598 came into view, the train driver throttled up and started to accelerate the train. Shortly after, the train driver felt a slight jerk and the brake air pipe pressure began dropping.

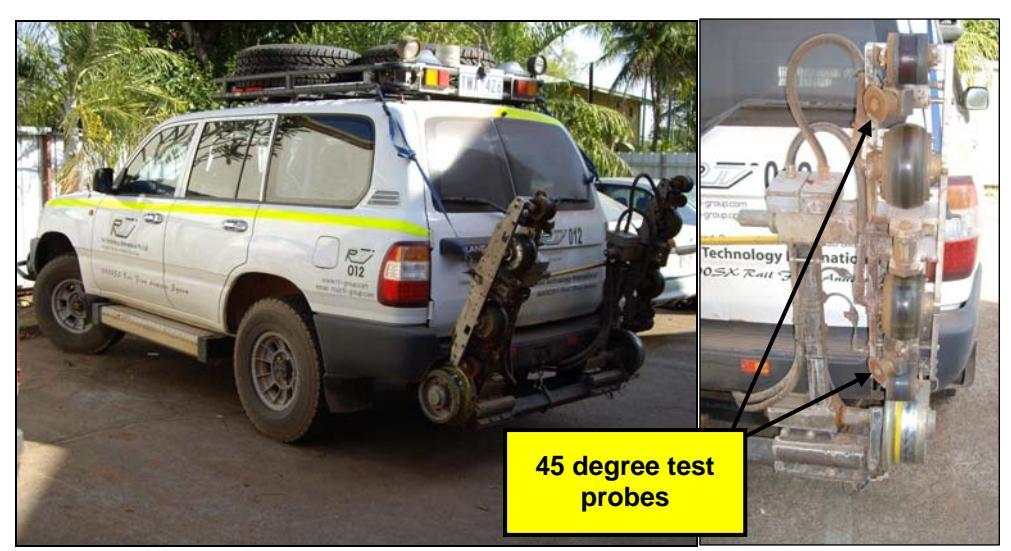
Figure 13: RTI Ultrasonic test car

The 2 x 45 degree lateral probes (Figure 13) are positioned to detect vertical split head defects in the rail, that is, cracks that are vertical and run within the head and web of the rail, parallel to the face of the rail. They are additional to the basic requirements of RTI's contract with WestNet Rail.

A review of the data collected by the ultrasonic on-track test car on 6 June 2007, revealed that a small vertical split head defect had been detected in the area most likely to have been near the point of derailment. At that time, the recording vehicle had reversed over this defect and re-tested it to ensure that the reading was not due to distortion or loss of signal arising from poor rail condition.
