# Aviation Short Investigation Bulletin Fourth Quarter 2011

Issue 8

Aviation Short Investigations  
AB-2012-019  
Final

| Report No. | Publication date | ISBN |
|---|---|---|
| AB-2012-019 | 14 March 2012 | 978-1-74251-249-5 |

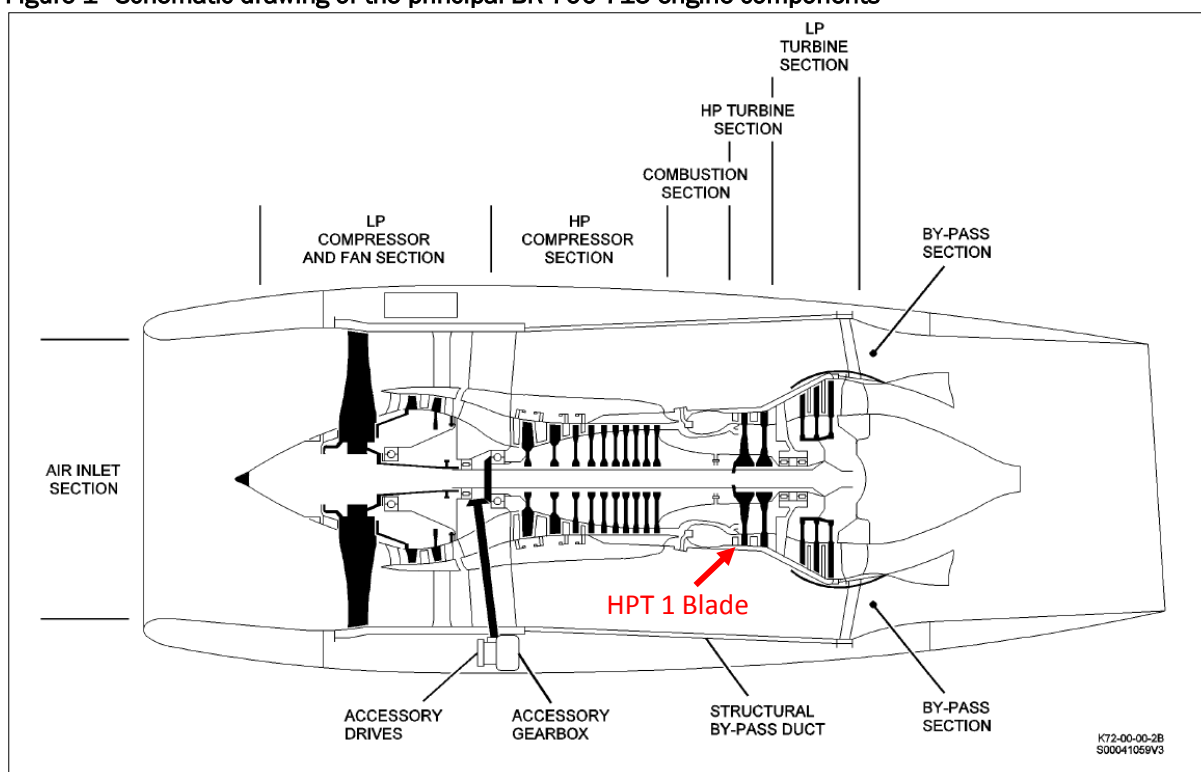
**Figure 1 Schematic drawing of the principal BR 700-715 engine components**

The aircraft was fitted with two Rolls-Royce BR 700-715 series engines. A subsequent examination of the left engine revealed metallic debris in the tailpipe and physical bulging of the high-pressure turbine (HPT) module. A detailed internal (borescope) inspection confirmed multiple failures of high-pressure turbine, stage-1 (HPT1) blades, with subsequent, downstream damage through to the third stage of the low-pressure turbine (LPT, Figure 1). Damage upstream of the HPT1 blades at the nozzle swirler inlet and nozzle guide vanes was also found. The engine was then shipped to the manufacturer for a teardown examination, which was witnessed by the BFU (German Federal Bureau of Aircraft Accident Investigation) on behalf of the Australian Transport Safety Bureau (ATSB).

During the teardown examination, the LPT section proved difficult to remove due to case deformation. In the HPT module, four of the second stage blades had failed at  $\frac{1}{3}$  or  $\frac{1}{2}$  their height. All of that stage's blade shrouds were missing. Examination of the first stage of the HPT module found all of the blades had fractured. Further observation identified that only one HPT1 blade had fractured below its root platform (Figure 2). Microscopic examination revealed that blade's failure had initiated at the inner shank wall on the pressure side<sup>4</sup>.

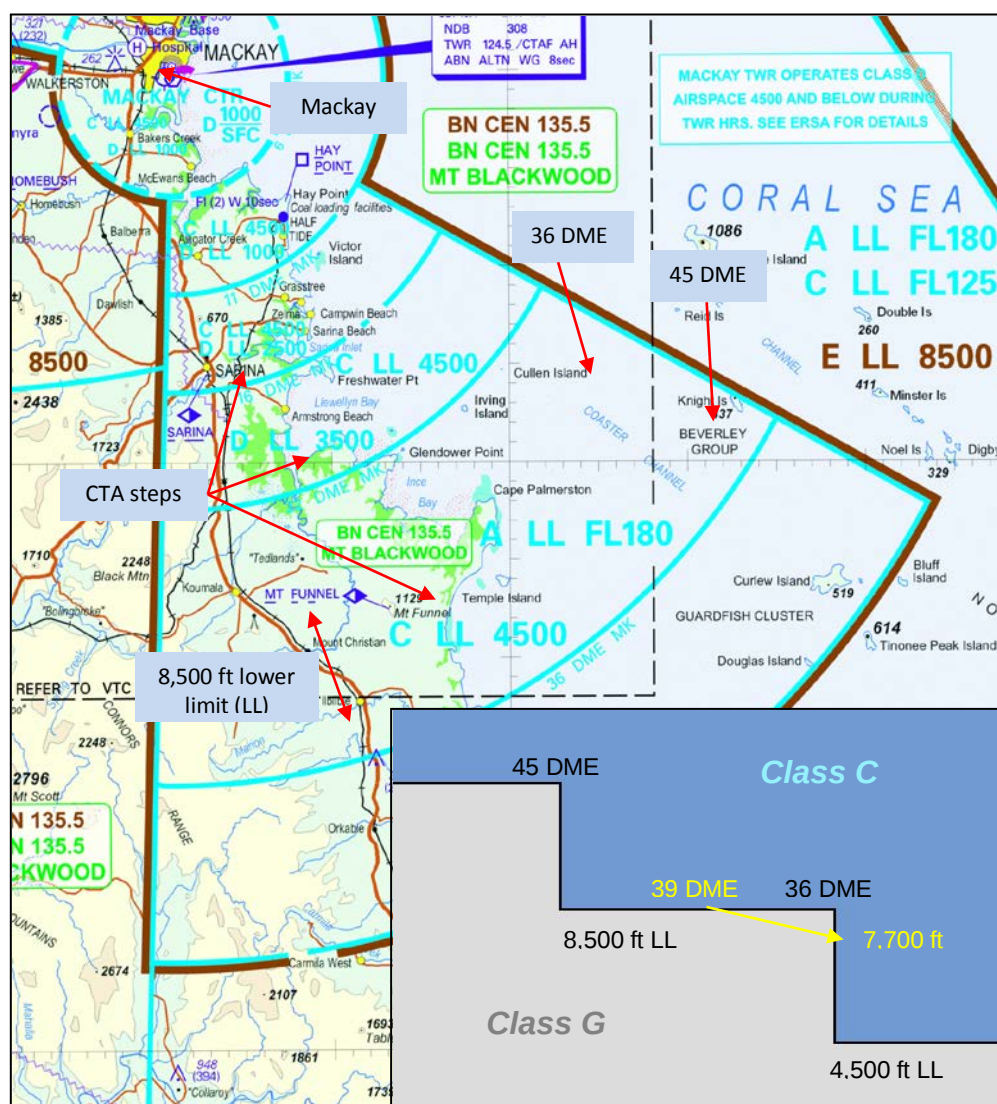
Figure 1: Mackay CTA steps and aircraft's approximate vertical profile (yellow)

- the removal of the range rings on the navigation display
- the apparent exclusion of a brief for the high speed descent
- the descent being conducted in the *VNAV speed* mode rather than the *VNAV path* mode
- both crew members reported feeling tired, which may have degraded their performance.

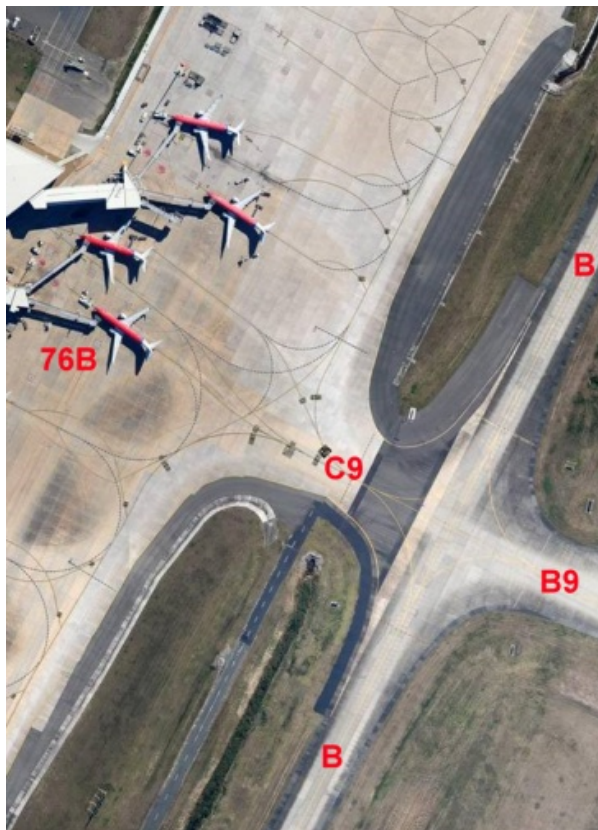
**Figure 1: Parking Bay 76B and Taxiway C9**

The stairs were free standing with two fixed wheels at the rear and two caster wheels at the front. Once in position, locking pads were manually lowered to each wheel to prevent free movement of the stairs.

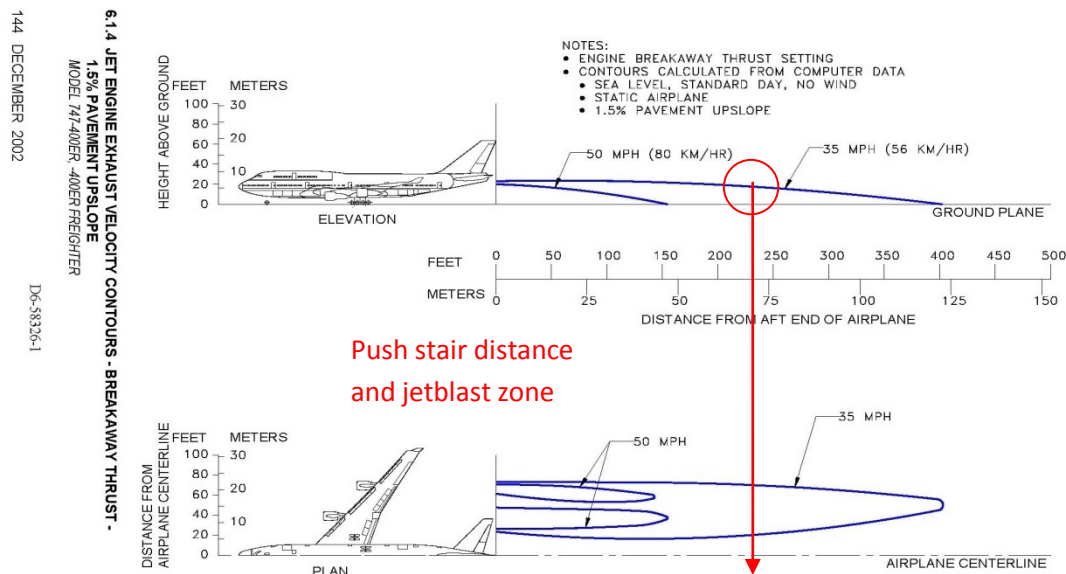
Figure 2: Jet Engine Exhaust Velocity Contours

engine exhaust velocity should not exceed 32 kts (60 km/h) where passengers are expected to walk or people are expected to congregate. Where personnel are working on an aircraft the recommended maximum exhaust velocity is 43 kts (80 km/h).

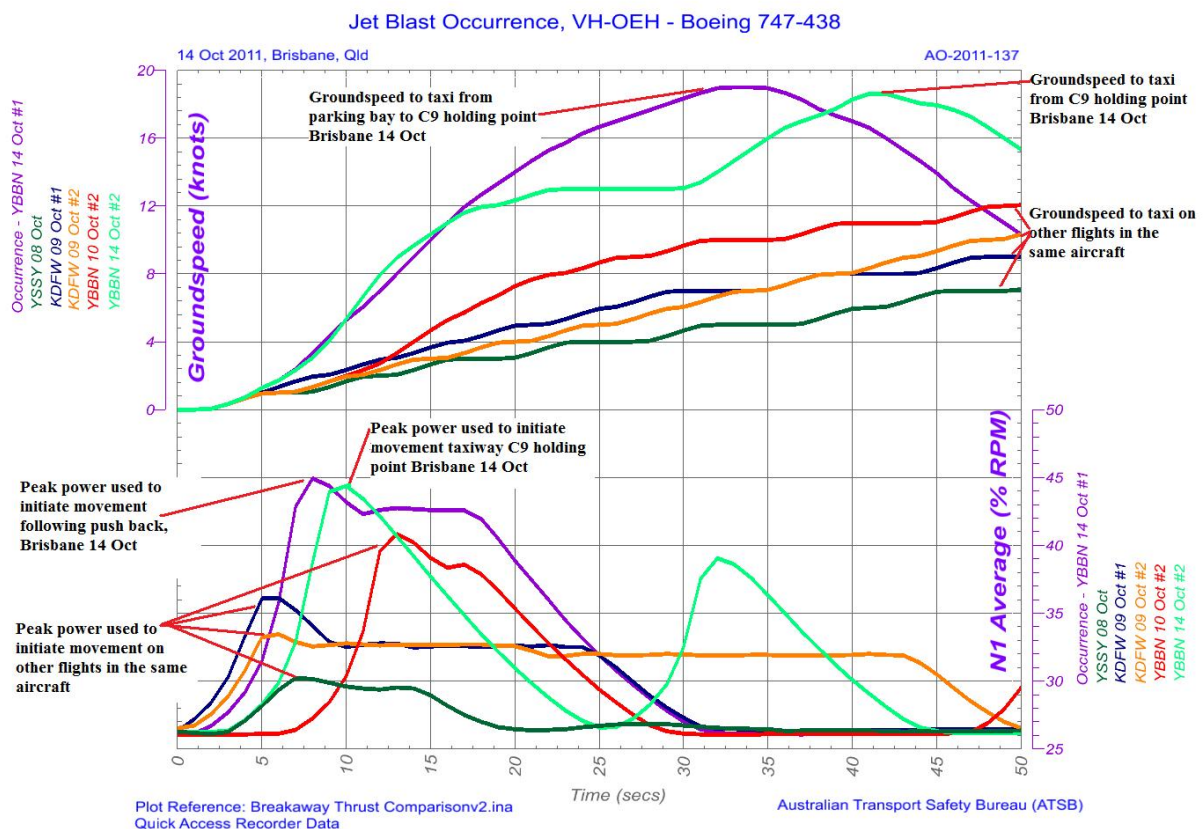
**Figure 3 - Breakaway Thrust Comparison VH-OEH**

Data from OEH's flight data recorder was reviewed by the ATSB, to determine the breakaway thrust used during the taxi. The average engine low pressure compressor speed (N1), and aircraft ground speed, were compared to data from four previous flights. Figure 3, shows a graphical representation of the values obtained with the purple and light green traces representing this occurrence:

On this occasion OEM was relatively lightly loaded, with a takeoff weight of 234,417 kg compared to a maximum takeoff weight of 412,769 kg. That takeoff weight was the lightest compared to the other flights depicted in figure 3.

There was a 26 cm increase in height from the taxiway C9 holding point to the centreline of taxiway Bravo intersection. Data on the slope of the surface on the other flights depicted in Figure 3 was not available.

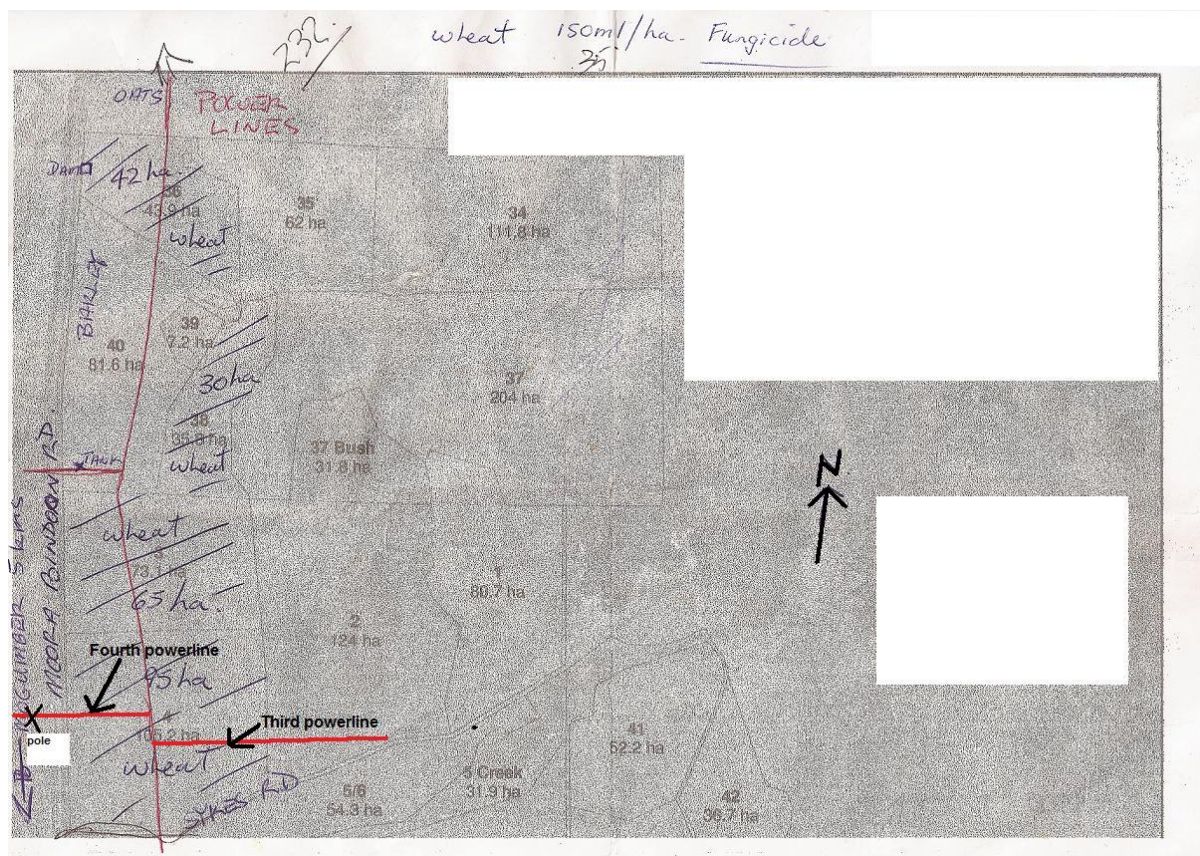
**Figure 1: Farmers map with added powerlines marked**

The pilot also reported that he did not see the power pole hardware associated with the struck

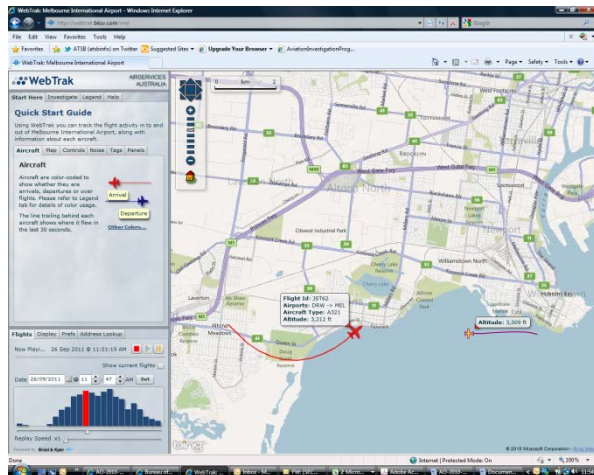
**Figure 1: Webtrak depiction of aircraft tracks**

The pilot of the Archer later reported that he misheard the QNH from the Moorabbin Airport automatic terminal information service and used an incorrect value to set the aircraft's altimeter. He could not understand why he did not detect the error during his cross-check of the altimeter readout against the airport elevation. Moorabbin Airport elevation is 50 ft above mean sea level.

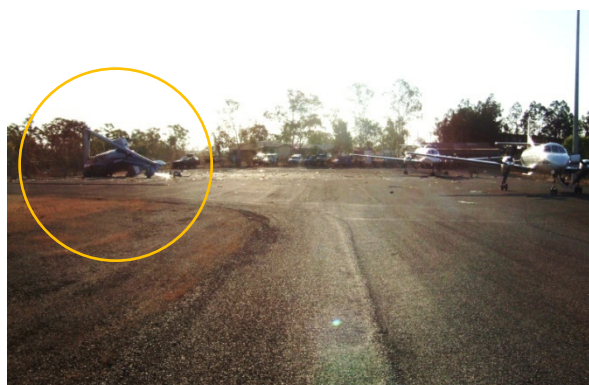
**Figure 5: View of Port Keats Airport apron from taxiway after accident (Helicopter circled)**

Almost immediately there was a 'tick tick' sound then loud crunching sounds. The main rotor blades had struck the light pole (Figure 3) and started to break apart with debris flung about. The helicopter was rapidly propelled towards the light pole, toppling over onto its left side while vibrating vigorously and shedding blade debris in all directions.

The light pole bent where the main rotor blades had struck it. The upper section fell onto the helicopter with electrical wiring exposed, but unpowered. The left side of the cockpit was pushed inwards from contact with the light pole. The helicopter's tail section was also damaged.

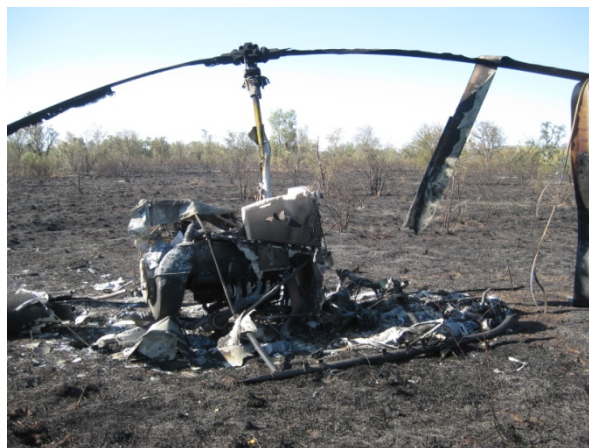
**Figure 1: Accident site**

The pilot notified the company and a nearby helicopter was dispatched to retrieve the pilot and passengers.
