Australian Transport Safety Bureau

Aviation Occurrence Investigation A0-2010-066

# Uncontained engine failure and air turn-back Near San Francisco Airport, USA 30 August 2010

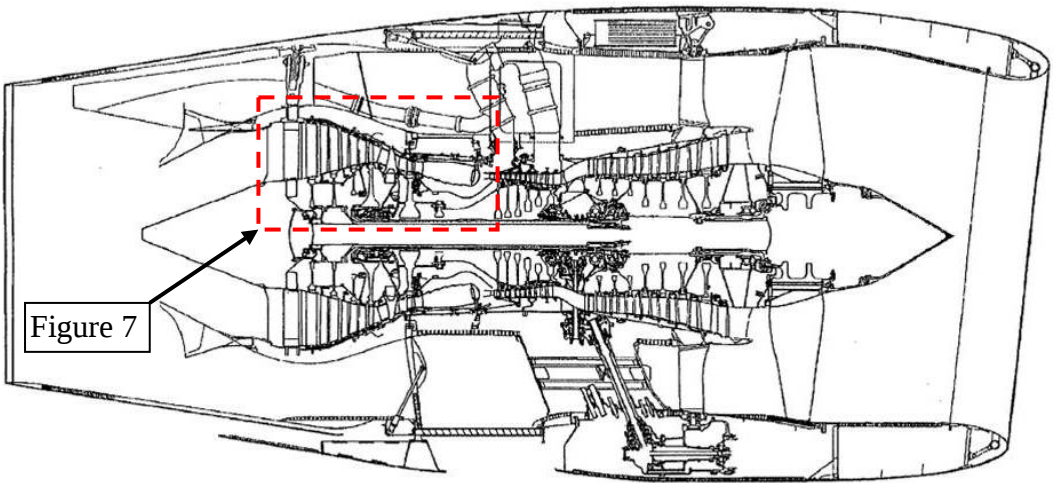
Figure 6: RB211-524 engine

(Figure 5). Figure 6 shows the general layout of the RB211-524 engine and Figure 7 shows the turbine section in detail.

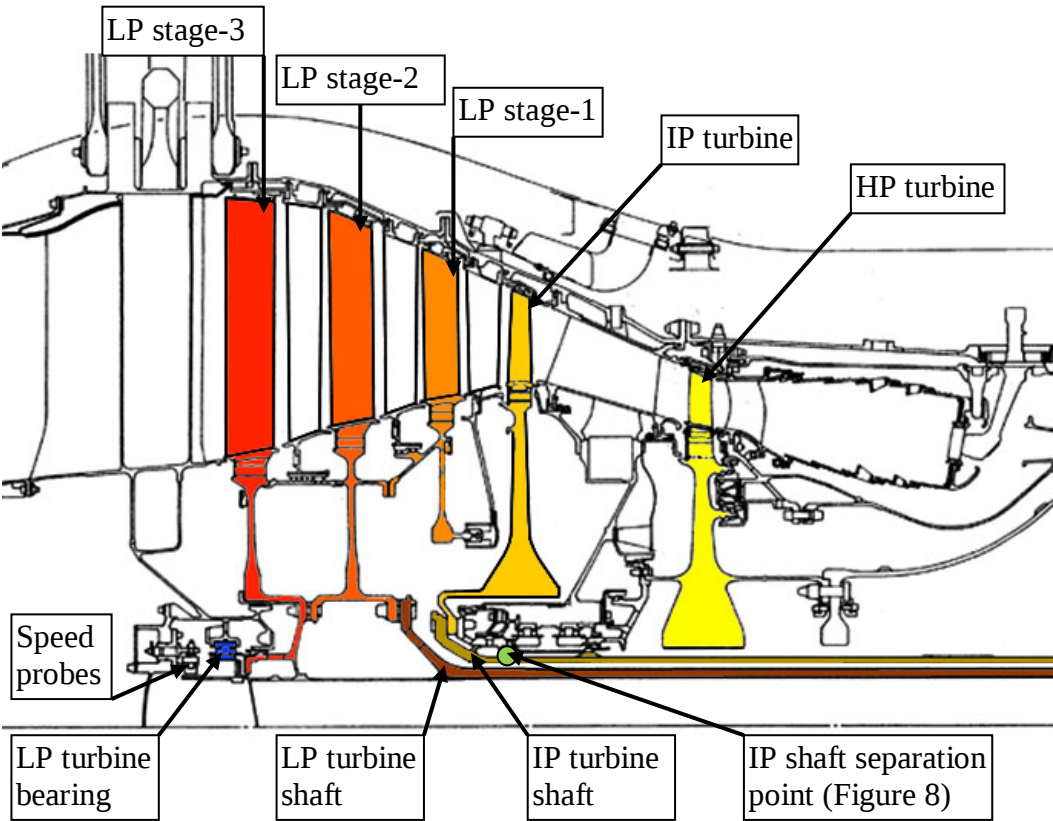
Figure 7: RB211-524 turbine section

Disassembly of the LP/IP turbine module revealed the LP turbine bearing, phonic wheel<sup>4</sup> and speed probe assembly had been destroyed in the failure sequence.
