# Aviation Short Investigation Bulletin

Issue 9

Aviation Short Investigations  
AB-2012-044  
Final

**Report No.** AB-2012-044

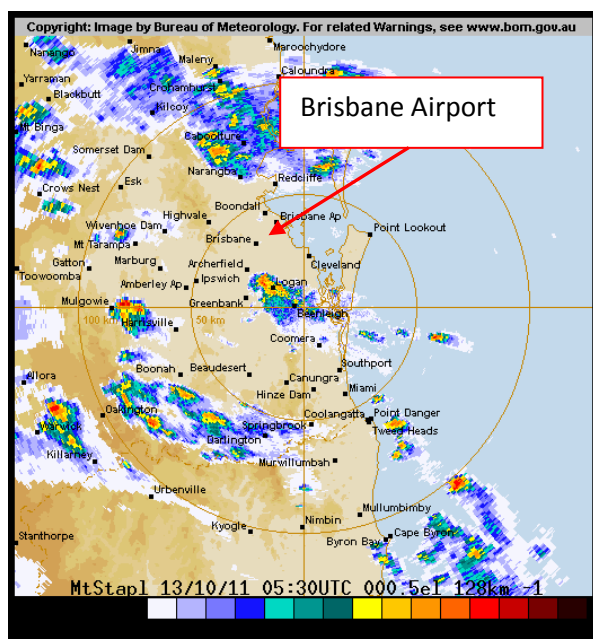
Figure 2: BOM Brisbane weather radar image (1530 EST)

The controller also requested they inform him when they could turn left. The flight crew recalled that the aircraft weather radar showed an intense weather cell with heavy rainfall to the left of their track.

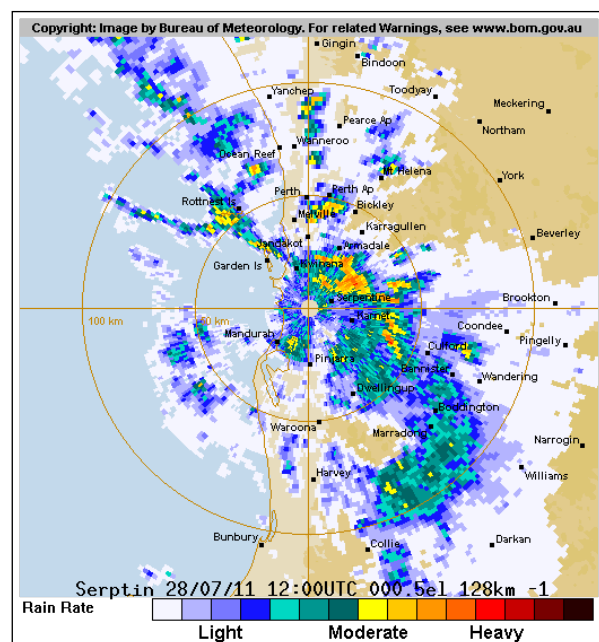
Figure 1: Perth weather radar image (2000 WST<sup>2</sup>)

The crew were aware that the arrival into Perth would coincide with the passage of a cold front with thunderstorms and associated severe weather (Figure 1). Expecting air traffic control (ATC) delays, the crew ensured adequate fuel uplift at Meekatharra. They also secured the cabin earlier than normal, briefing the cabin attendant and passengers on the expected turbulent flight conditions.

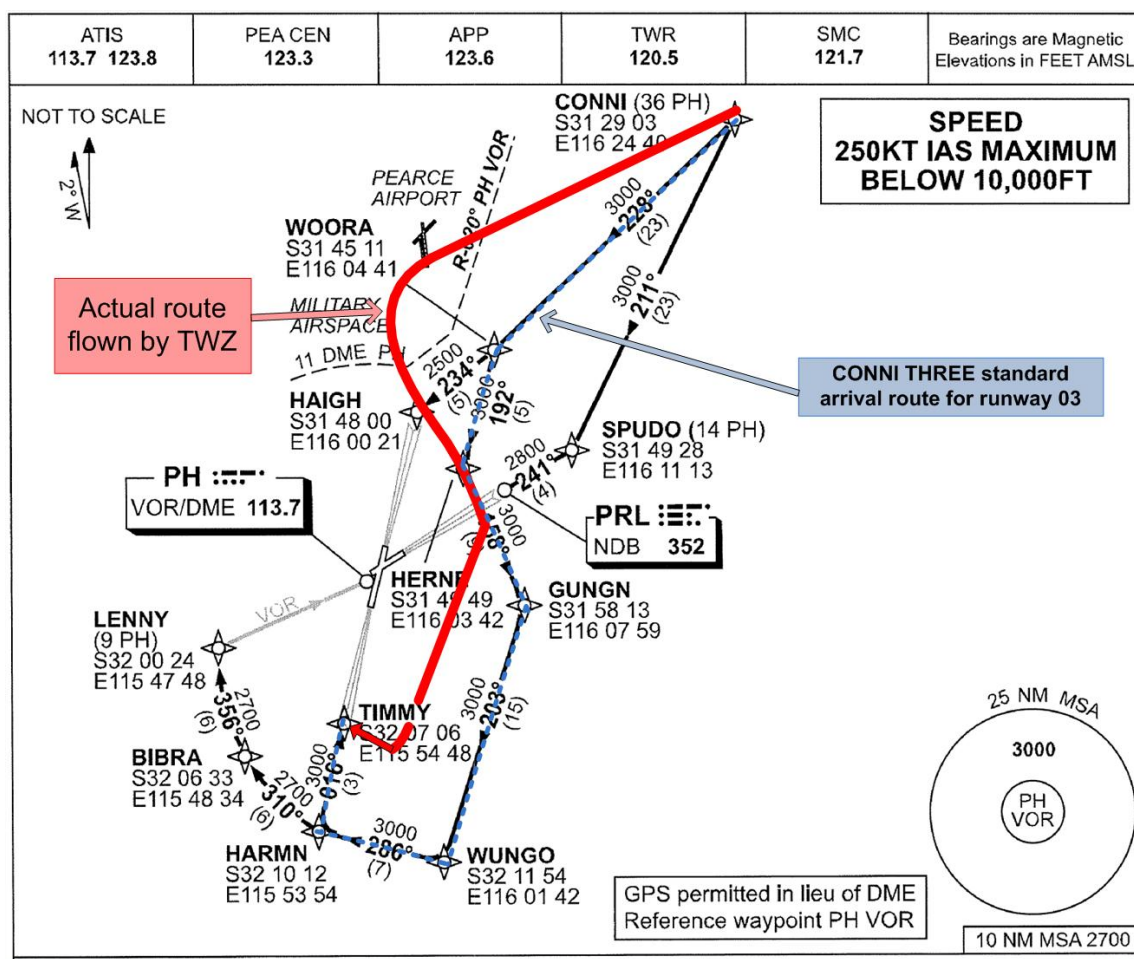
Figure 2: CONNI THREE STAR showing approximate flight path of TWZ into Perth

Prior to descent, the crew were issued a clearance by ATC to carry out the CONNI THREE standard arrival route (STAR) (Figure 2) for an instrument landing system (ILS) approach to runway 03. After passing waypoint CONNI, the crew requested and were approved to divert 10 NM right of track to avoid weather. The STAR was subsequently re-joined at waypoint HERNE, but shortly thereafter

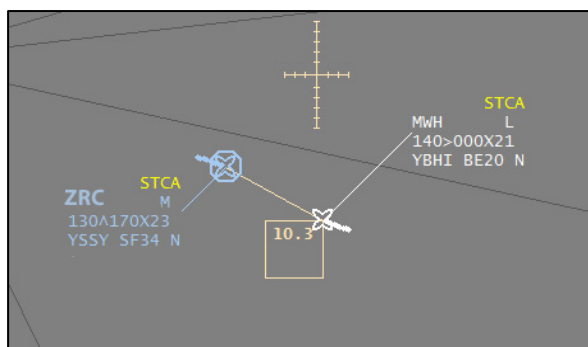
**Figure 1: Position of aircraft at 0720:22**

Review of the Airservices Australia radar data indicated that at 0720:22, a short term conflict alert (STCA)<sup>5</sup> on The Australian Advanced Air Traffic System (TAAATS) activated. At that time, ZRC was climbing through FL130 and MWH was maintaining FL140, with 10.3 NM between them (Figure 1).

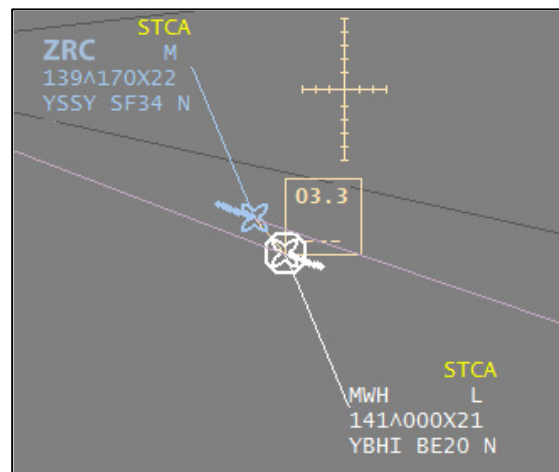
**Figure 2: Position of aircraft at 0721:25**

At 0721:25, separation reduced to 3.3 NM laterally and 200 ft vertically (Figure 2)

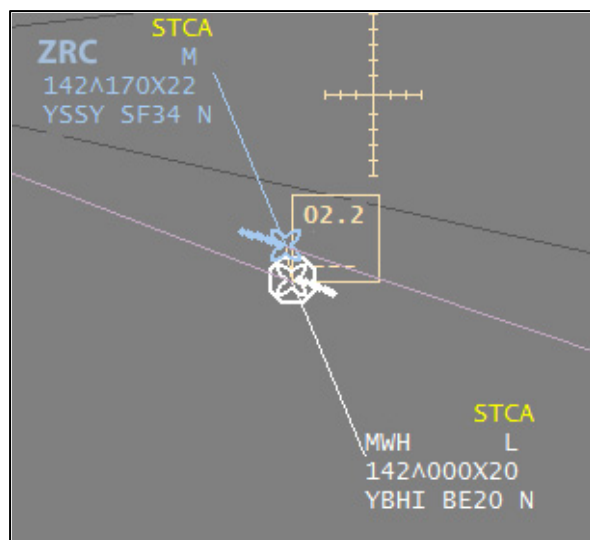
**Figure 3: Position of aircraft at 0721:38**

At 0721:38, with both aircraft at FL142, lateral separation reduced to 2.2 NM (Figure 3).

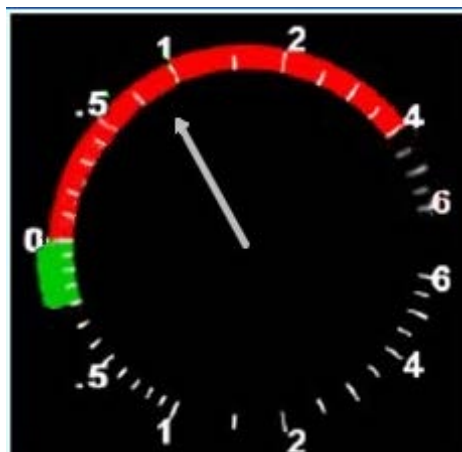
**Figure 4: Illustration only of VSI with TCAS lights**

In ZRC, TCAS RA guidance is incorporated into the aircraft's vertical speed indicator (VSI). Two rows of coloured lights, one green and one red, were positioned around the VSI scale and were used to indicate whether to climb, descend or remain level. When a TCAS RA is received, certain segments of the green lights and red lights will illuminate. The pilot is then required to manoeuvre the aircraft to place the VSI in the area represented by the green lights only; the red area should be avoided (Figure 4).

The FO reported that, prior to receiving the TCAS RA; he believed that they were above MWH. Consequently, when the 'adjust vertical speed, adjust' announcement was heard, he anticipated the RA command and commenced a climb before interpreting the VSI. When the FO referenced the VSI, he initially observed red lights illuminated up to the 4,000 feet per minute climb rate, with no further indications noted. The FO momentarily thought that this confirmed his action to climb. However, he then noted the green lights illuminated in the lower arc, indicating a descent was required.

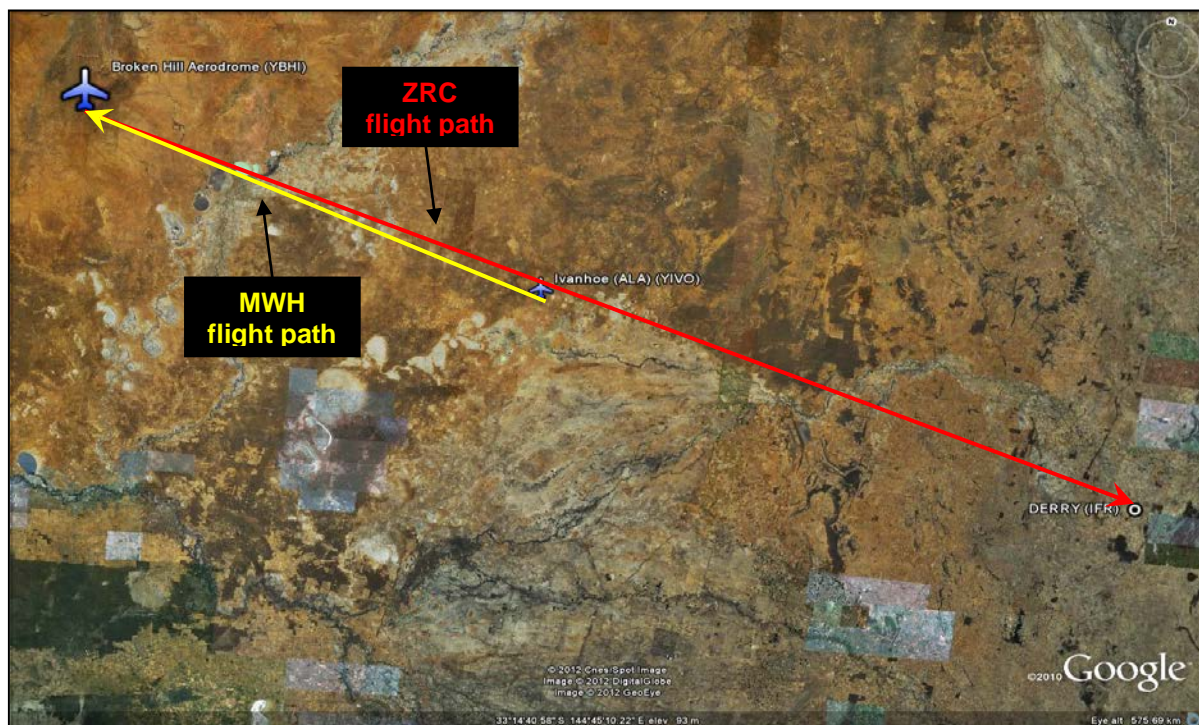
Figure 5: Approximate aircraft flight paths

While maintaining flight level (FL)140, the pilot was advised by Melbourne Centre, air traffic control (ATC) of a Regional Express S.A.A.B. Aircraft Corporation 340B aircraft, registered VH-ZRC (ZRC) that had departed Broken Hill for Sydney on climb to FL170 (Figure 5). At the time, MWH was about 50 NM from Broken Hill in class G airspace<sup>1</sup>. The estimated time of passing of the two aircraft was 0721 Eastern Standard Time<sup>2</sup>.

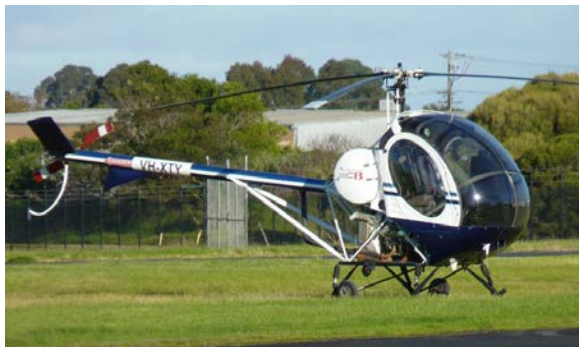
**Figure 1: VH-XTY, Schweizer 269C-1**

During the afternoon of 5 December 2011, an instructor and student were conducting emergency procedures training in the circuit at Moorabbin Airport, Victoria, in a Schweizer 269C-1 helicopter, registered VH-XTY (Figure 1). The flight was to include low-level autorotations to simulate an engine failure during the takeoff and approach.

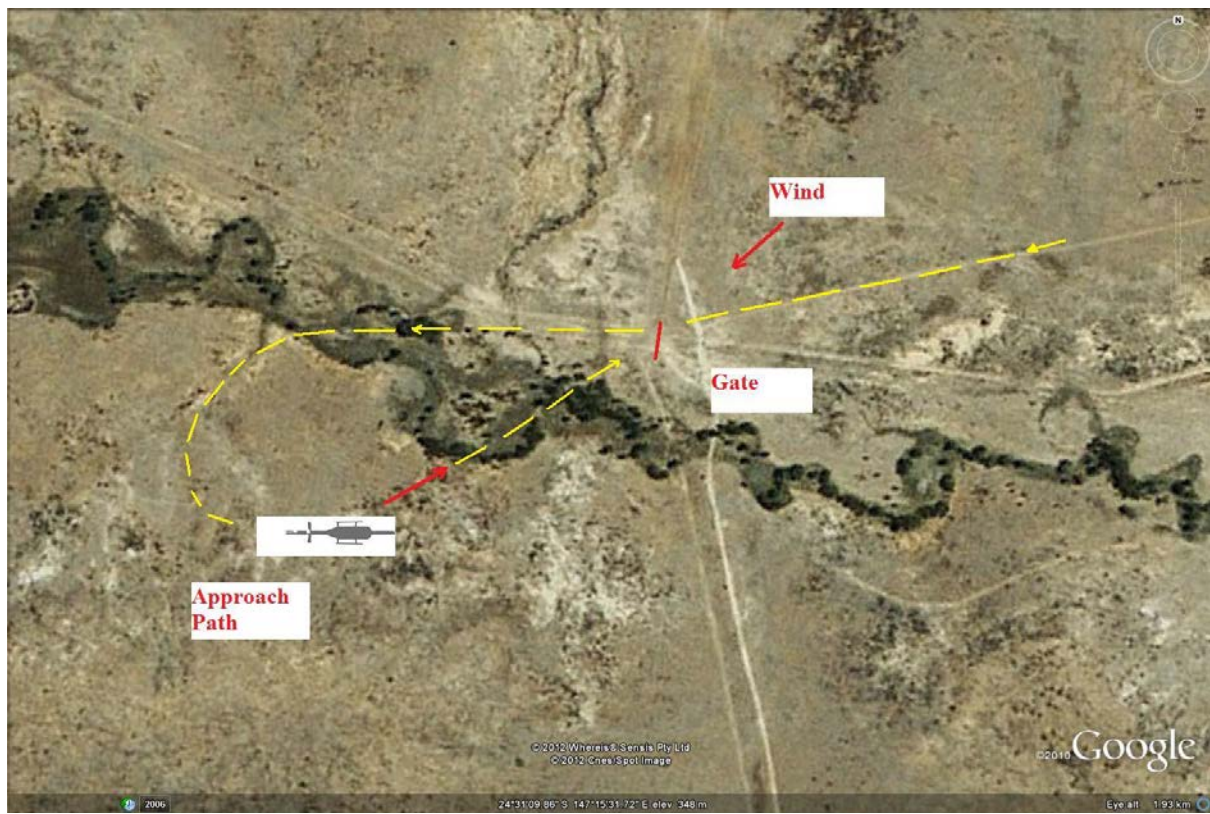
Figure 3: Approach path to the gate

Having landed at the particular gate on at least six previous occasions, the pilot was familiar with a clear landing area located nearby. The pilot flew over the gate from the north-east and made a 180-degree turn back into wind to approach an area clear of saplings and long grass (Figure 3). The pilot
