Aviation Short Investigation Bulletin

Issue 10

Report No. AB-2012-065

Publication date 25 June 2012

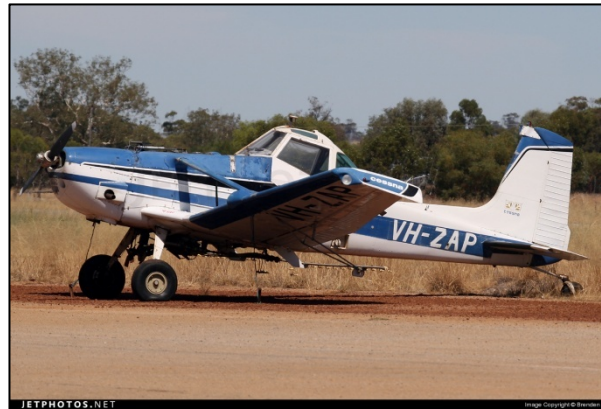
Figure 2: VH-ZAP file photo

The aircraft (Figure 2) was equipped with an emergency dump control system. The system consisted of an emergency dump gate which was controlled by a flow control handle located in the cockpit. Pushing the handle forward jettisoned the contents of the hopper.
