Derailment of train 1MP5

Goddards, Western Australia | 28 December 2010

ATSB Transport Safety Report
Rail Occurrence Investigation
RO-2010-015
Final

Report No. RO-2010-015

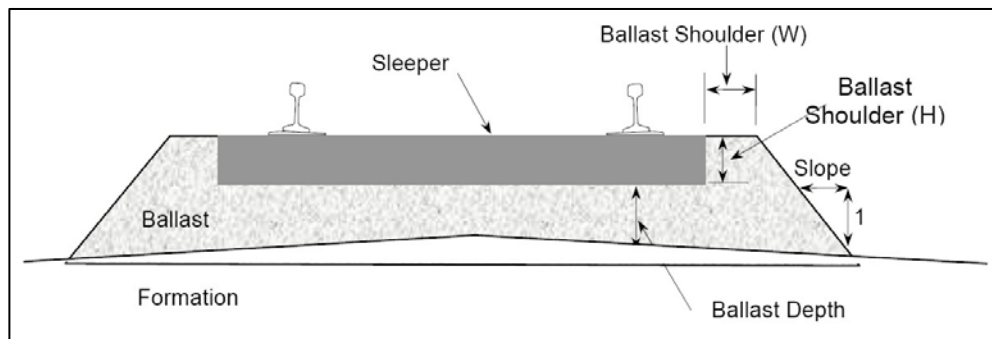
Figure 10: Drawing from ARTC Code of Practice, Section 4 Ballast

Track buckling is heavily influenced by the quality/quantity of ballast surrounding sleepers, particularly within the crib and surrounding the shoulder. Where ballast within the crib and/or shoulder is deficient or in poor condition, the track will be more susceptible to misalignment due to a lack of lateral track stability.

The *ATRC Track and Civil Code of Practice SA/WA and Victoria, Infrastructure Guidelines – Section 4 Ballast* specifies a minimum width (W) of 300 mm, height (H) of (150 mm) and a shoulder slope of 1 in 1.5 for concrete sleepers (Figure 10).

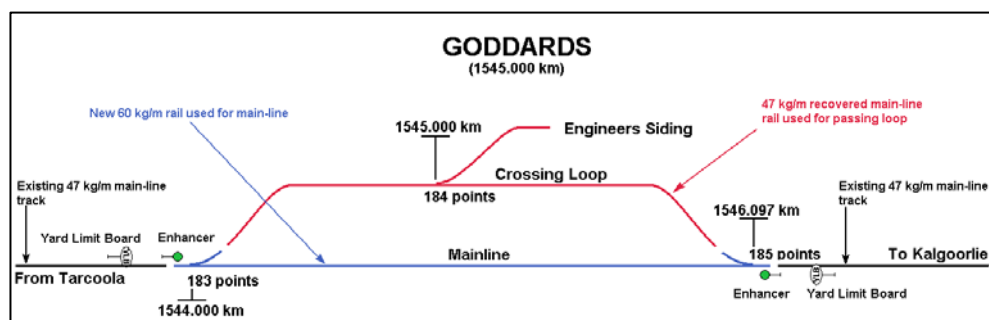
Figure 13: Goddards crossing loop works

The Goddards crossing loop was installed in-between existing 47 kg/m tangent track, with two new 60 kg/m turnouts located at the extremities of the crossing loop and new 60 kg/m rail connecting the turnouts (Figure 13). The new turnouts and associated concrete bearers were substantially heavier than the tangent track and therefore acted as fixed points. It was therefore essential to correctly de-stress the 60 kg/m tangent rail, located between the two turnouts (fixed points), to limit the magnitude of any longitudinal rail forces and the associated risk of track buckling.
