ATSB TRANSPORT SAFETY REPORT

MO-2010-002

Independent investigation into the stevedore fatality on board the
Antigua and Barbuda registered container ship

Vega Gotland

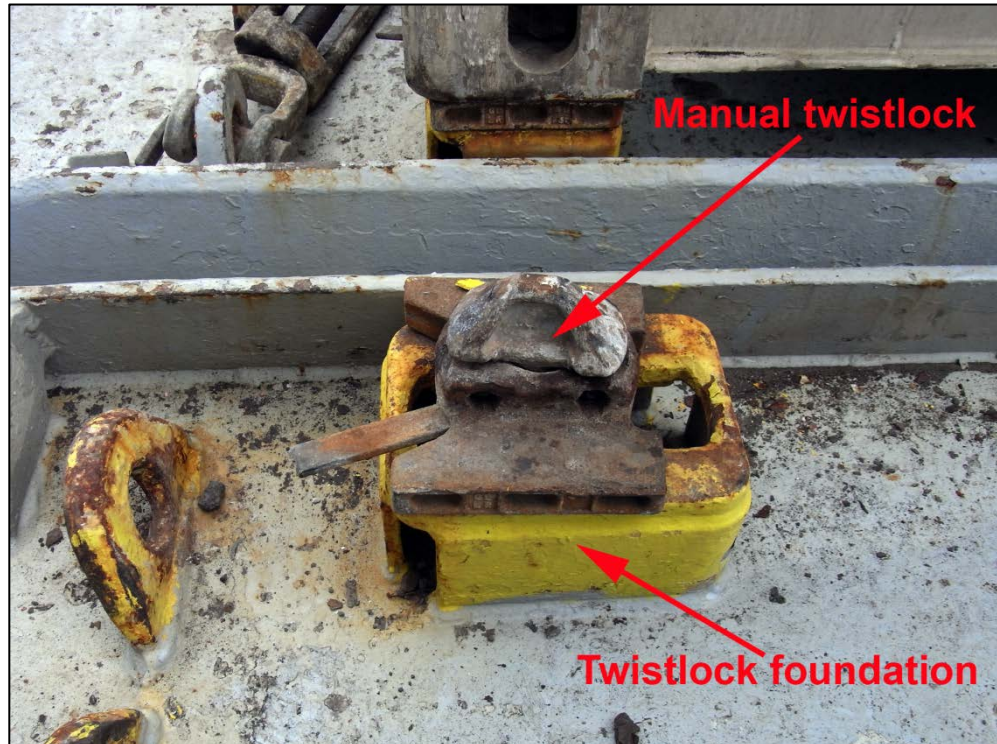
Figure 3: A manual twistlock seated in a foundation

The investigation also found that the failure of the twistlock foundation was brought about by an attempt to reposition the container and was consistent with its exposure to gross overstress conditions as a result of the leverage forces applied to it by the container and the unsecured hatch cover.

The twistlock foundations are welded to the hatch covers and stand 110 mm off the hatch covers. The twistlocks and foundations have a nominal breaking load of 500 kN (about 50 tonnes) in tension and 420 kN in shear.

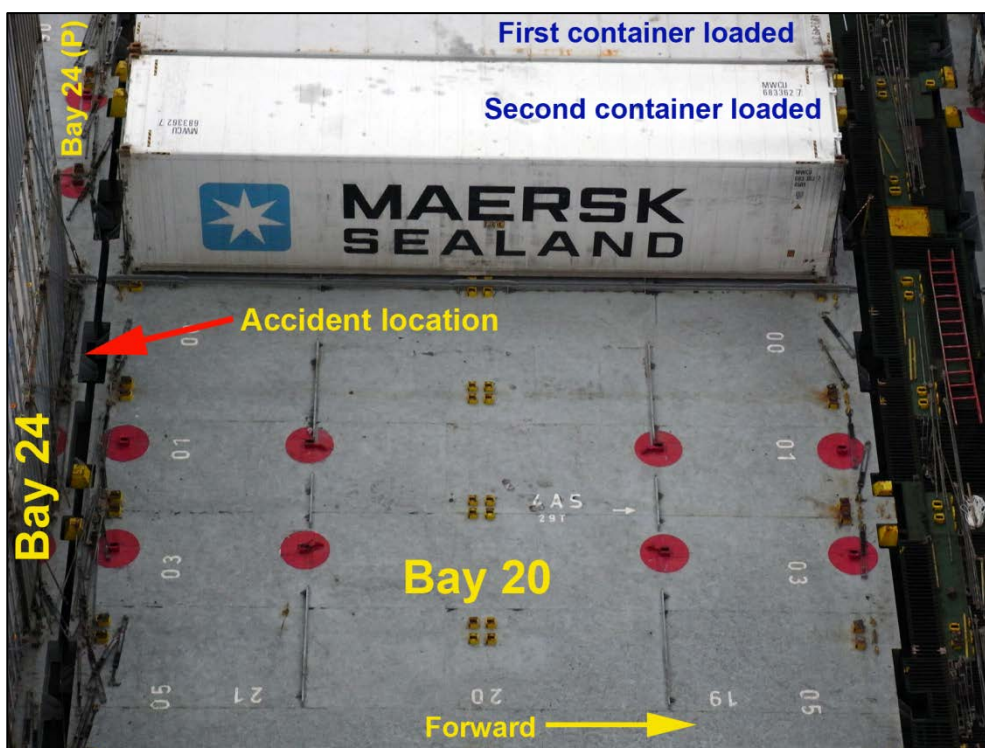
Figure 7: View of Bay 20 from the portainer cabin

At 1917, a third container was lowered into position, this time onto the starboard side hatch cover in Bay 20 (Figure 7). As with the first two containers, the third container did not sit properly on the after twistlocks. The deck team leader locked the twistlock at the forward inboard corner of the container, so that there would be a point around which the container could pivot horizontally. He then moved away from the container, and stood on the forward end of the hatch cover, well to starboard so that the portainer driver could see him clearly. He asked the portainer driver to lift the container slightly so that it could be positioned over the after twistlocks.

The lashing team leader moved towards the third container, in preparation to lock the after twistlocks. He stood at the after end of the hatch cover, between the container which was being loaded and a FEU which had been loaded in Bay 24 (Figures 7 and 8).
