Grounding of the Panama registered bulk carrier *Dumun*

Gladstone, Queensland | 29 April 2011

ATSB Transport Safety Report
Marine Occurrence Investigation
285-MO-2011-004
Final

Report No. MO-2011-004

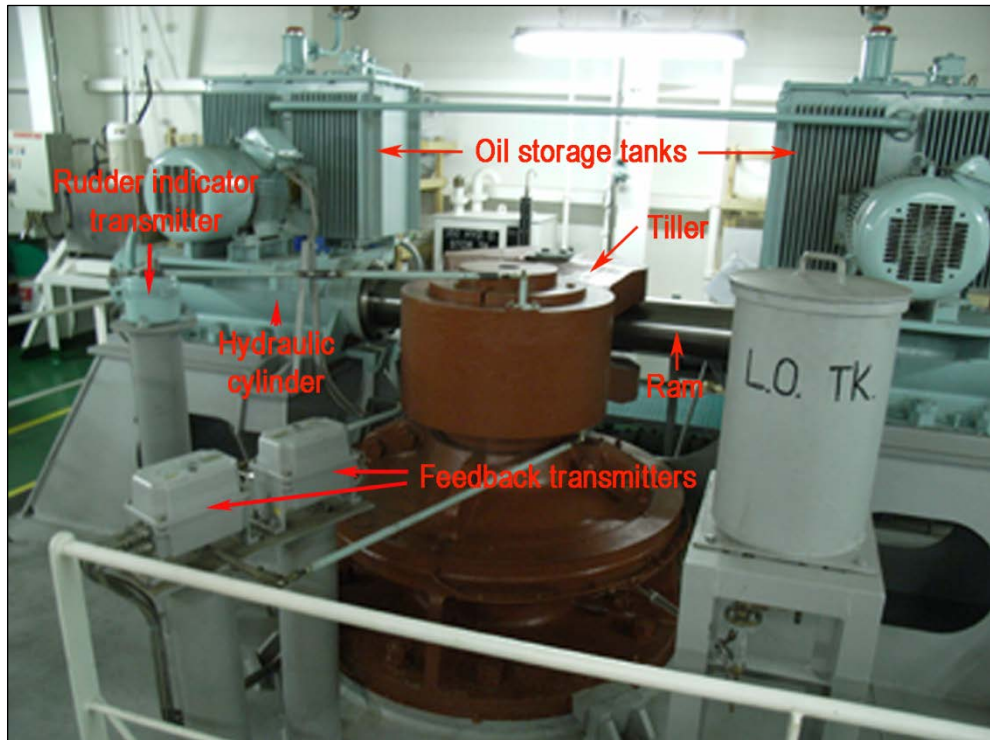
Figure 3: The steering gear

Dumun was fitted with a Mitsubishi SFC-80TS electro-hydraulic steering gear, which comprised two, opposed, single-acting hydraulic cylinders attached to the rudder tiller arm. Oil was supplied under pressure to the hydraulic cylinders by two identical and independent hydraulic units (Figures 3 and 4). Each of the hydraulic units consisted of an electric motor, a hydraulic pump mounted in an oil storage

The control systems were designed to provide complete redundancy. As a result, each system relied on its own tiller position transmitter for a feedback signal. A third tiller position transmitter (Figure 3) provided an independent signal to the bridge-front mounted rudder angle indicator.

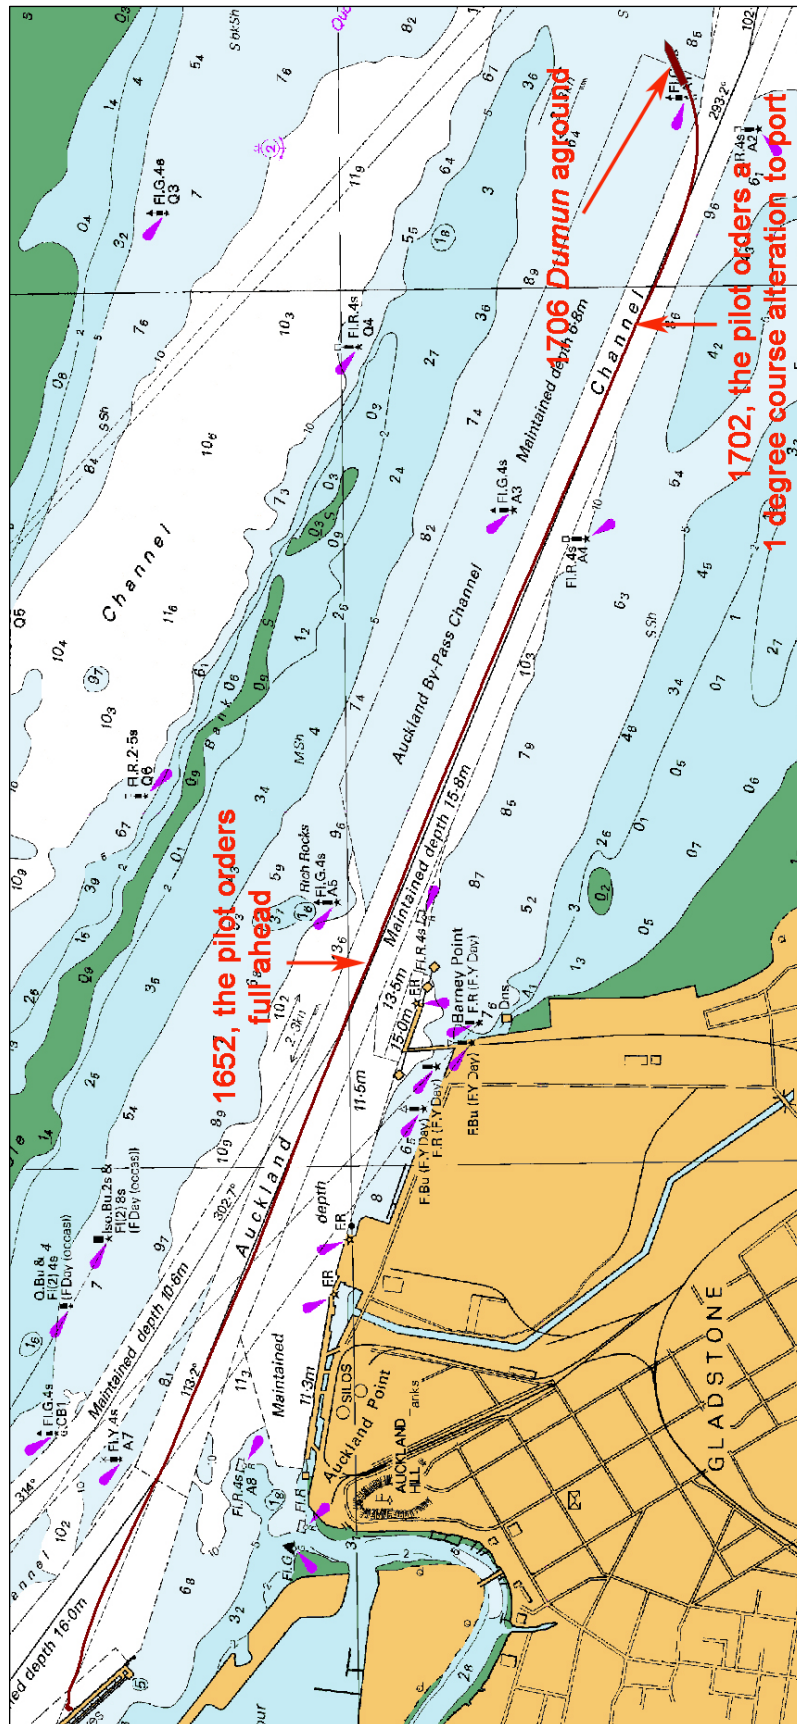
Figure 7: Section of navigational chart Aus 366 showing *Dumun's* track in red

Shortly afterwards, the chief mate arrived on the bridge. He went straight to the chart table, noted the GPS position and plotted it on the chart. The ship was now approaching the A3 and A4 beacons (Figure 7). The helmsman was steering 115° and the ship was maintaining a course made good of about 113° (T).

At 1703¼, the pilot ordered the main engine stopped and, soon afterwards, the ship started to swing to port. At about the same time, the chief mate selected NFU steering control and operated the steering control lever. The rudder angle indicator still did not move. Shortly afterwards, the master changed over steering motors, but still nothing appeared to respond.
