## **Appendix A: Technical Analysis Report**

# **Examination of failed landing gear struts MD Helicopters, Model MD520N VH-MPI 21 June 2004**

Report No. 35/04

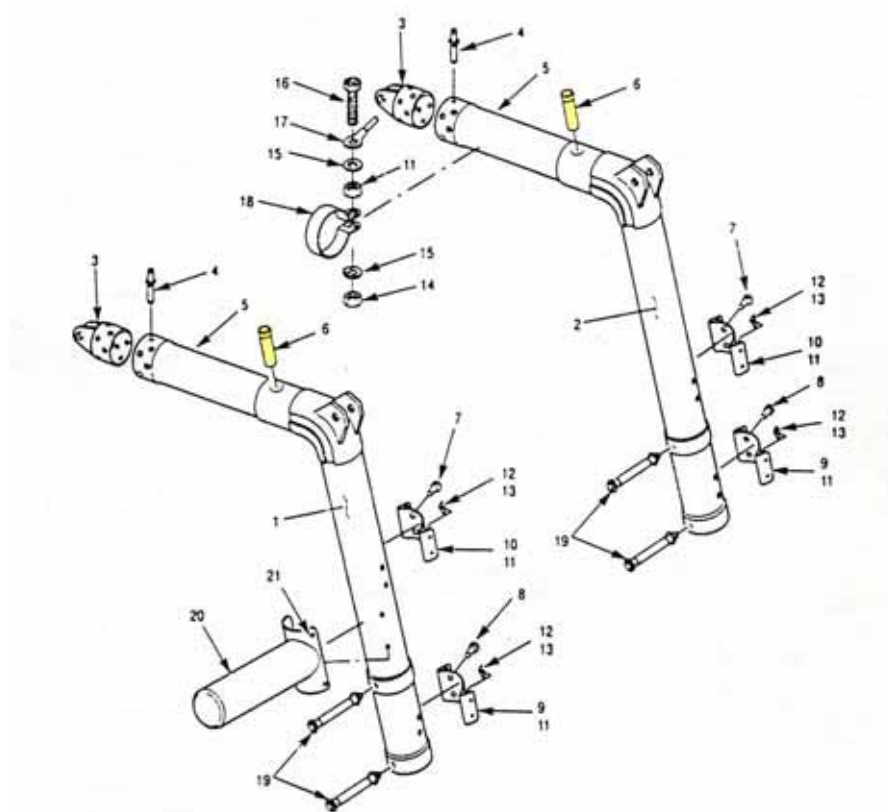
**FIGURE 10: Drawing from the illustrated parts catalogue showing the use of bushings (item 6) at the drag brace connection points**

A cylindrical steel bushing had been fitted to the rear strut drag brace attachment point (through which fracture occurred) and served to transmit forward and aft landing gear loads into the drag link (see Figure 9).

The helicopter manufacturer indicated that several bushing parts were available to suit the strut-brace connection, however the outer diameters of all were less than the bushing fitted to the rear strut from VH-MPI. The manufacturer also indicated that all original equipment bushings were supplied with a larger diameter flanged upper end (see Figure 10) and were manufactured from an AISI/SAE 4130 alloy steel, or a 17-4PH stainless steel as an alternative.

The bushing was identified as a corrosion resistant austenitic stainless steel meeting the general chemical composition of a 316L (UNS S31603) grade. The strut alloy was a typical age hardening aluminium alloy of the 7075 (UNS A97075) type.
