# Loss of control Robinson Helicopter Company R44 Astro, VH-HFH

Cessnock Aerodrome, New South Wales | 4 February 2011

AO-2011-016

**Report No. AO-2011-016**

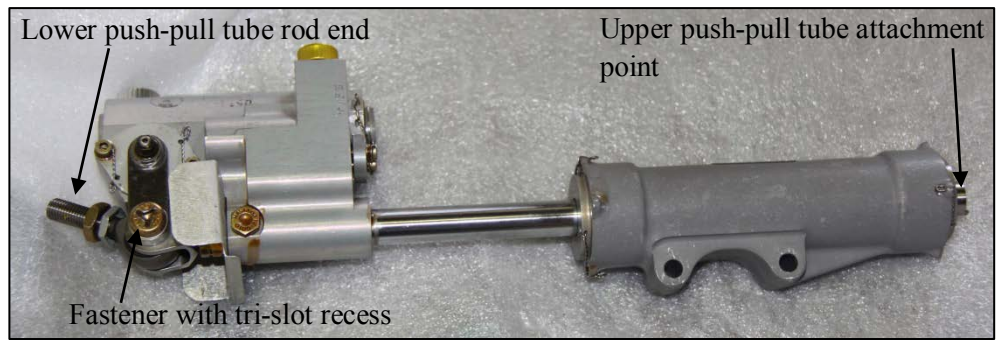
**Figure 3: Hydraulic-boost servo**

The approved method of replacing the hydraulic-boost servo was detailed in the manufacturer's R44 maintenance manual. The procedure involved the disassembly of a number of major components, including the fuel tanks, to gain access to the servos. In addition, the upper and lower flight control push-pull tubes needed to be disconnected from their servo attachment points (Figure 3).

The manual required the removal of the lower push-pull tube from the servo by unthreading it from its rod end (Figures 3 and 8) and stipulated that disconnection of the tube by disassembling the rod end securing fastener (Figure 8), was prohibited. The manufacturer advised that correct assembly of that fastener was critical to the proper operation of the servo and that the helicopter would be rendered uncontrollable if there was a disconnection of any of the upper or lower push-pull tubes.

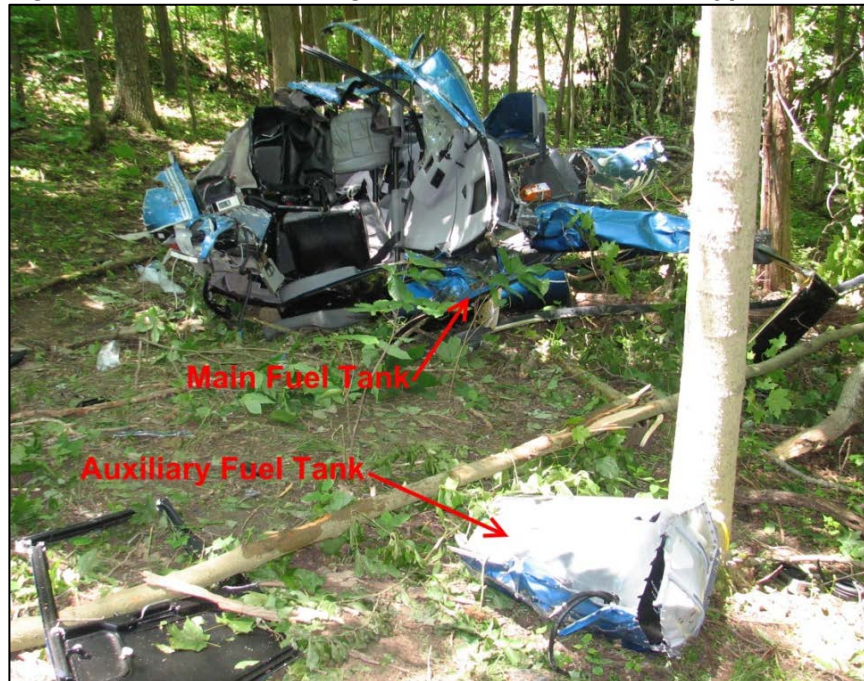
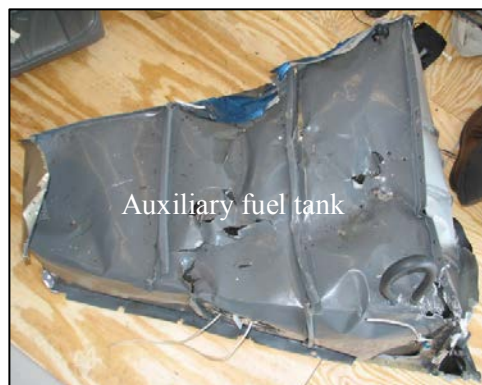
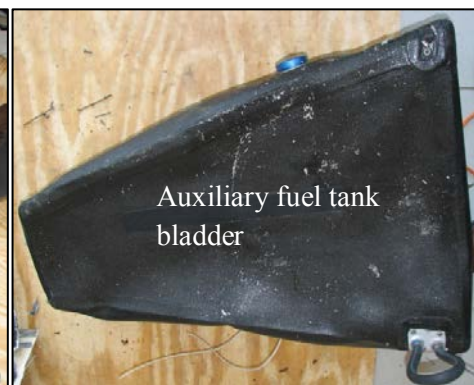
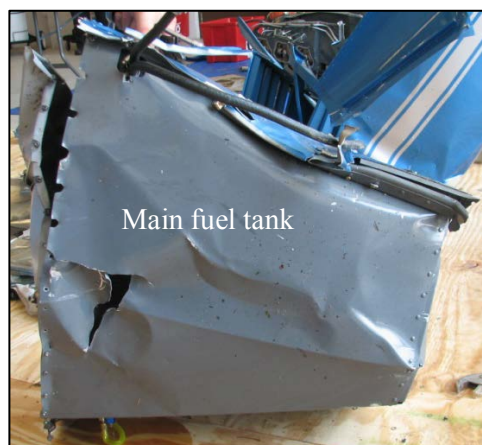
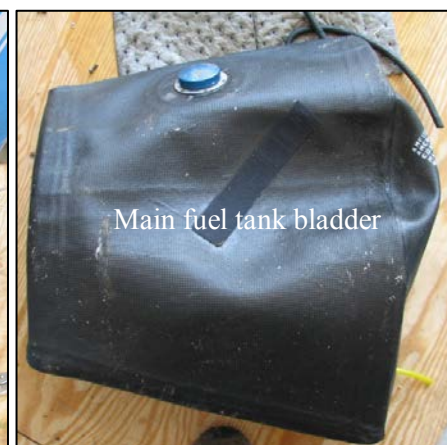
**Figure 7: Accident involving an R44 fitted with bladder-type fuel tanks**

The helicopter manufacturer also advised that they were aware of four accidents involving R44 helicopters with bladder-type tanks that were of sufficient severity to result in fatal or serious injury to the occupants. The manufacturer advised that three of these accidents did not result in a post-accident fire (for example, see Figure 7). At the time of writing, the manufacturer was unable to confirm whether a post-accident fire occurred in the fourth instance.

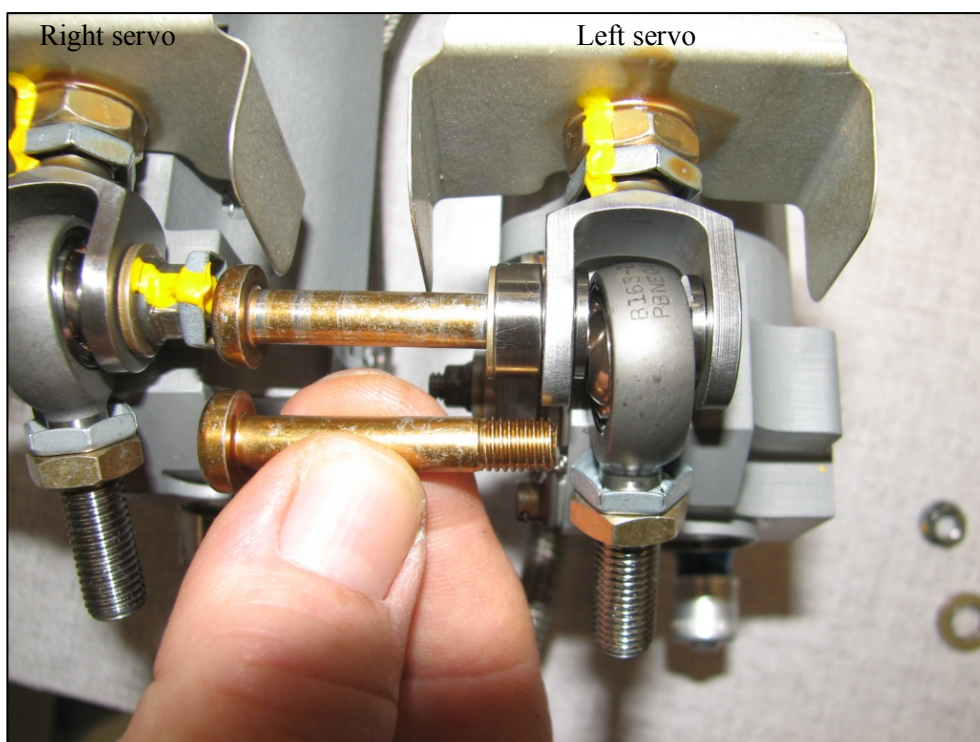
**Figure 16: Front hydraulic-boost servos**

The testing also identified that the relative position of the installed front servos allowed a detaching bolt from the left servo to contact the right servo (Figure 16). This permitted the movement of the right servo to interfere with the normally independent movement of the left servo.

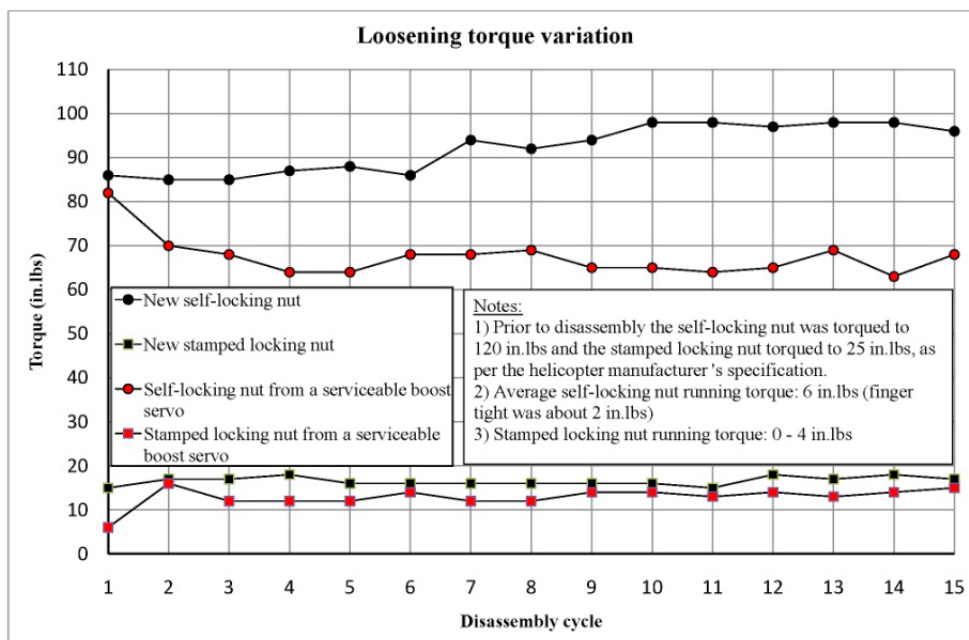
**Figure 17: Loosening torque variation**

The helicopter manufacturer permitted the re-use of serviceable fastener components. In order to assess the behaviour of the fastener following repeated use, two complete sets of fastener components were disassembled and reassembled multiple times. The torques that were required to loosen both the self-locking and stamped locking nuts were recorded together with the torques required to overcome the friction associated with unthreading both nuts (known as running torque). The results of that testing identified that (Figure 17):

- The average running torque of one of the stamped locking nuts was about 4 in.lbs. The running torque of the other stamped locking nut rapidly fell to zero within one quarter of a turn during each of the multiple assembly/disassembly cycles.
- The average running torque of the self-locking nuts was about 6 in.lbs.

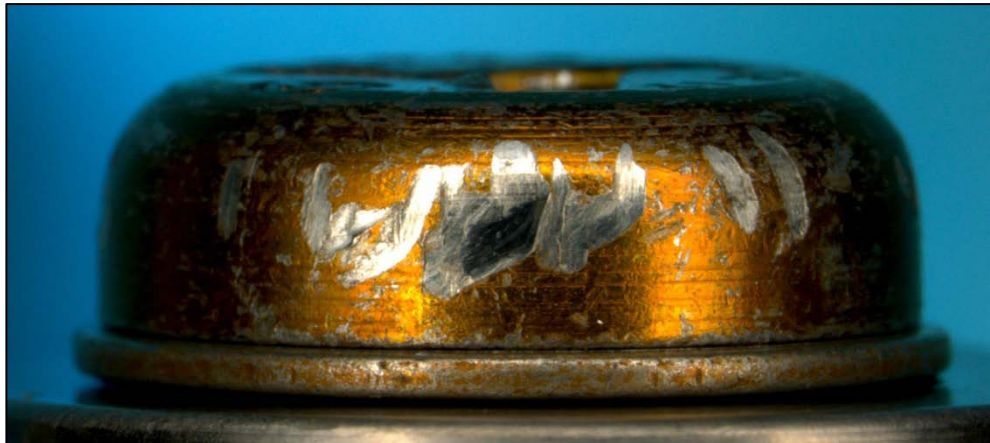
**Figure 18: Typical contact marks left by masked multi-grip-type hand tools**

A final test involved the disassembly of the fastener using masked<sup>18</sup> multi and locking-type grips. That testing identified that only the locking-type grips could secure the bolt head sufficiently in order to allow removal of the self-locking nut. Both types of grips left distinctive contact marks on the bolt head (Figure 18). No comparable marks were identified on the detached bolt from the accident helicopter.
